St. Thomas Cathedral, Fort, Mumbai

With standing the test of time and climatic changes, church building began to show the signs of wear and tear which was spotted by the trust caretakers. 'Savani Heritage Conservation Private Limited' a prestigious name in heritage site restoration was given the task to resurrect the building whilst preserving its architectural and textural features. A dedicated team of experts from Savani Heritage Conservation Private Limited engaged in the task by employing skilled masons and labourers under the supervision of Engineers to execute the task. In the year 2003, the Phase-I of the restoration began under the leadership of the Principal Ar. Brinda Somaya of Somaya and Kalappa Consultants which focused on the Altar and the Ancillary structure. While, the Phase-II restoration and repairs were carried out as required under the Consultation of Conservation Architect, Ar. Sheetal Gandhi, who focused on the tower and the internal repairs. Generous donations were made from Philanthropist Mr. T. Thomas and Mrs. Meera Issacs that made the big task of restoration of Cathedral possible.

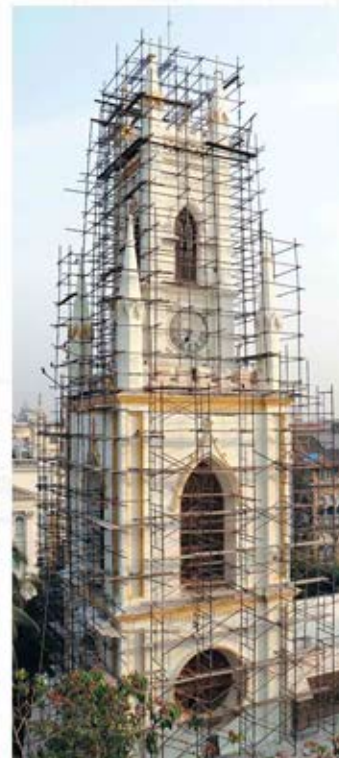
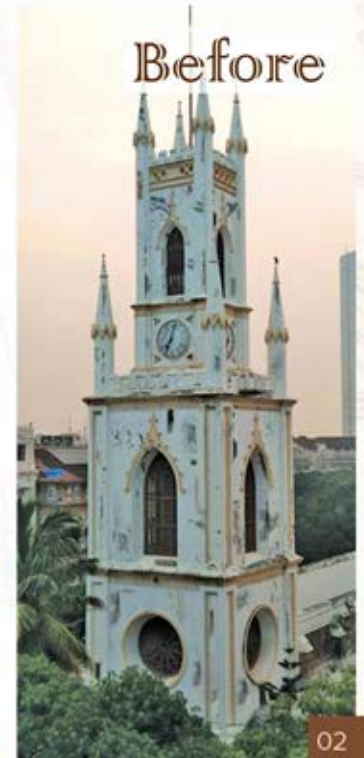
Before

With the passage of time, the entire structure of tower (its total length) got contaminated by biodeteriogens which resulted in algal growth and the plaster appeared flaked or faded giving a dull appearance. The dampness was the chief reason of deterioration as the damp patchesshowed prominently on surface of the tower and on its windows. After taking cognizance of the cause and effect, thoughtful measures were taken for conservation, restoration and repair work. All the flaws were eliminated from the structure of the tower which has been duly justified by the pre and post photograph of the site.

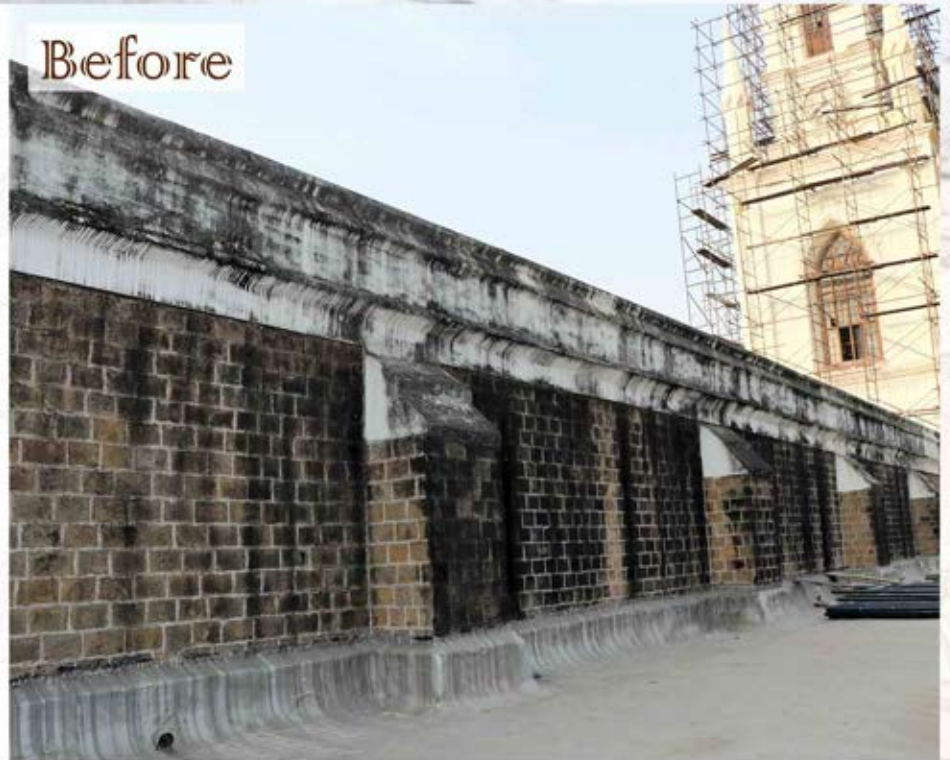
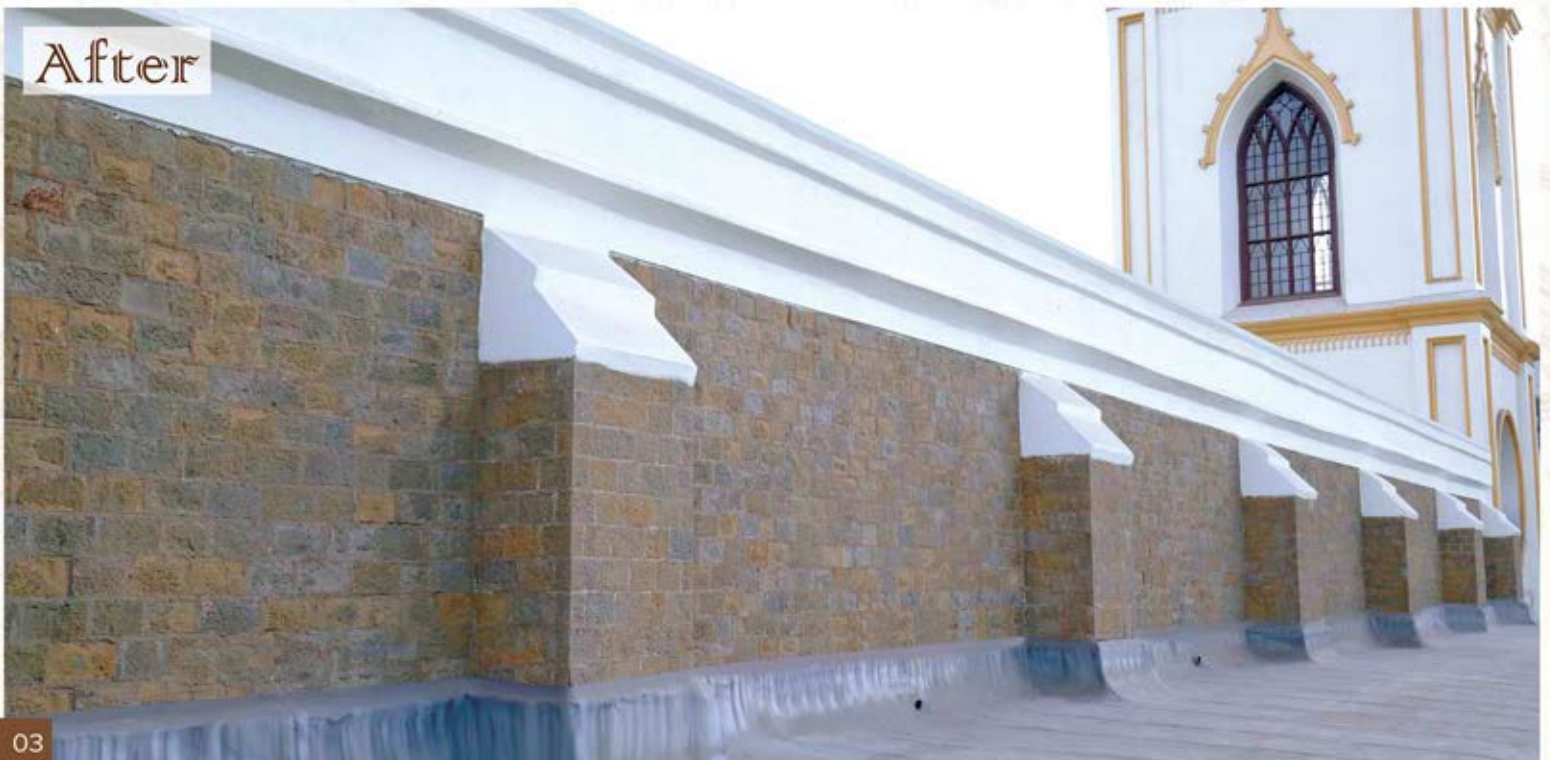
With standing the wear and tear of time, the piers of the church structure that supports the vault of the parapet and its wall looked pale and weak. Years of raining on the structure had led to proliferation of biodeteriogens that caused blackish layer over the stone surface. The enlarged black stains not only led to the further deterioration of the stone but also adversely affected its appearance.

The surface was gently cleaned and treated with water jet mist technique; re-pointing was executed with lime wherever required. The band of the parapet was re-plastered again using white paint and a layer of waterproofing was also meticulously executed to avoid any clack staining in future.

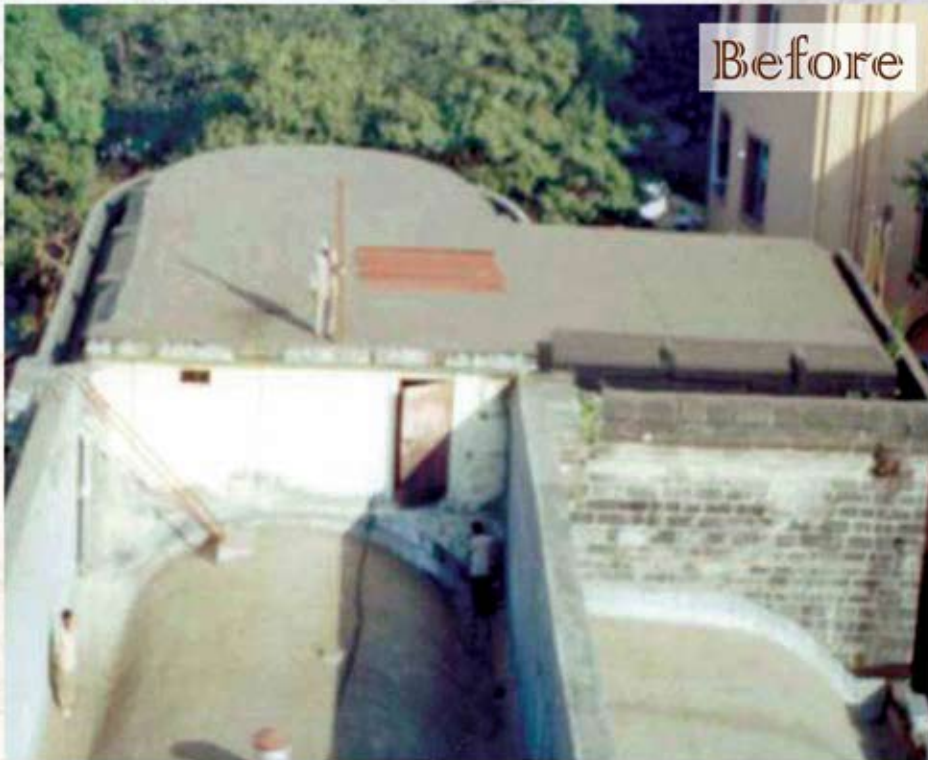
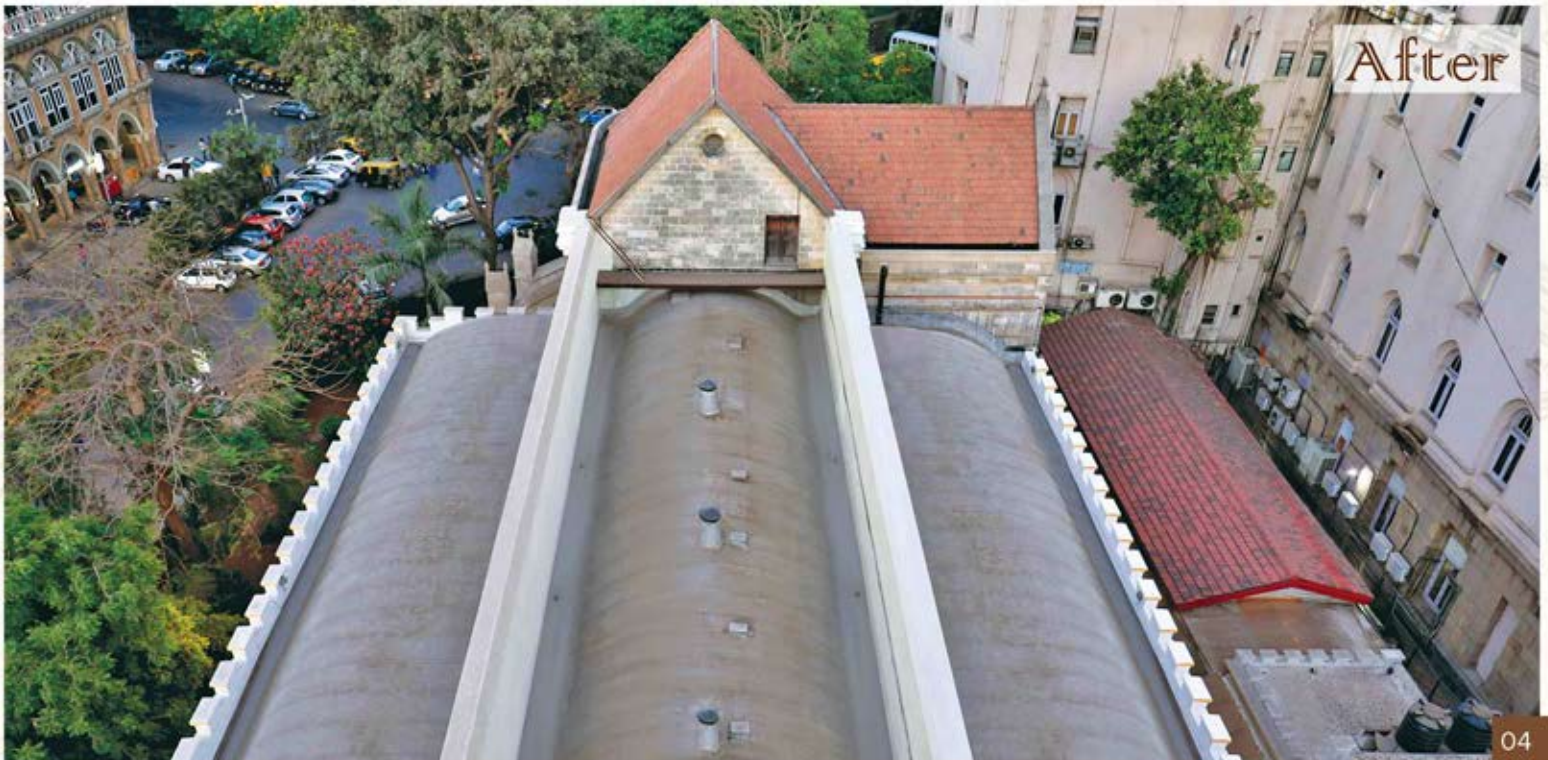
In the year 1920, the original sloping roof of the structure was replaced by a reinforced cement concrete (RCC) flat roof. Back then, it was widely used for concrete construction in the city of Mumbai. But by the year 1990, the RCC Roof deteriorated heavily causing waterleakage that flooded the vaults and damaged the carved details of the limestone.

A huge amount of restoration was diligently executed that included the replacing of the deteriorated RCC flat slab with a sloping roof reminiscent to its original structure built in 1865. Due restoration work was also applied over the altar and the organ room besides executing necessary masonry and paintwork.

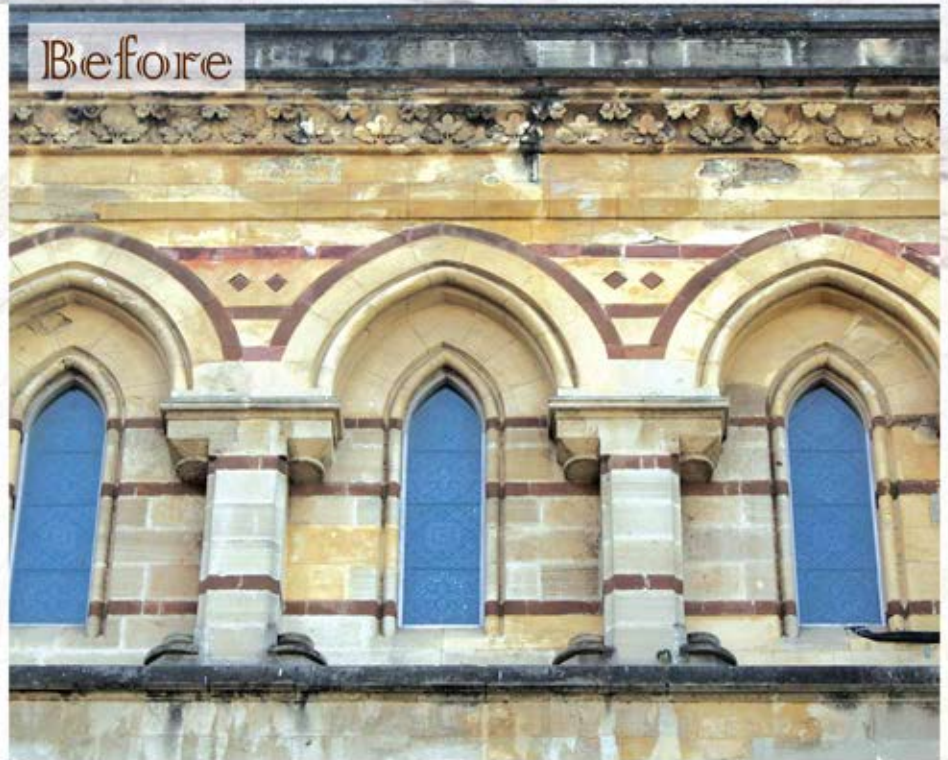
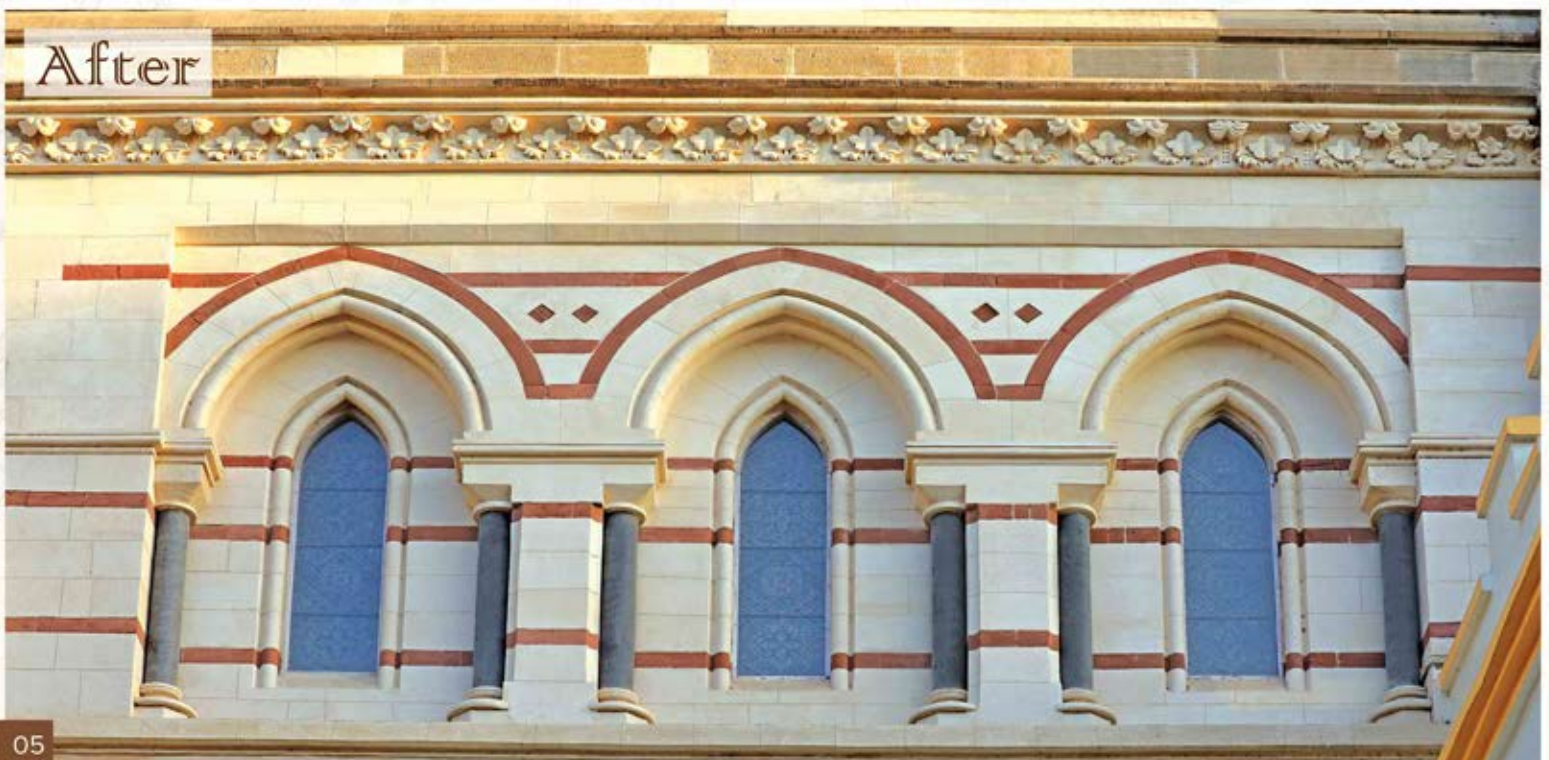
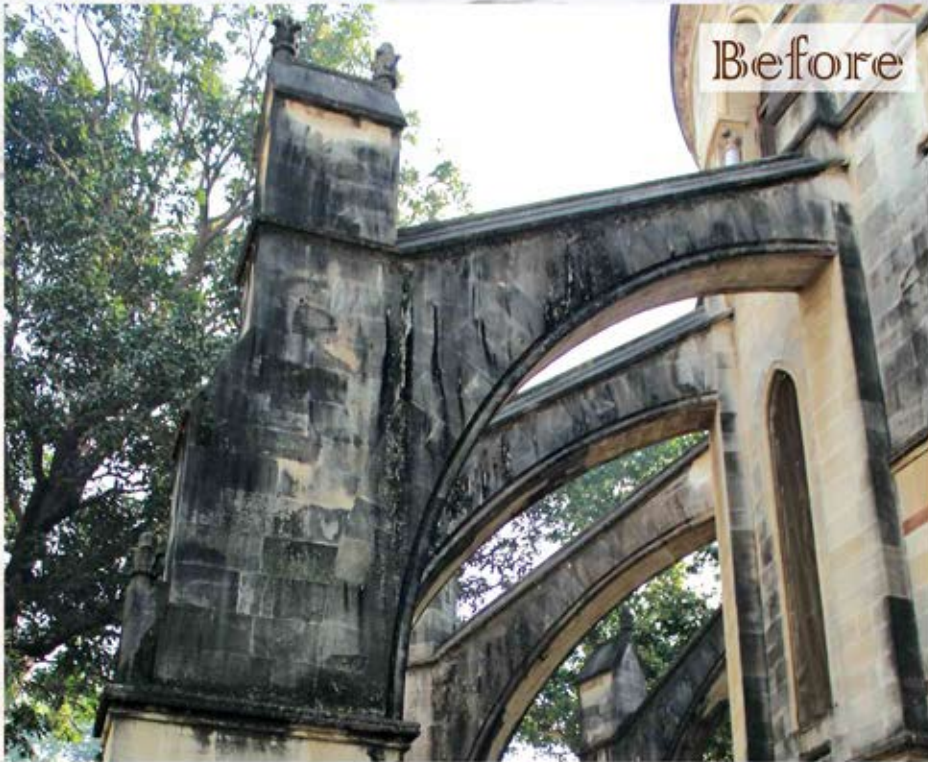
The stone surface around the clerestory of the east end left side appeared in distress with visible flaking of the plaster and vertical stone members of the clerestory arches were found absent. These were later retrofitted with the similar stones as present in original version. The exposed stone surface led to dampness due to water seepages and the pointing work which was missing, was re-done at certain places.

The floral band running under the parapet appeared stained due to algal colonization, the missing stone pieces of the band were retrofitted and the dust accumulation was cleaned thoroughly.

The cleaning work of the black stains was carefully executed after applying pressurized water jet cleaning that helped the stone surface to regain its shape and sheen.

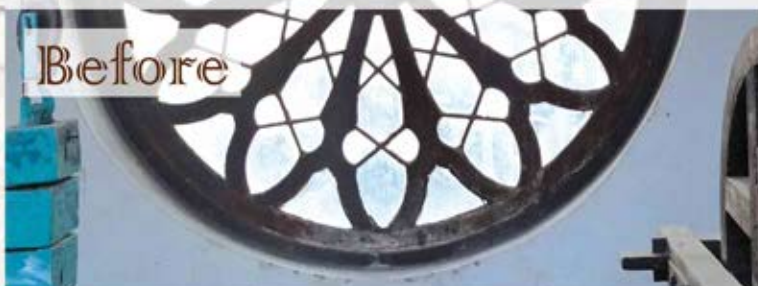
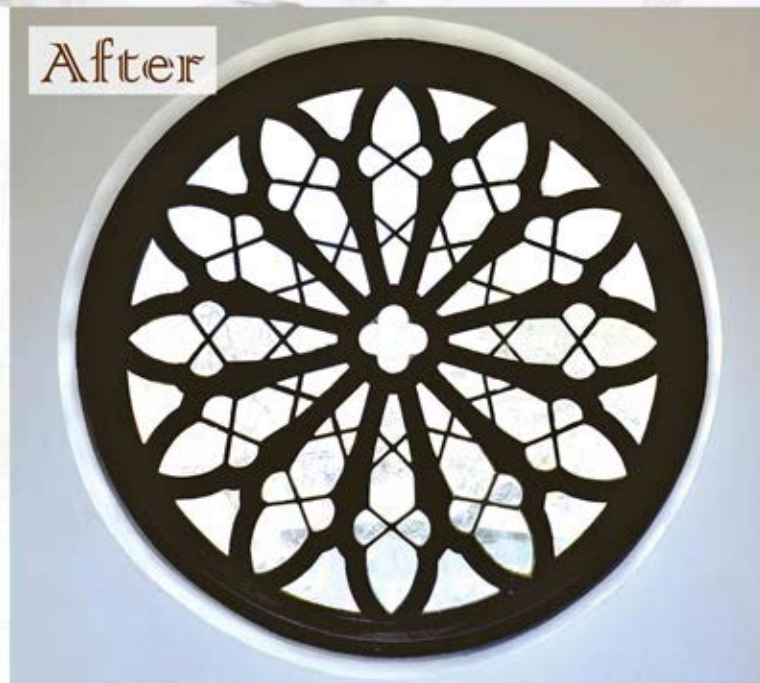
The walls near the windows appeared shabby and distressed due to flaking of its plaster and looked damp at certain places. This is now corrected with due re-plastering and repainting work to protect from dampness in future.

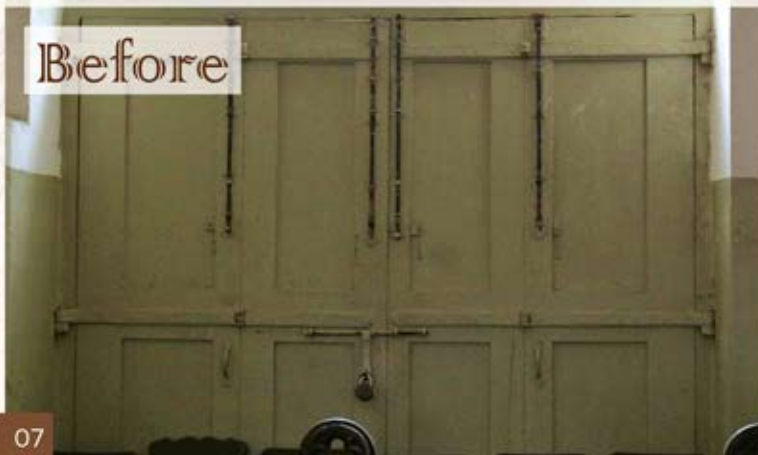
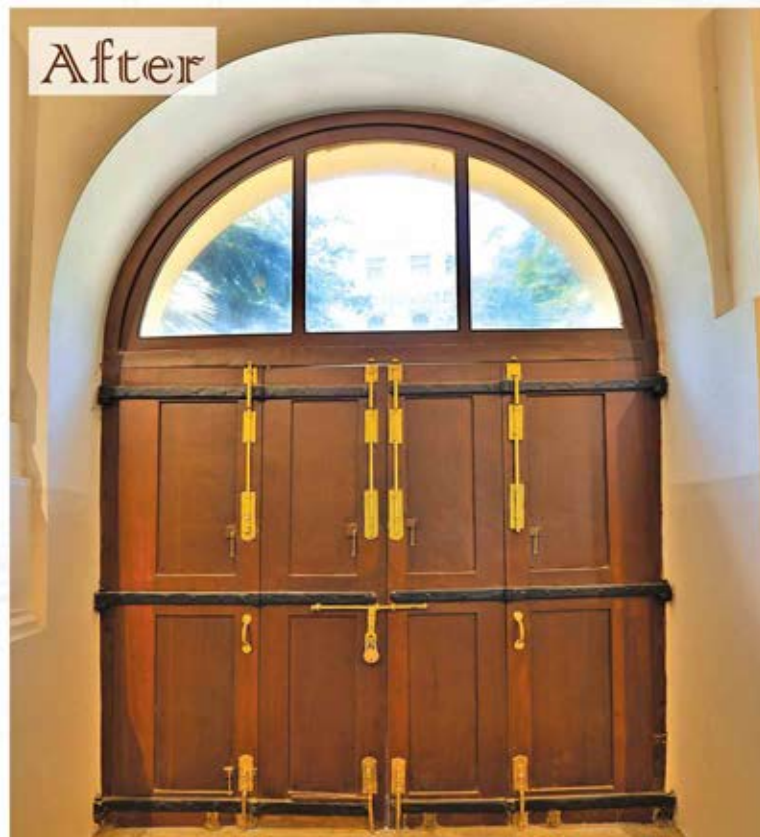
With passage of time, the timber window frame appeared decayed and deteriorated badly. The frames had layers of worn out paint, which had to be scraped off and the frames were treated with anti-termite and French polishing to give a tidy look.

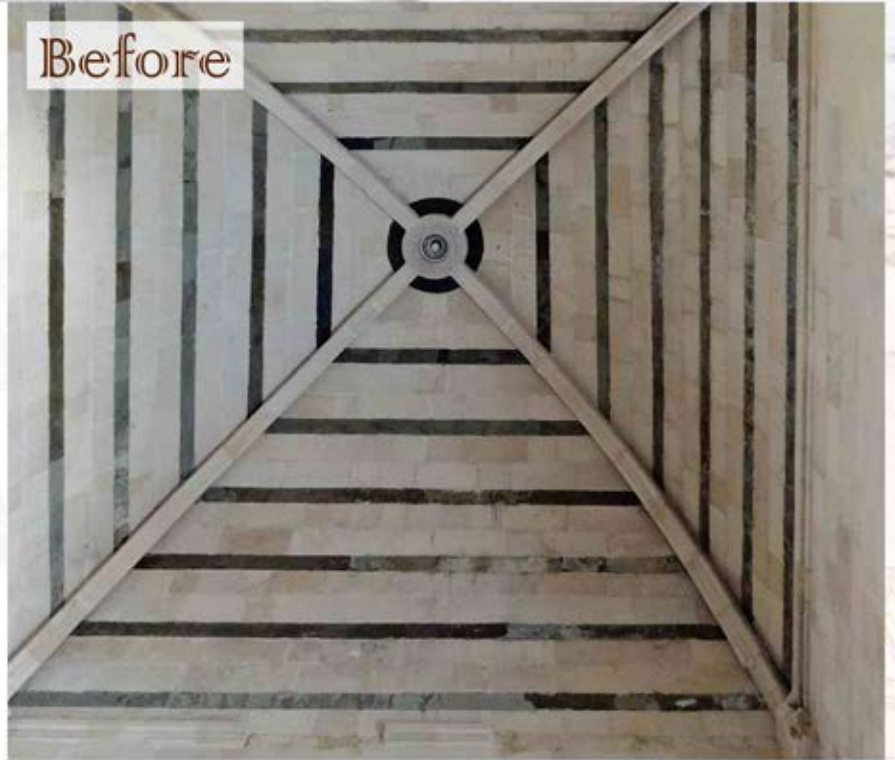
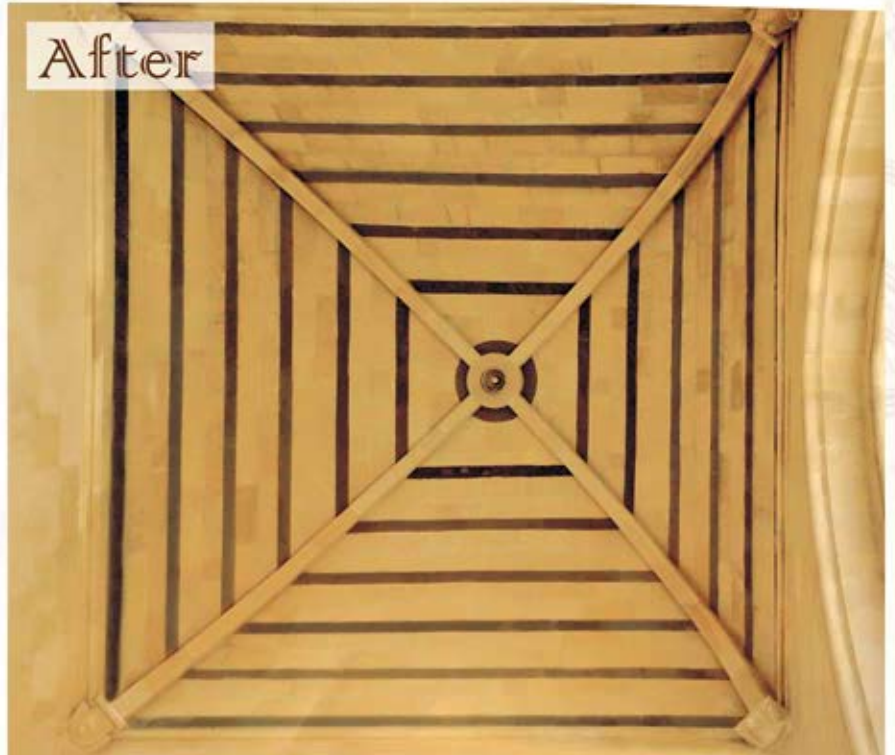
The vault arrangement forms an air-chamber to serve the purpose of air ventilation. This had developed intensive dampness due to flaked plaster. A considerable interior restoration and repair works of different kinds were executed to restore the structure. Moreover, the structure was applied with warm shades of illumination, which brought back the grandeur of the cathedral.

The ribbed vault roof in the chancel area of the cathedral is a typical roof setting of gothic style of architecture. An alternating band of stone strips in a darker shade is used to create a floral pattern in the vault. The vault was given minor repairs in terms of fabric and with respect to its joinery and stone surface.

A new light fixture was replaced at the center that lights up the space below at the chancel, another typical feature of the cathedral apart from the floral art work on the exterior face. These characteristic features of the Gothic Architecture Cathedral were meticulously revisited to give a tidy look.

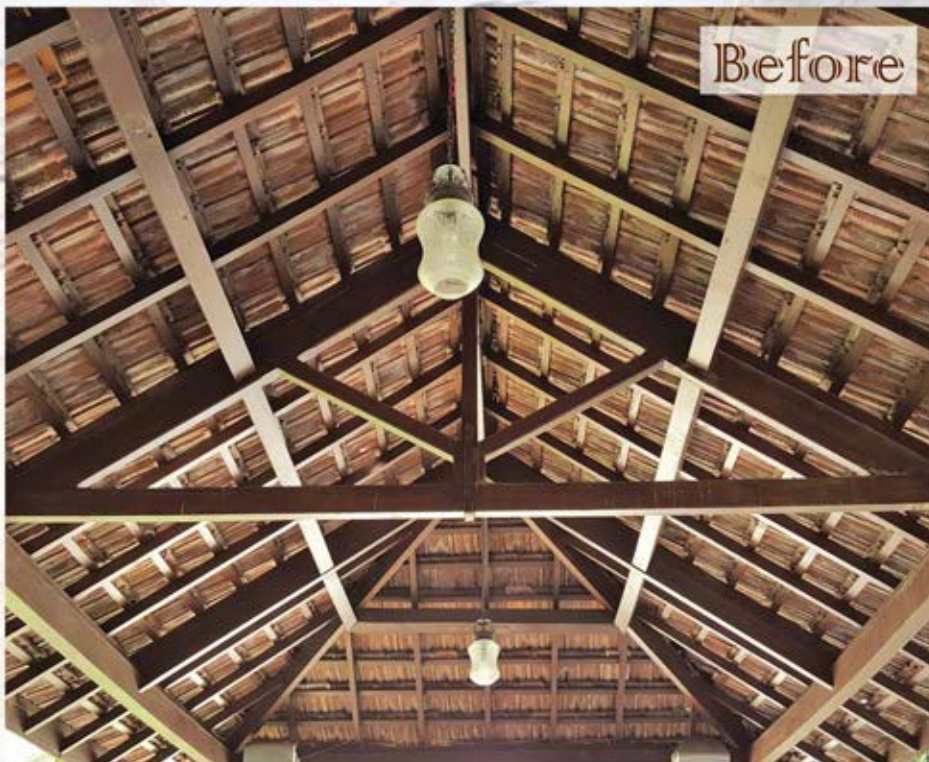
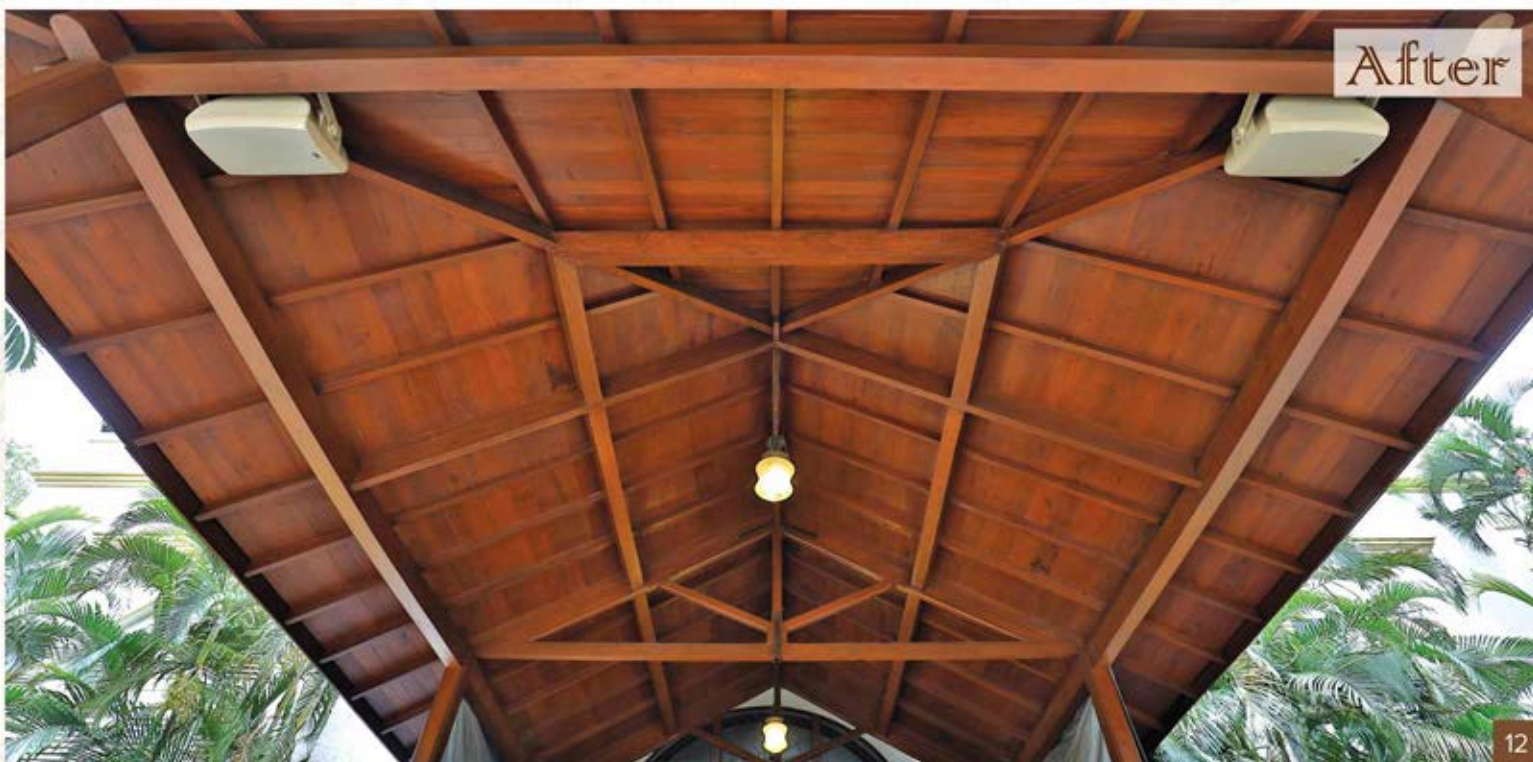
The timber porch at entrance of the cathedral is symbolic and meant to welcome the visitors. Due to the placement of Mangalore tiles directly over the purlins caused leakages.

In order to correct the damage caused by the leakages, the porch was treated with zero puncture system, a methodology developed by Savani Heritage Constervation Pvt. Ltd. This system involves sandwiched layers of aluminum and glass wool in between the purlins and the rafters, which is topped with Mangalore tiles.

The porch is now watertight and deftly restored after applying inner layer of boards to safeguard from the damages caused by the falling tree branches.

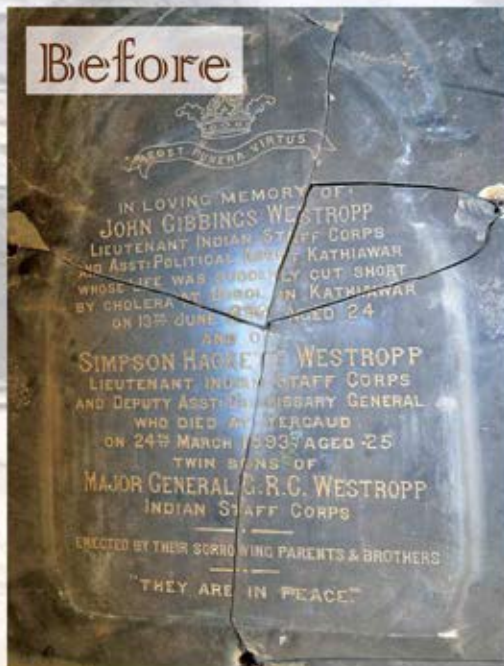
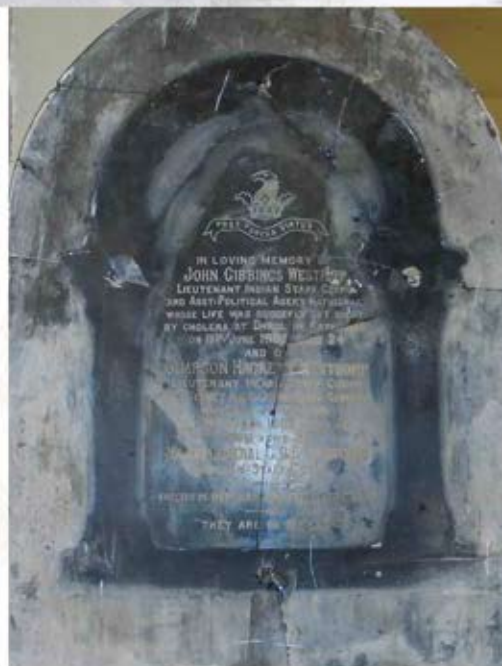
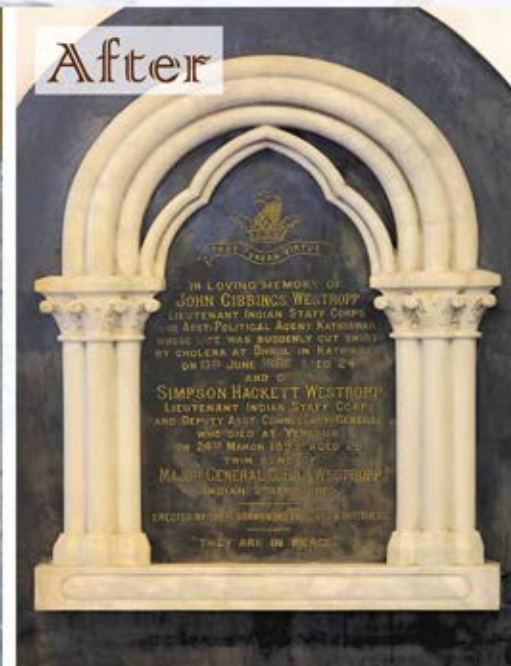
The black granite plaque which was broken into fragments had to be dismantled from its base. Before fixing it back, it was meticulously stitched and cleaned with the help of steam. Necessary repainting and polishing works were extended to uphold its respectful appearance.

The missing arched frame made out of marble was re-fixed from the leftover marked evidences and placed back on the wall.

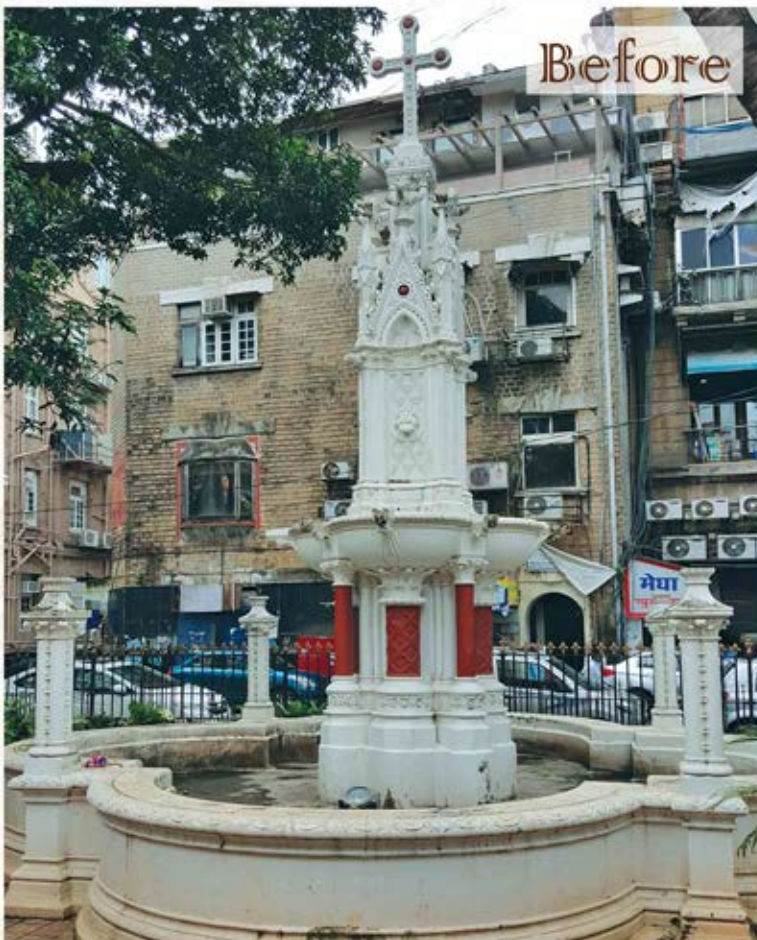
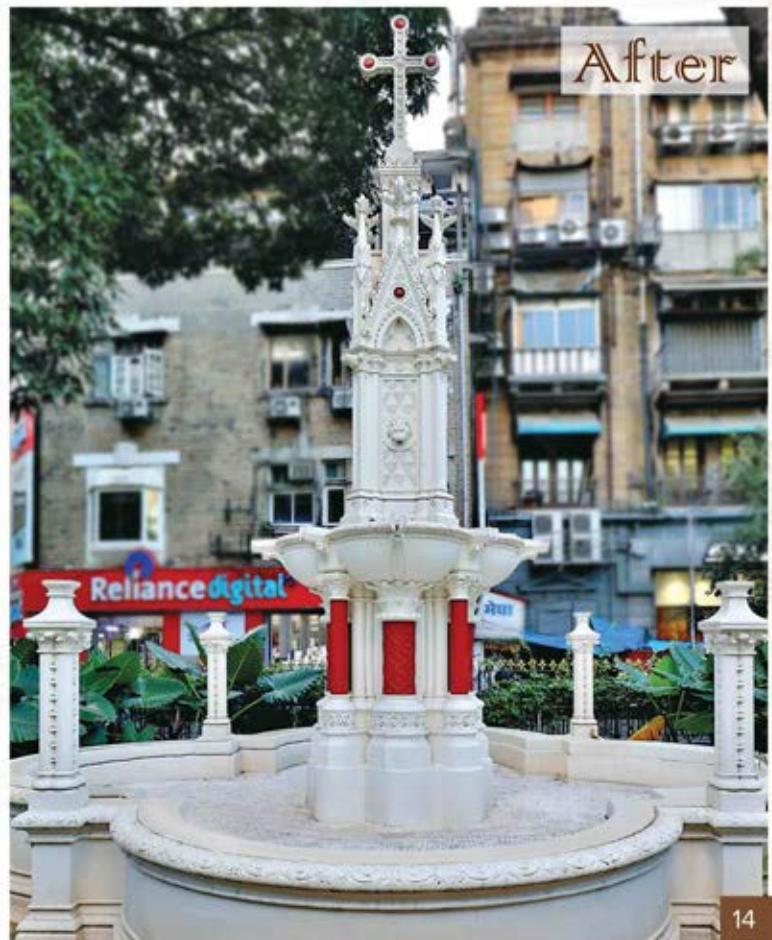
The elegant fountain was designed and executed by Ar. Gilbert Scott where the pipes are well concealed. But with passage of time, the fountain developed severe damages and leakages and wore a stained look due to algal growth.

The fountain was cleaned, plastered and brought back into working condition.

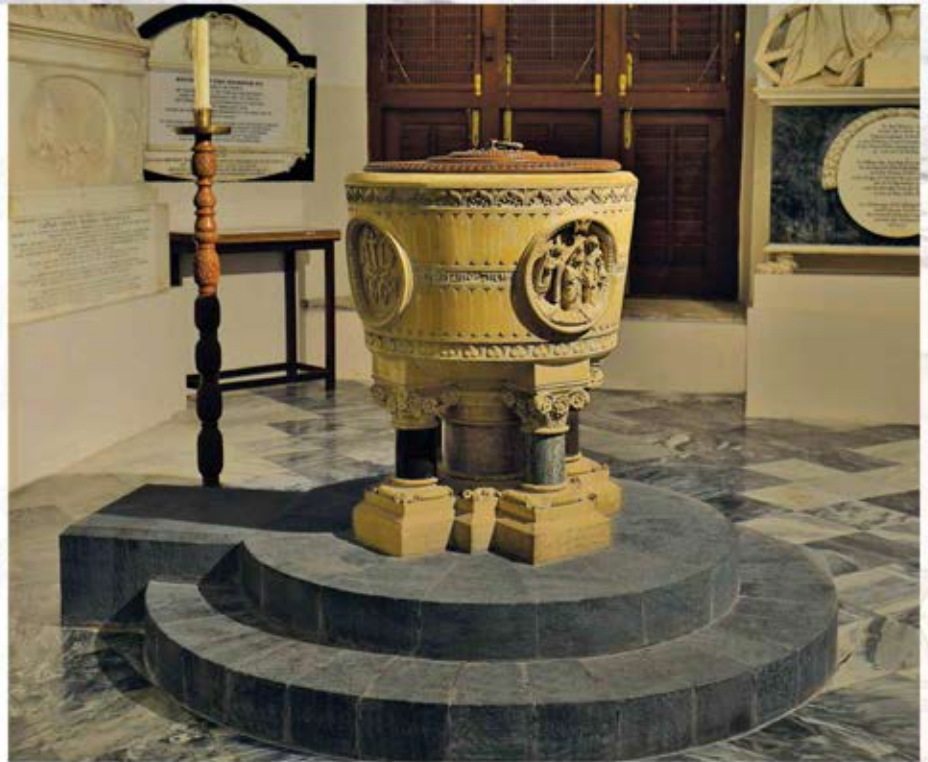
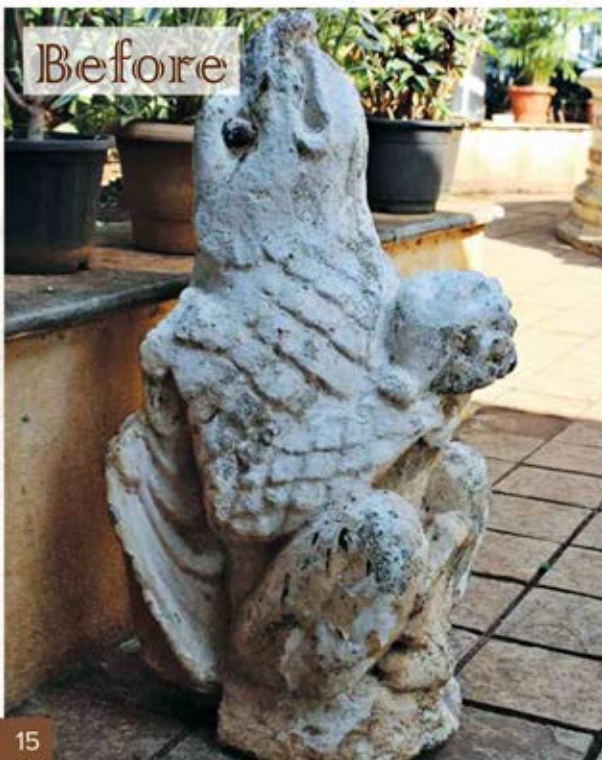
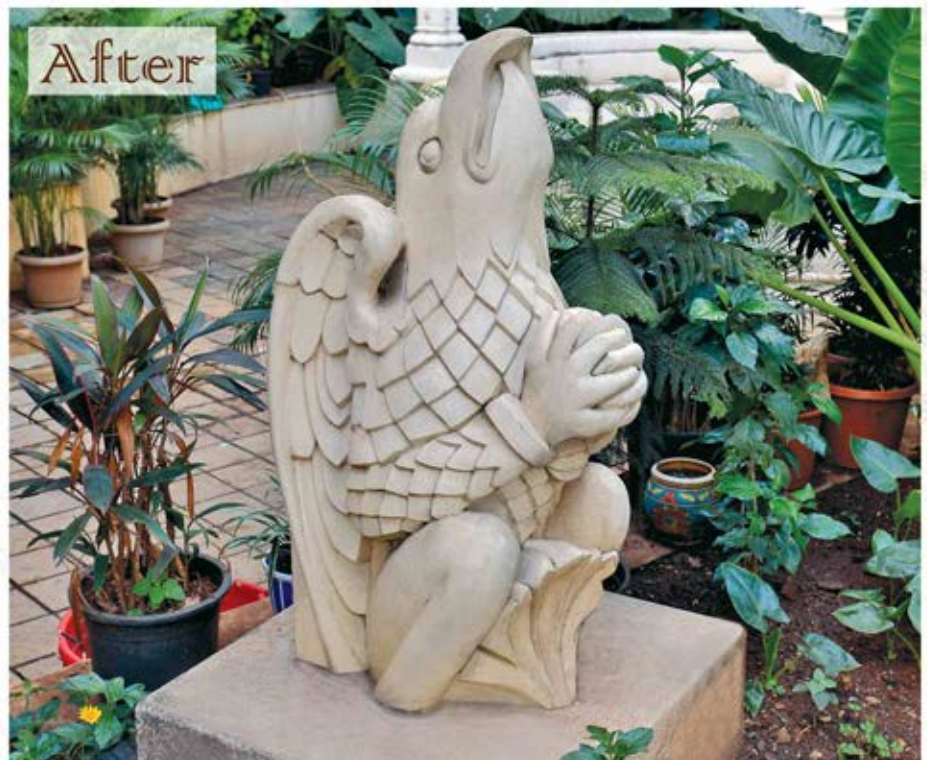
The cathedral has a sculpture installed with a bird like creature. The sculpture looked completely distressed and damaged. A special procedure of plastic repairs was executed for its repairing.

The broken wings, head, torso and legs were mended meticulously. A special base pedestal was created to help the sculpture stand firmly.
