ST. PHILOMENA'S CHURCH

MYSURU

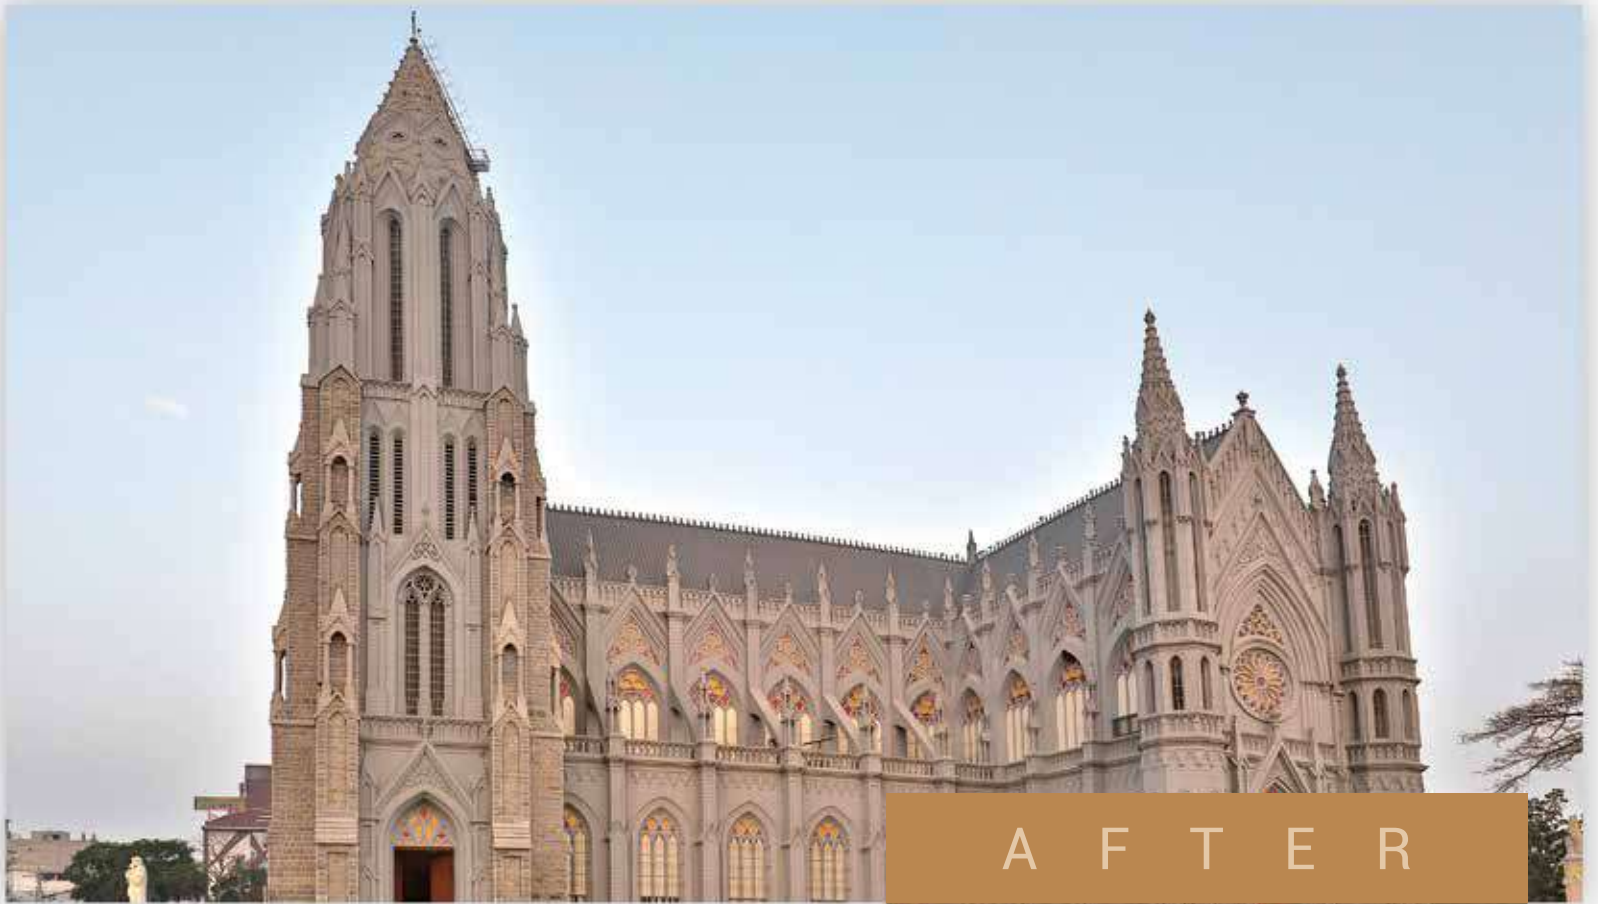
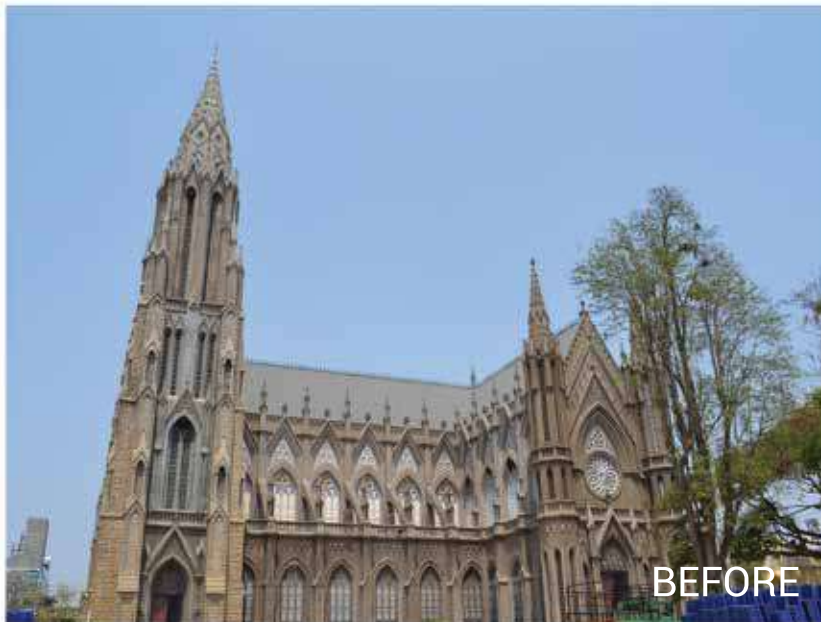
The plan of the church is always in the shape of cruciform where the main axis crosses at right angle between the nave and the choir. The exterior of the structure was in a state of colossal despair and required urgent restoration and repairs. Also, it was severely infested with moss growth and water seepage.

The facades were cleaned, treated in the shade of gray with the use of lime.

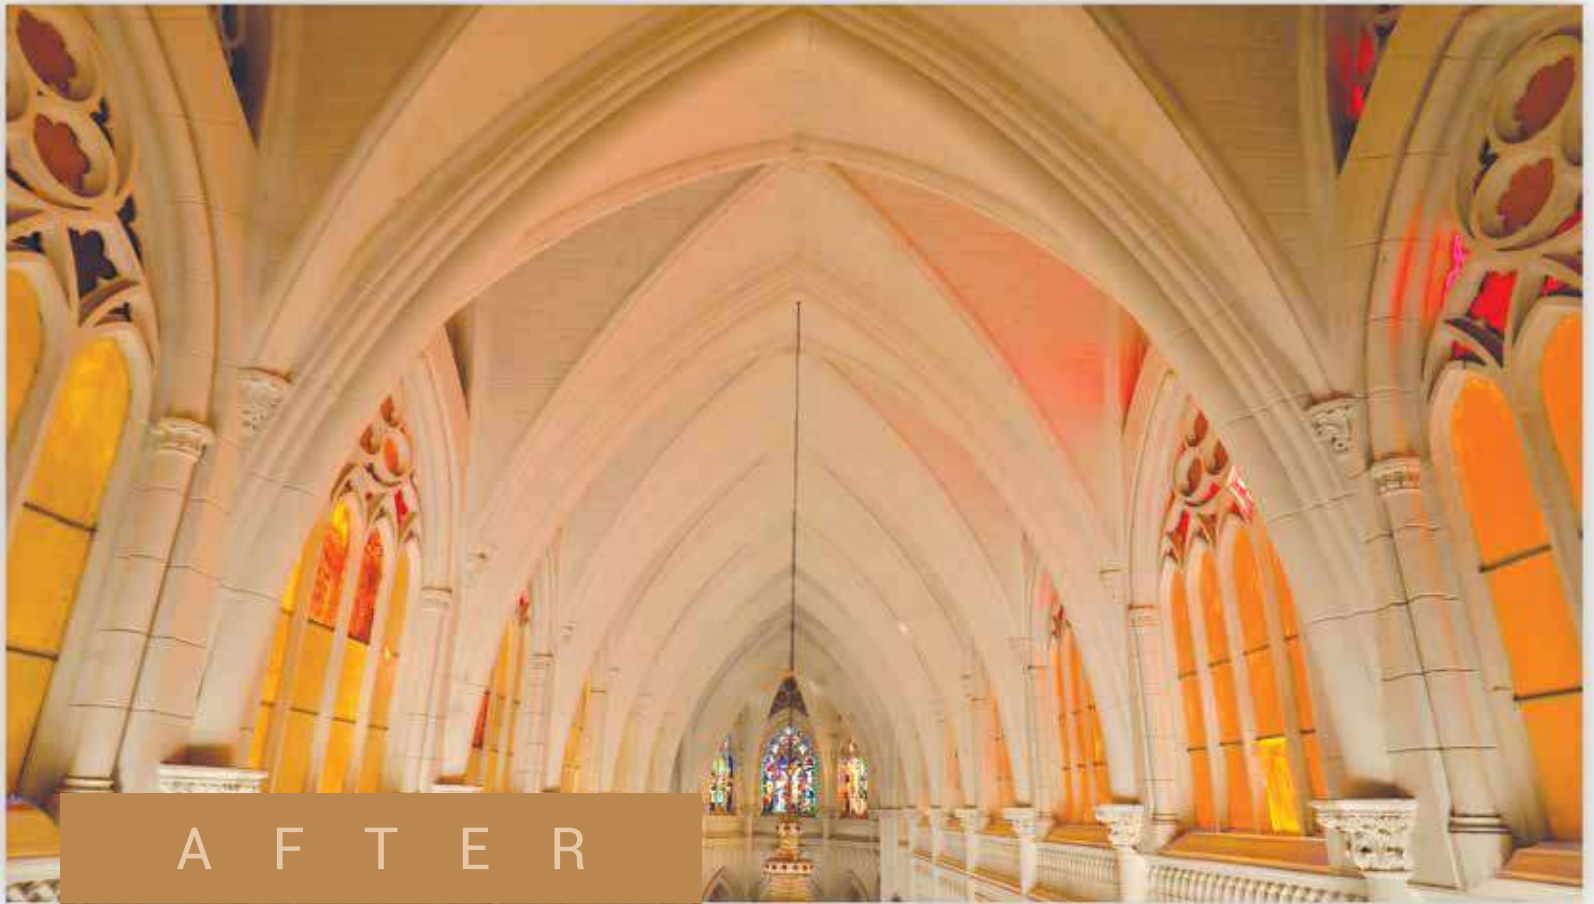
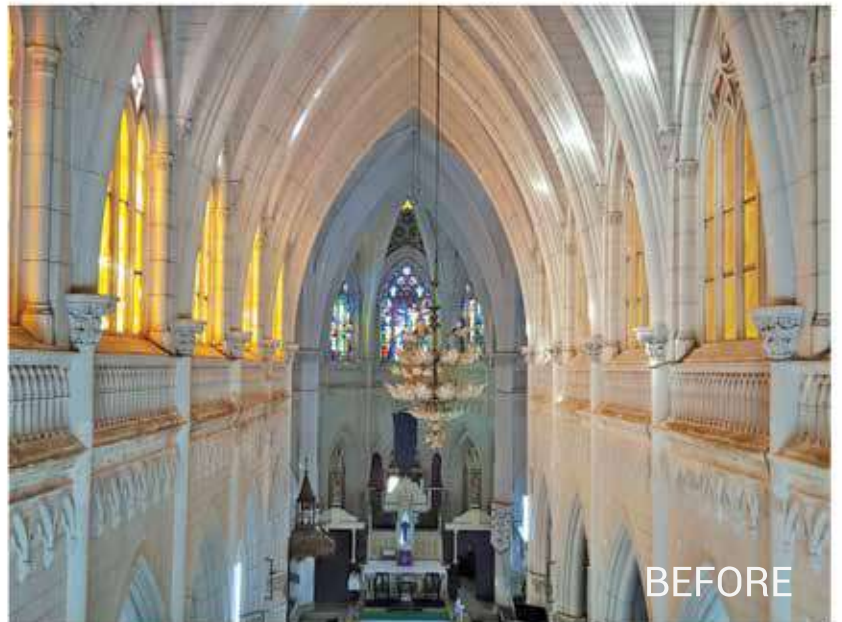
The triforium is an arcaded storey in a church between the roof and the series of the arches below. The clerestory and the vault of the church were soiled with dust accumulation and lack of cleaning at higher levels. The triforium is adorned with a series of coloured glasses fused with the shades of yellow and pink.

These glasses are fixed into iconic pointed arches, typical of a church. The dossier being a supplementary capital above the column receives the thrust of the arch. The chandelier at the triforium level was changed to suit the overall ambience.

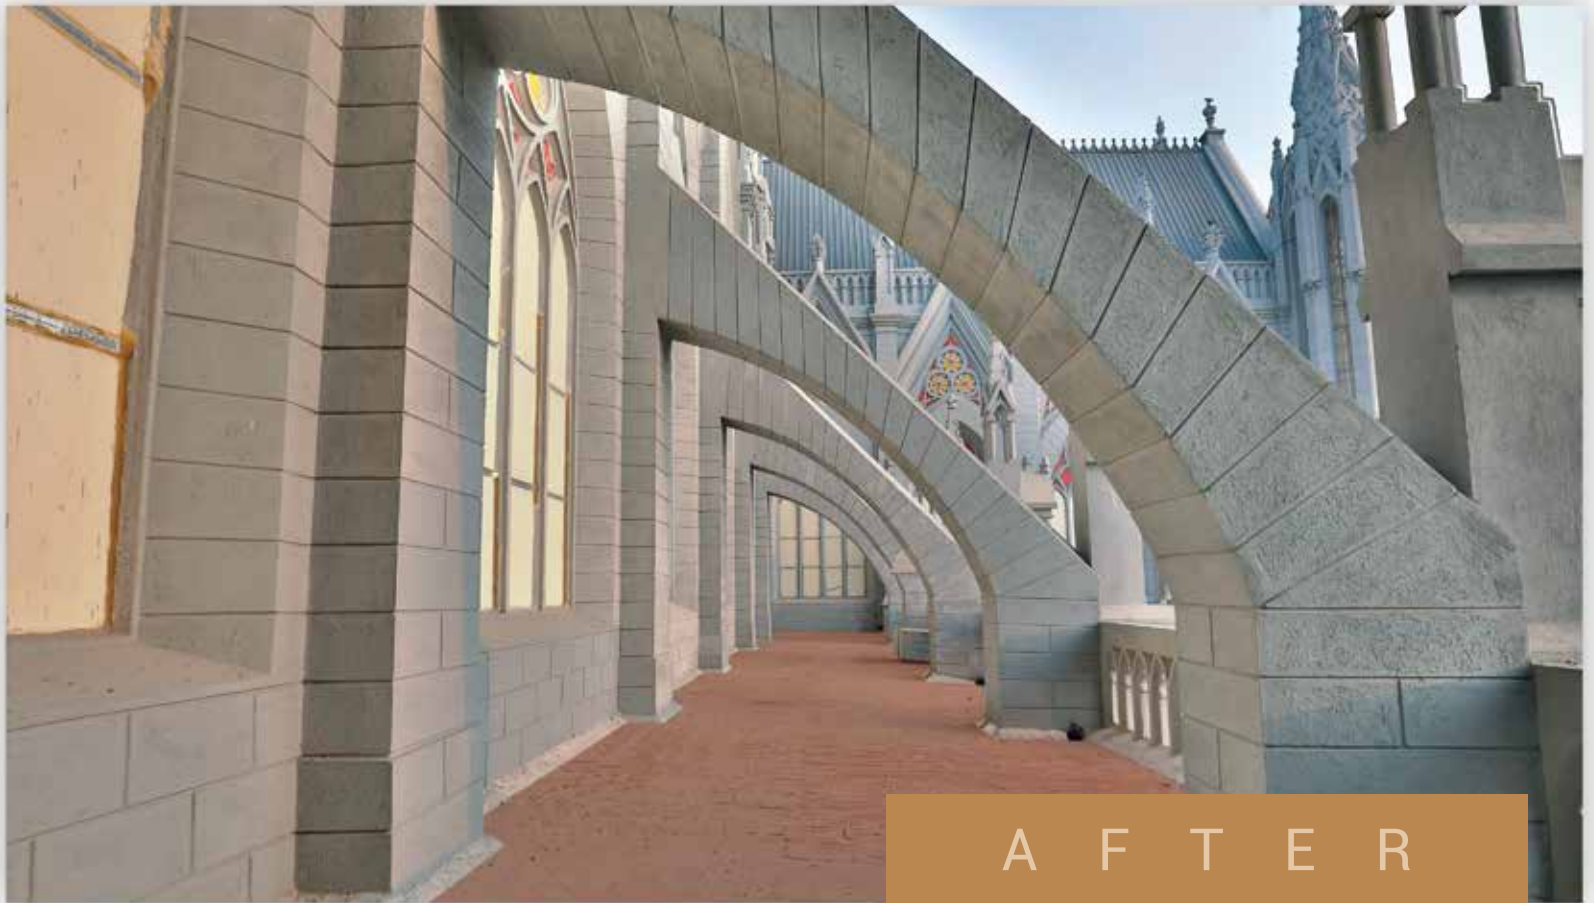
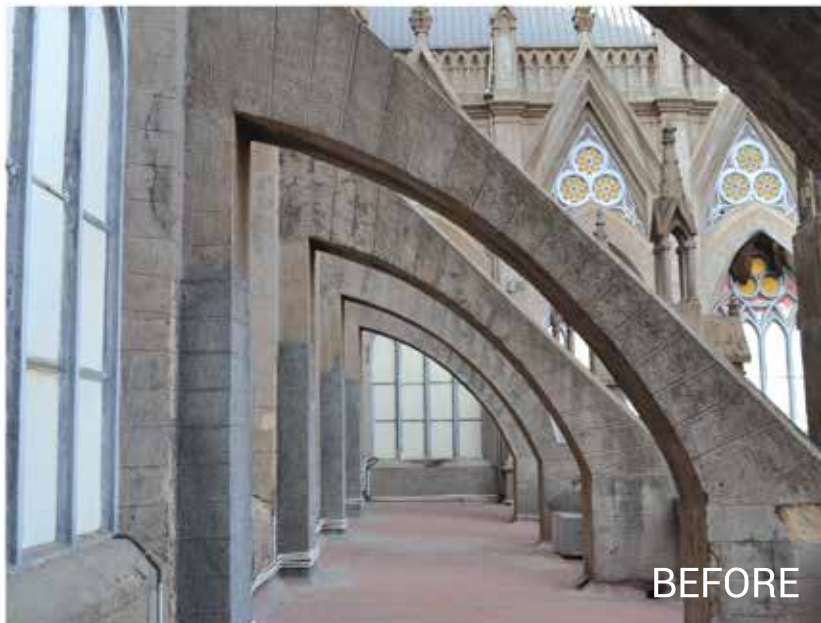
The flying buttresses are an important structural element of the church. The upper portion is arched which transfers the load below. The previous interventions were done in cement where the threat of further deterioration was possible.

Therefore, the restoration for the same was finished with lime. The intermediate floor below the arches was cleaned and checked for any leakages.

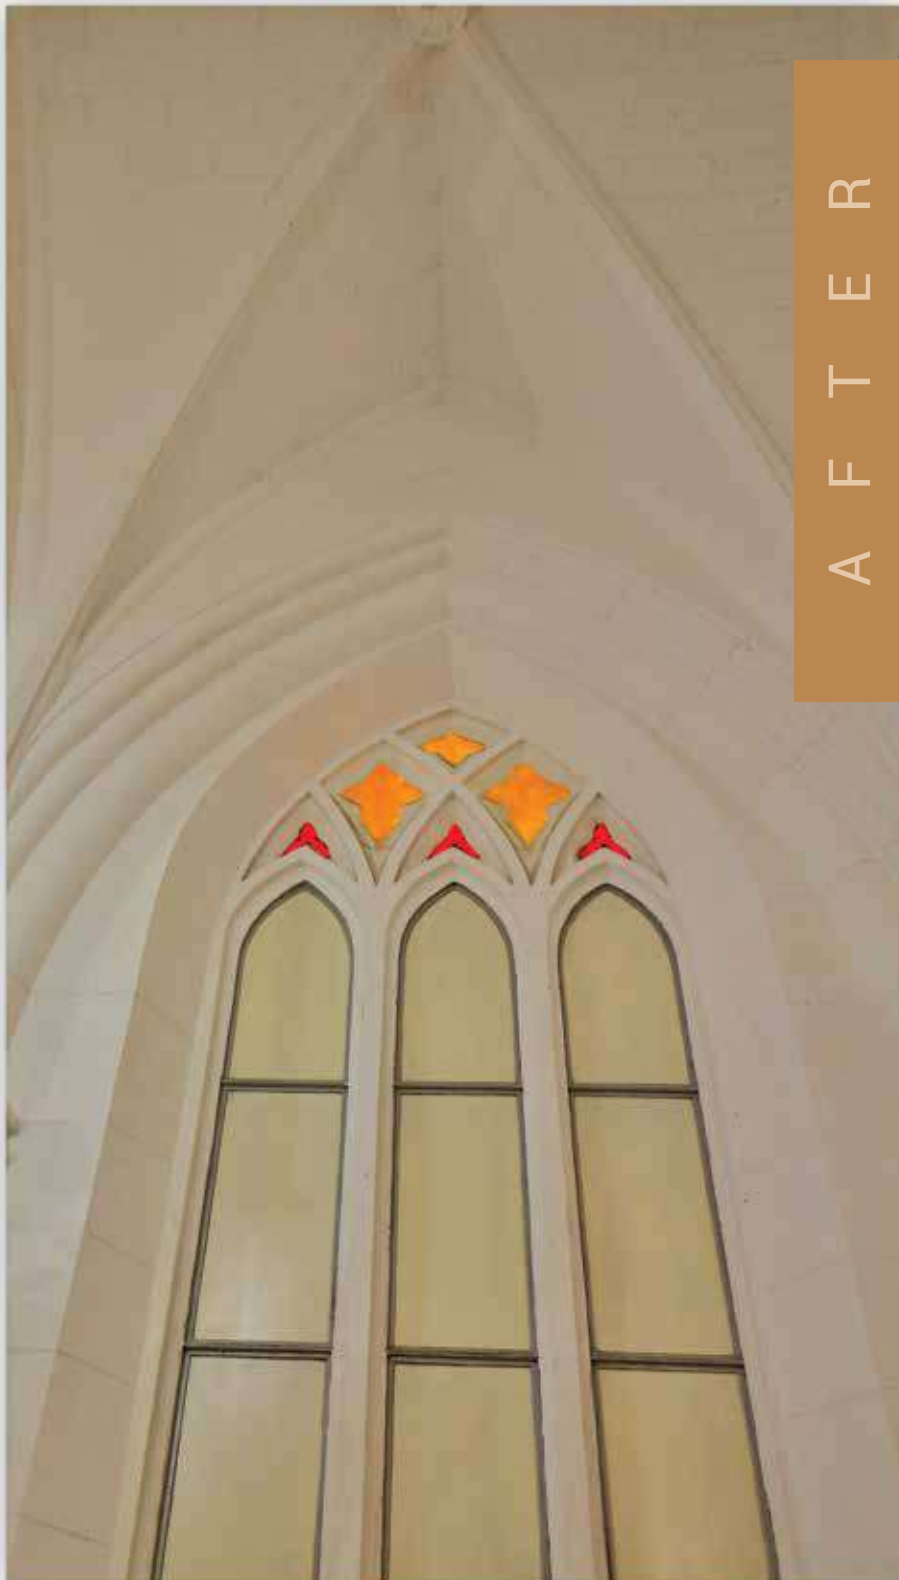
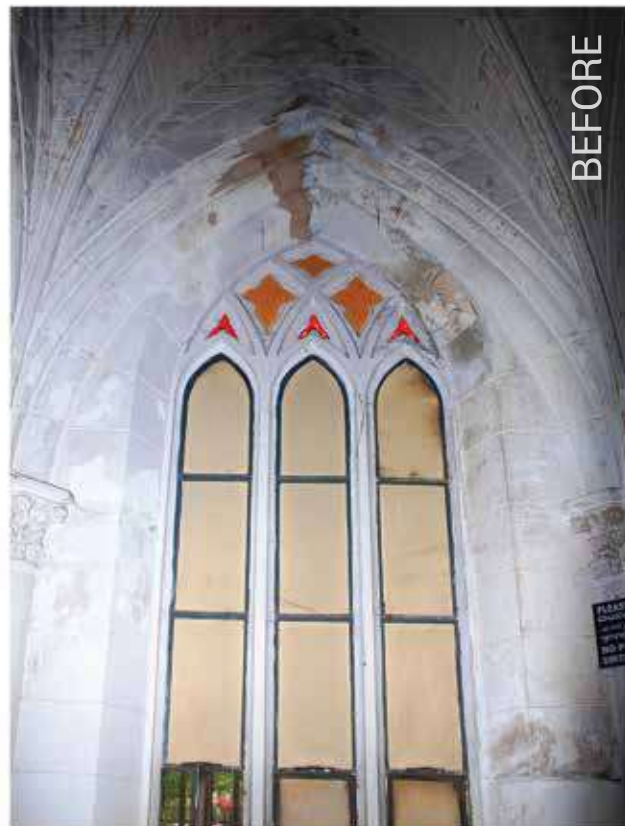
The pointed arch window was severely affected with damp which had caused flaking of the paint layers and the number of windows all together caused a dullness.

Lime wash followed by lime plaster method was implemented to arrest the water leakages as lime plaster cures the dampness and gave a fresher appearance in the aisles. The window frames were resealed to avoid water ingress.

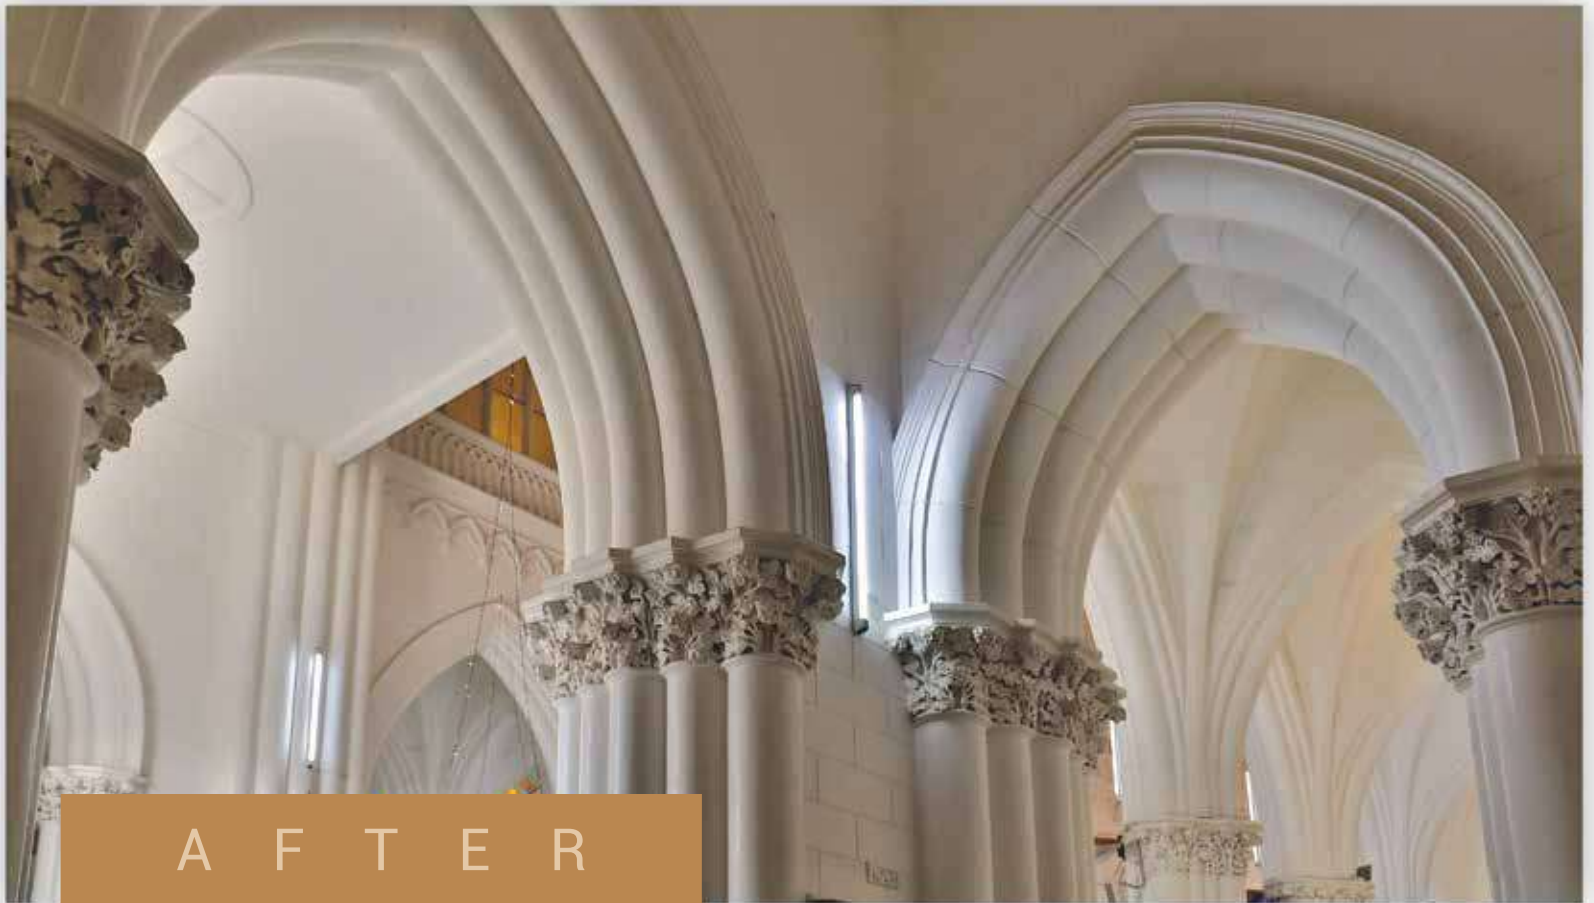
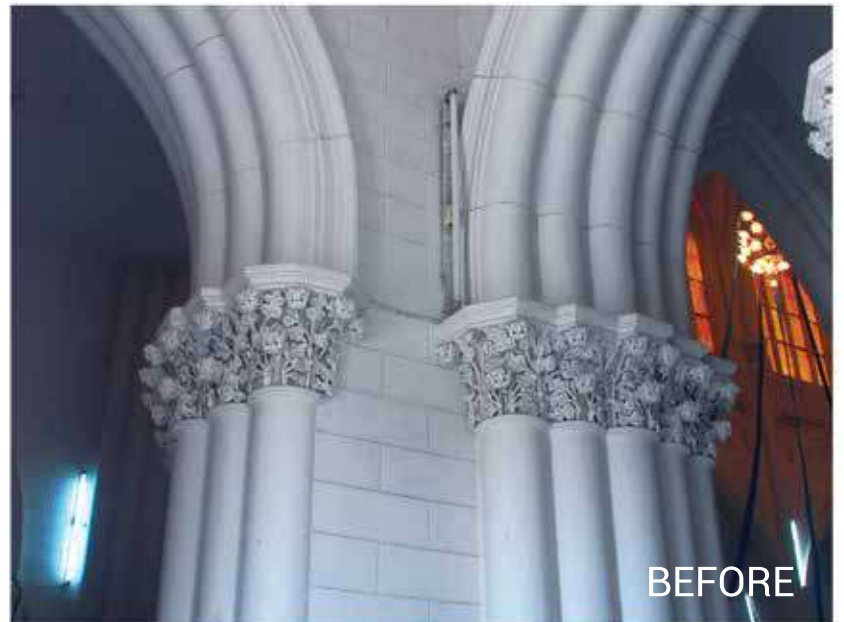
The series of arcades supported on piers in the interior of the church along the isles needed repairs, which received lime and was followed by lime plaster. The arcade did not show major signs of dampness but was in a dire need of a facelift. Some of the crockets showed signs of cracks and few were in a broken state. The fine moldings were restored back skillfully using lime.

The lime plaster was rendered to the columns so that it can reflect the light back. The reflection of the light helps to illuminate the space to some extent, thus driving away gloominess.

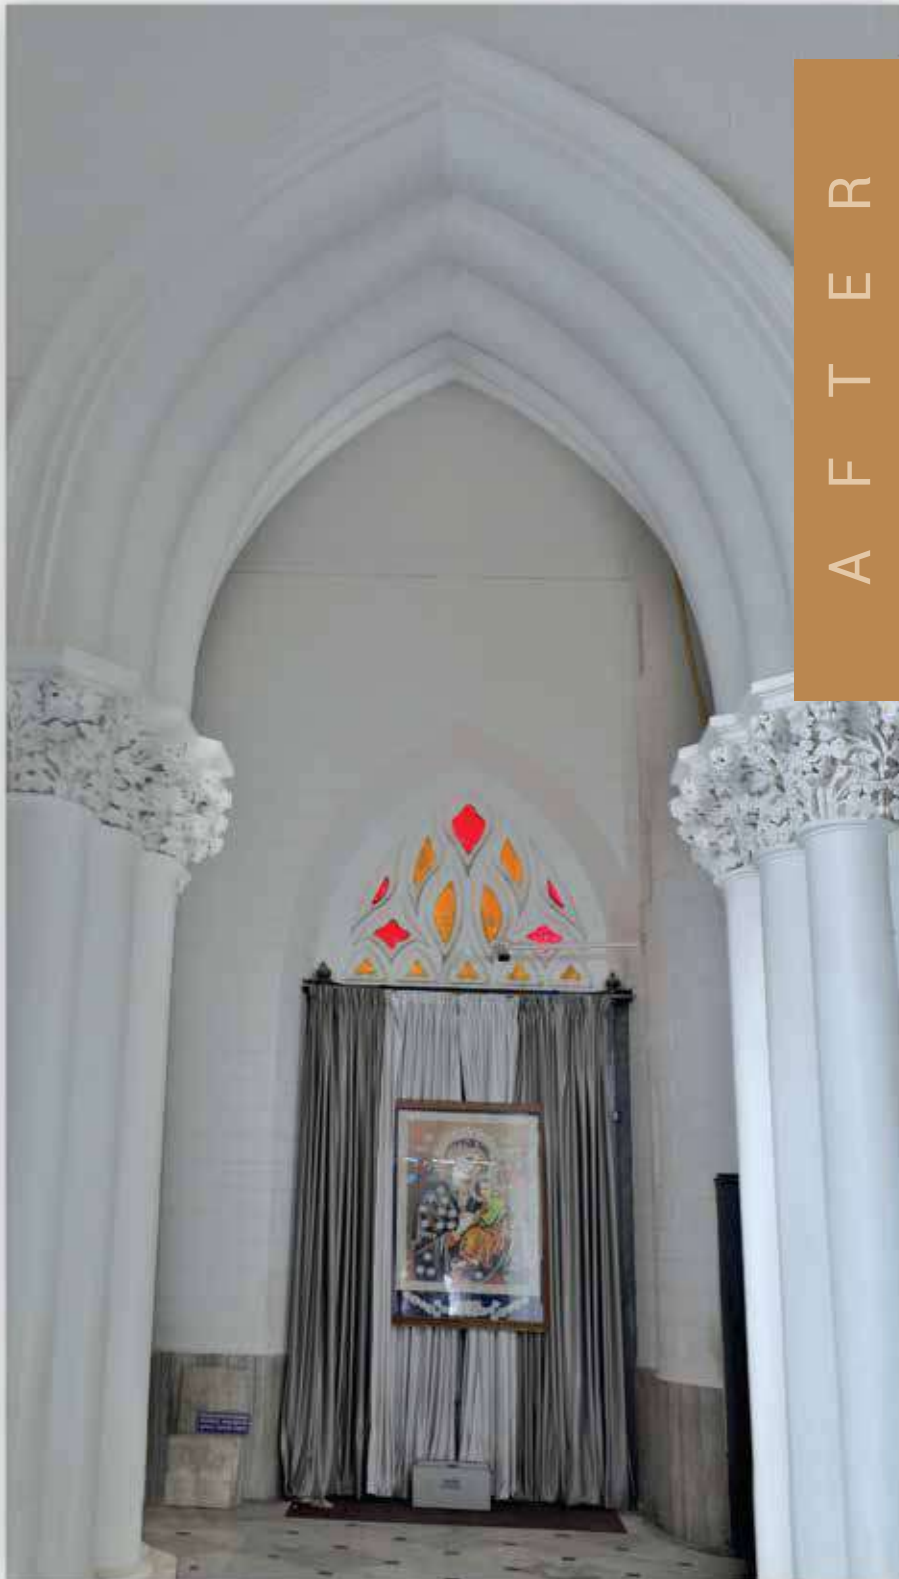
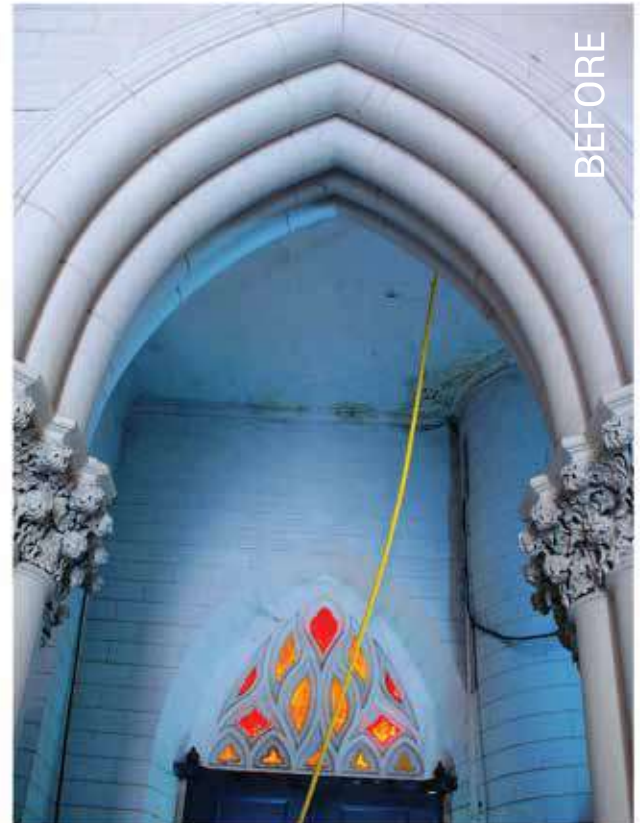
The interior side of the facades show prominent signs of dampness. The dampness had led to moss growth in the areas of water seepages.

The seepage can spread through capillary action and deteriorate other members further. The door has been closed down for the use of entry and exit.

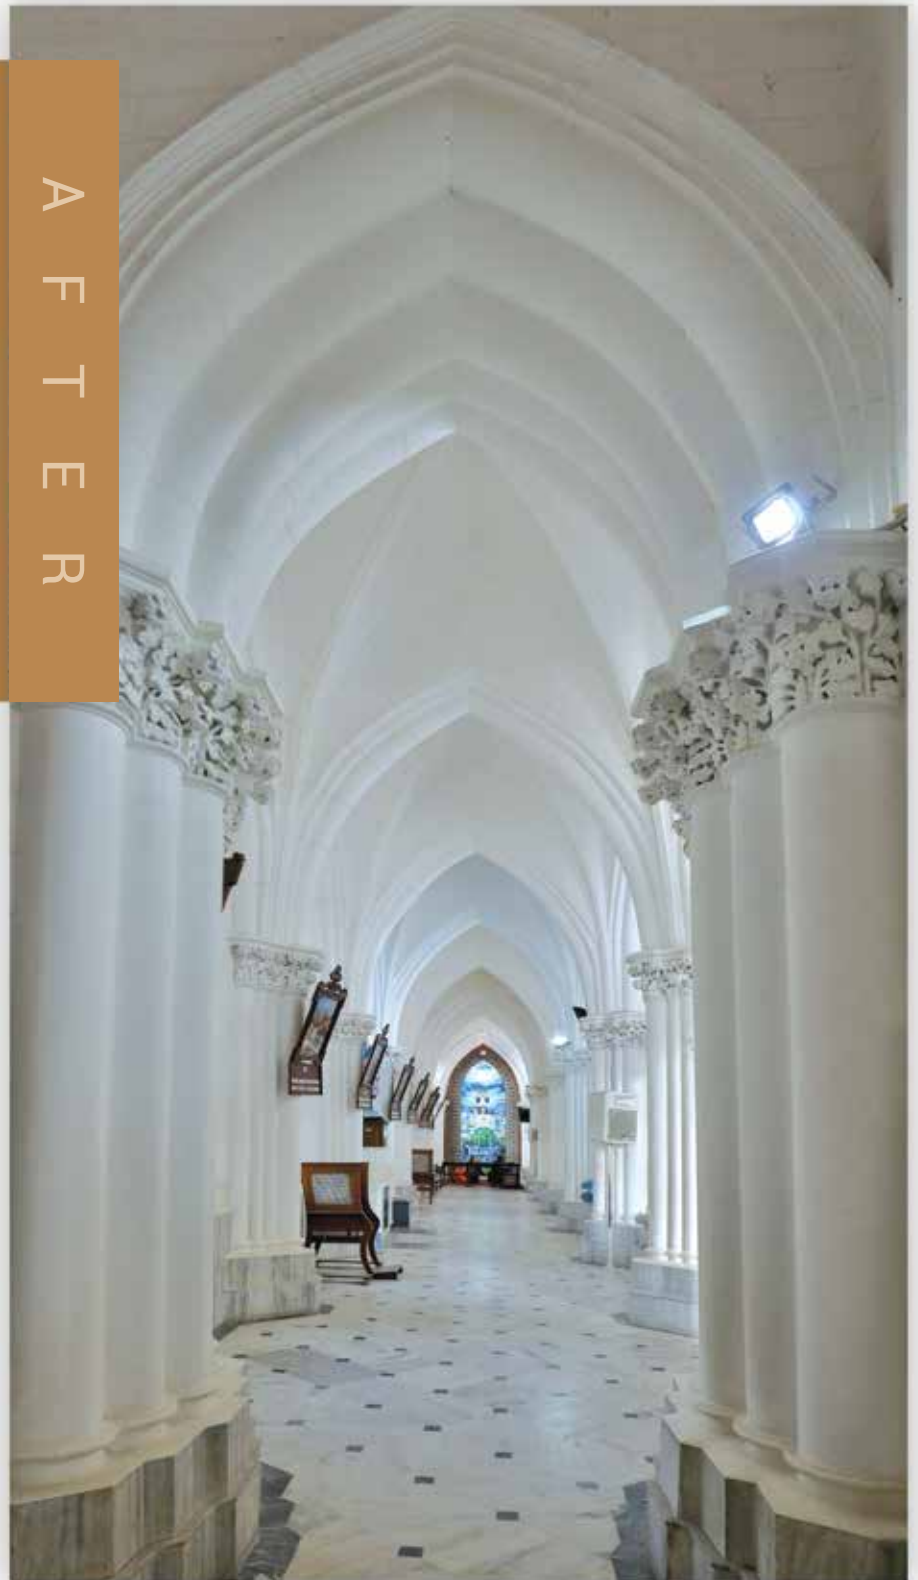
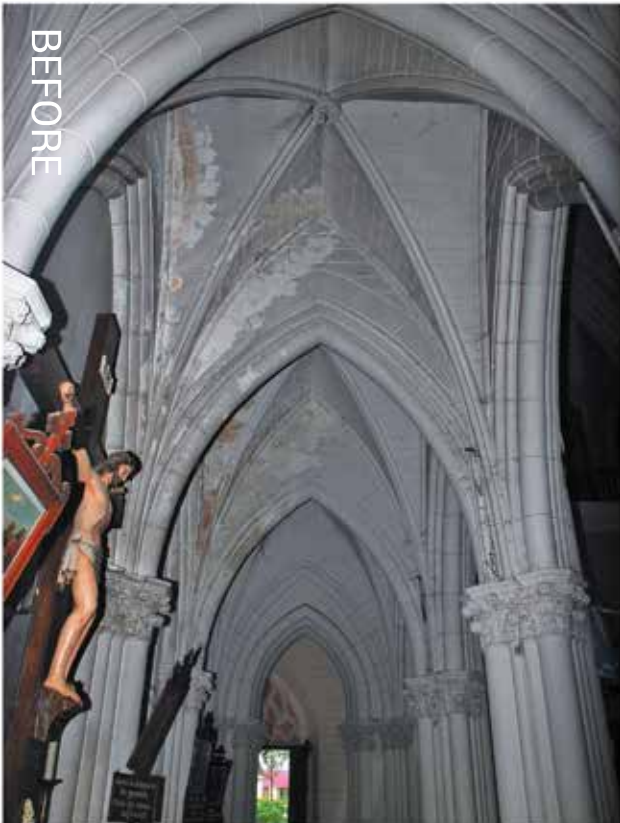
The vaults of the arcades in the aisles showed signs of flaking and required lime plaster. The vaults of the arcade are an important structural members which hold two or more other members should not be weakened due to dampness which can lead to structural instability.

The crocket which were deteriorated were also mended with the help of lime.

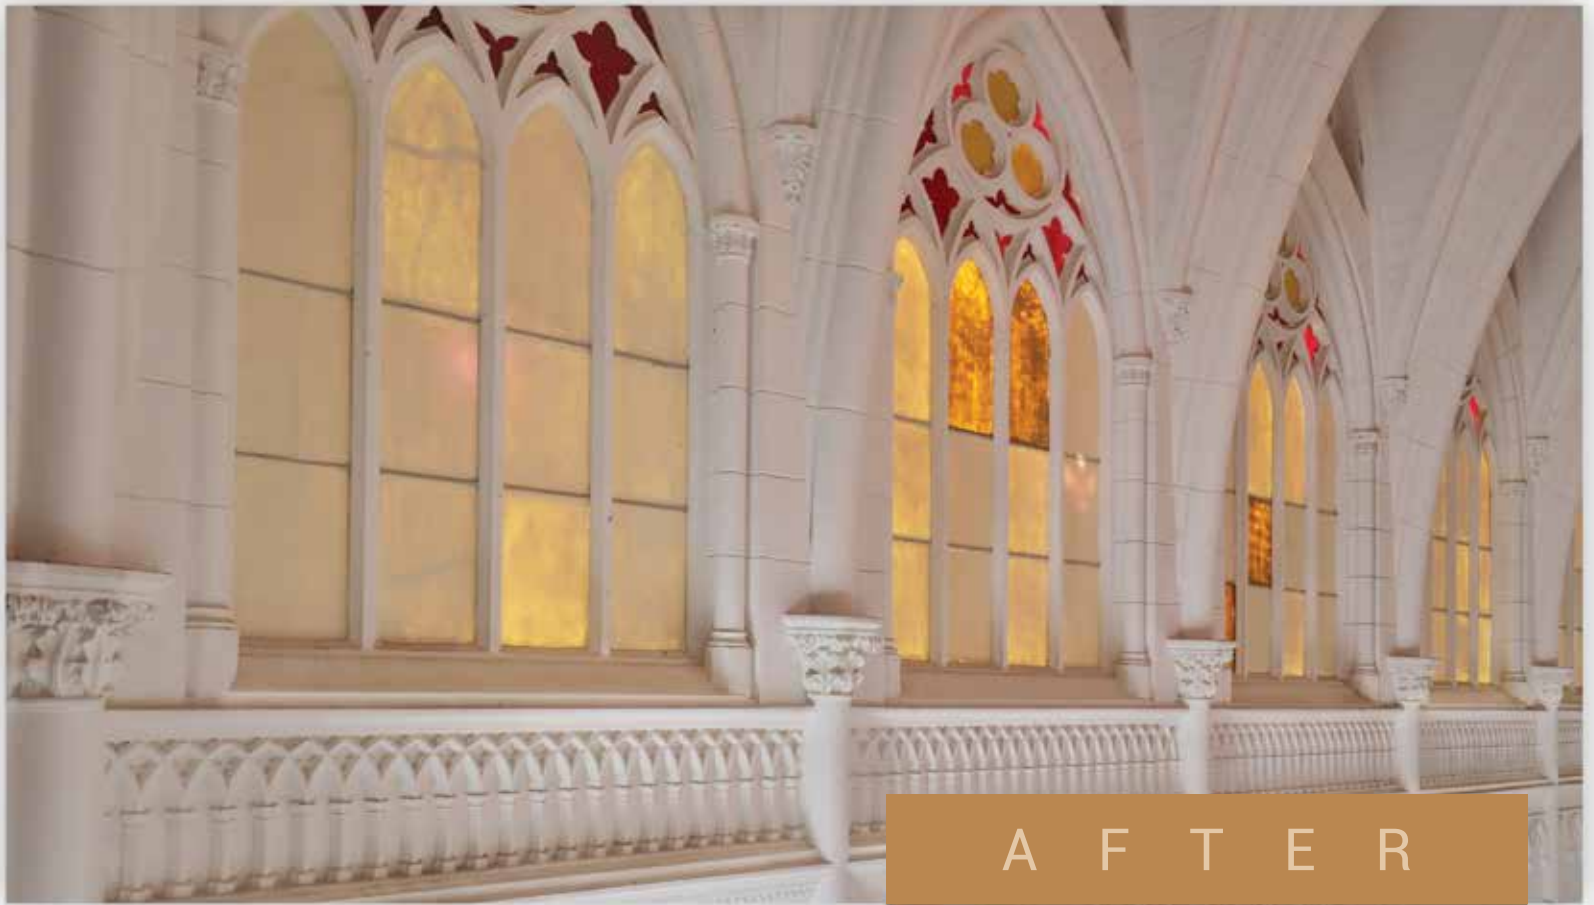
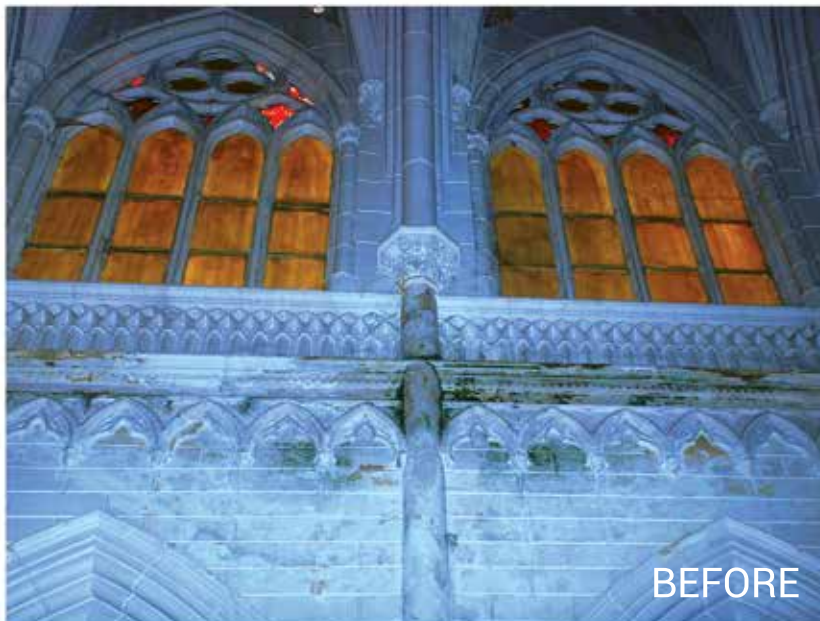
The water seepage over the years can cause patchy moss growth, especially to the members facing the exterior. The triforium level here can be spotted with a green patch which was cleared and treated later on.

The horizontal band of crocket was delicately treated with the help of lime wash.

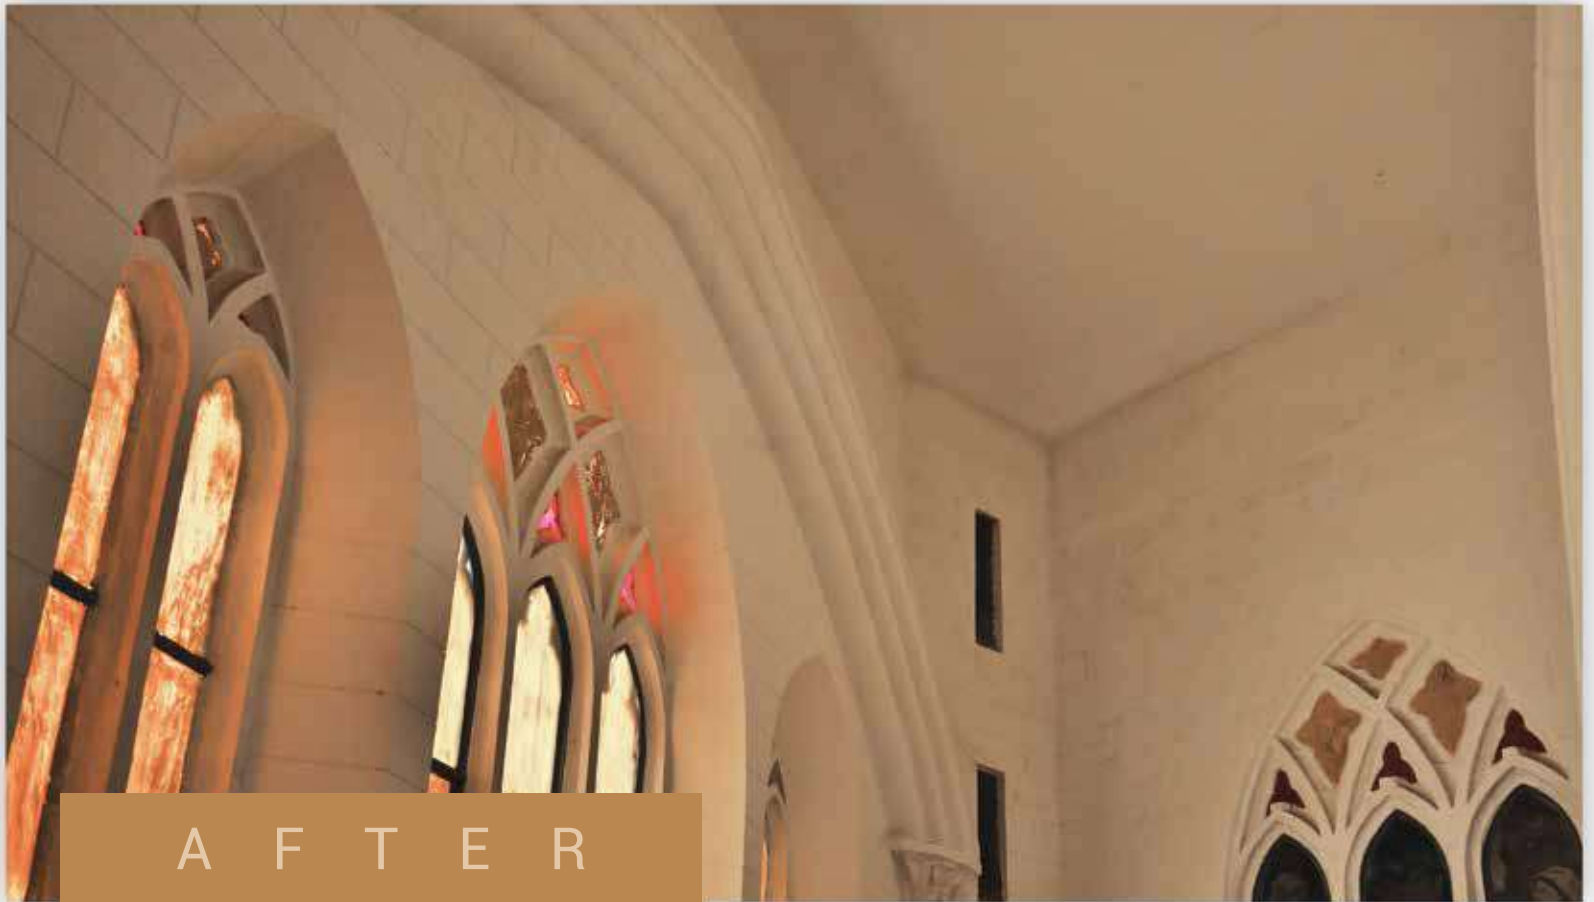
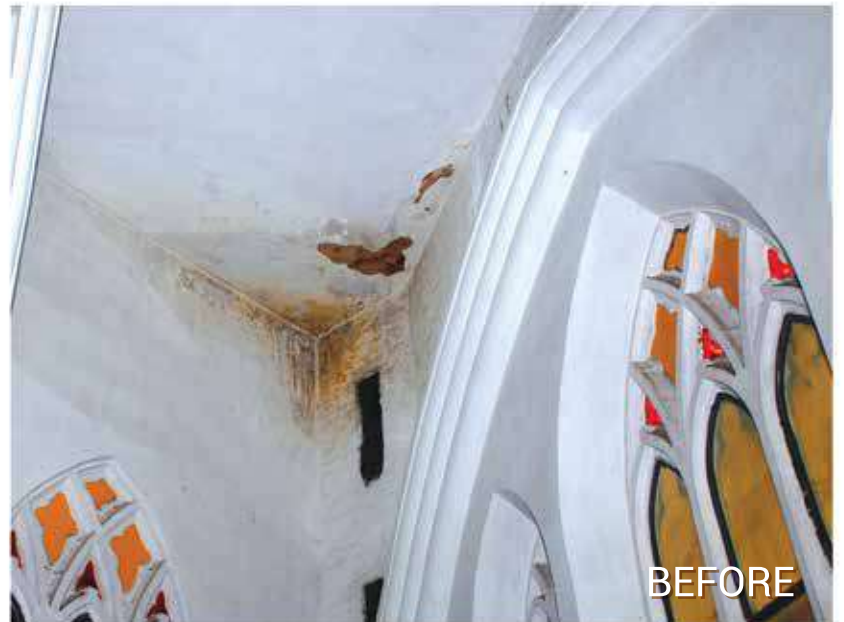
The problem of dampness and flaking was grave throughout the church building. The corners were especially damp and wet. Hence it became very important to treat the leakage to stop seepage further. All the windows in the church were made water tight.

The use of lime has played an important role as a finishing material making it damp proof.

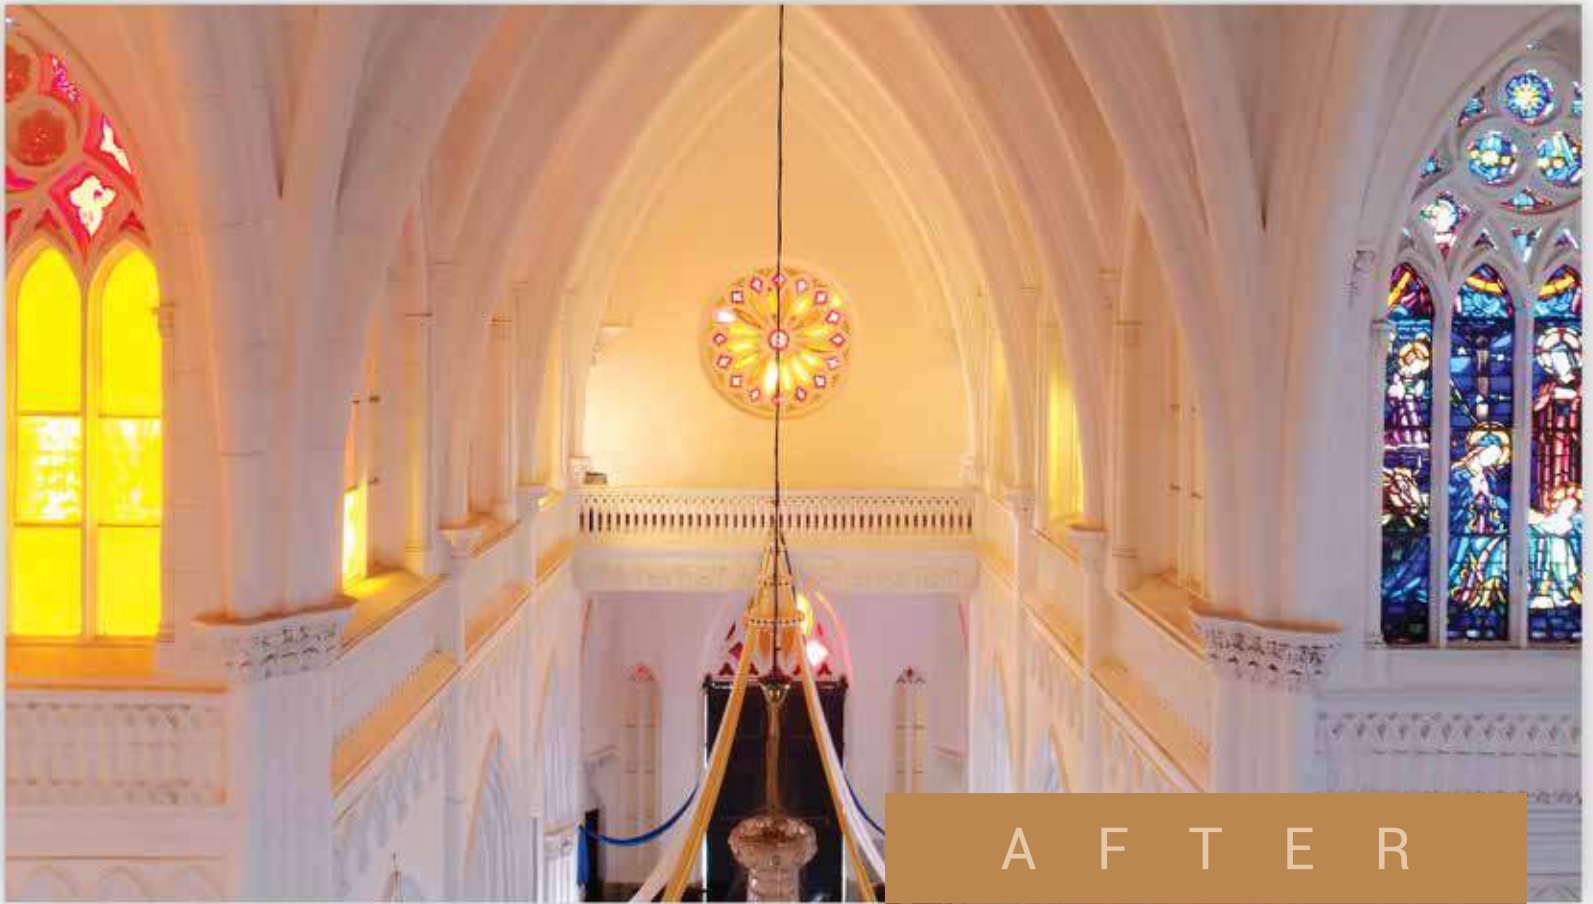
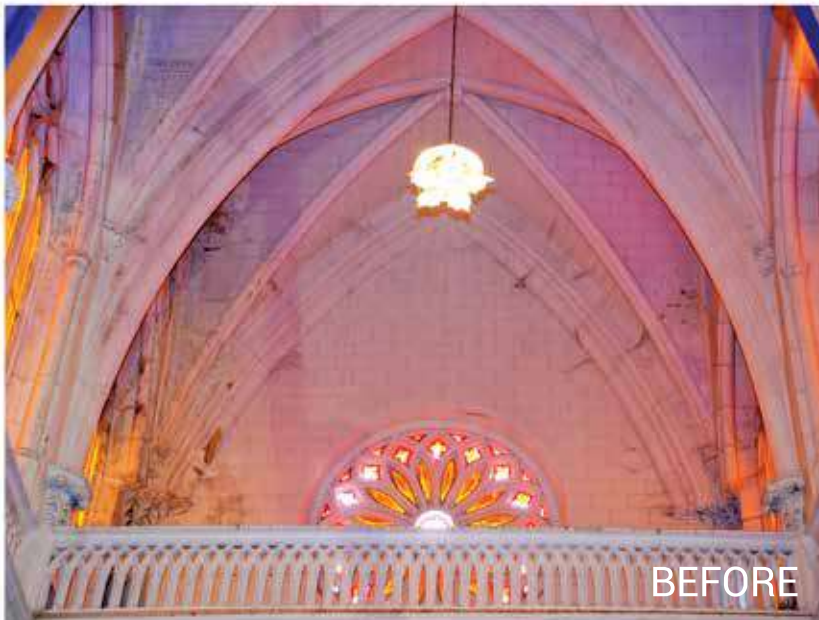
The vaults around the rose window showed signs of dirt accumulation thereby affecting the appearance. The dirt was cleared and the rose window was restored.

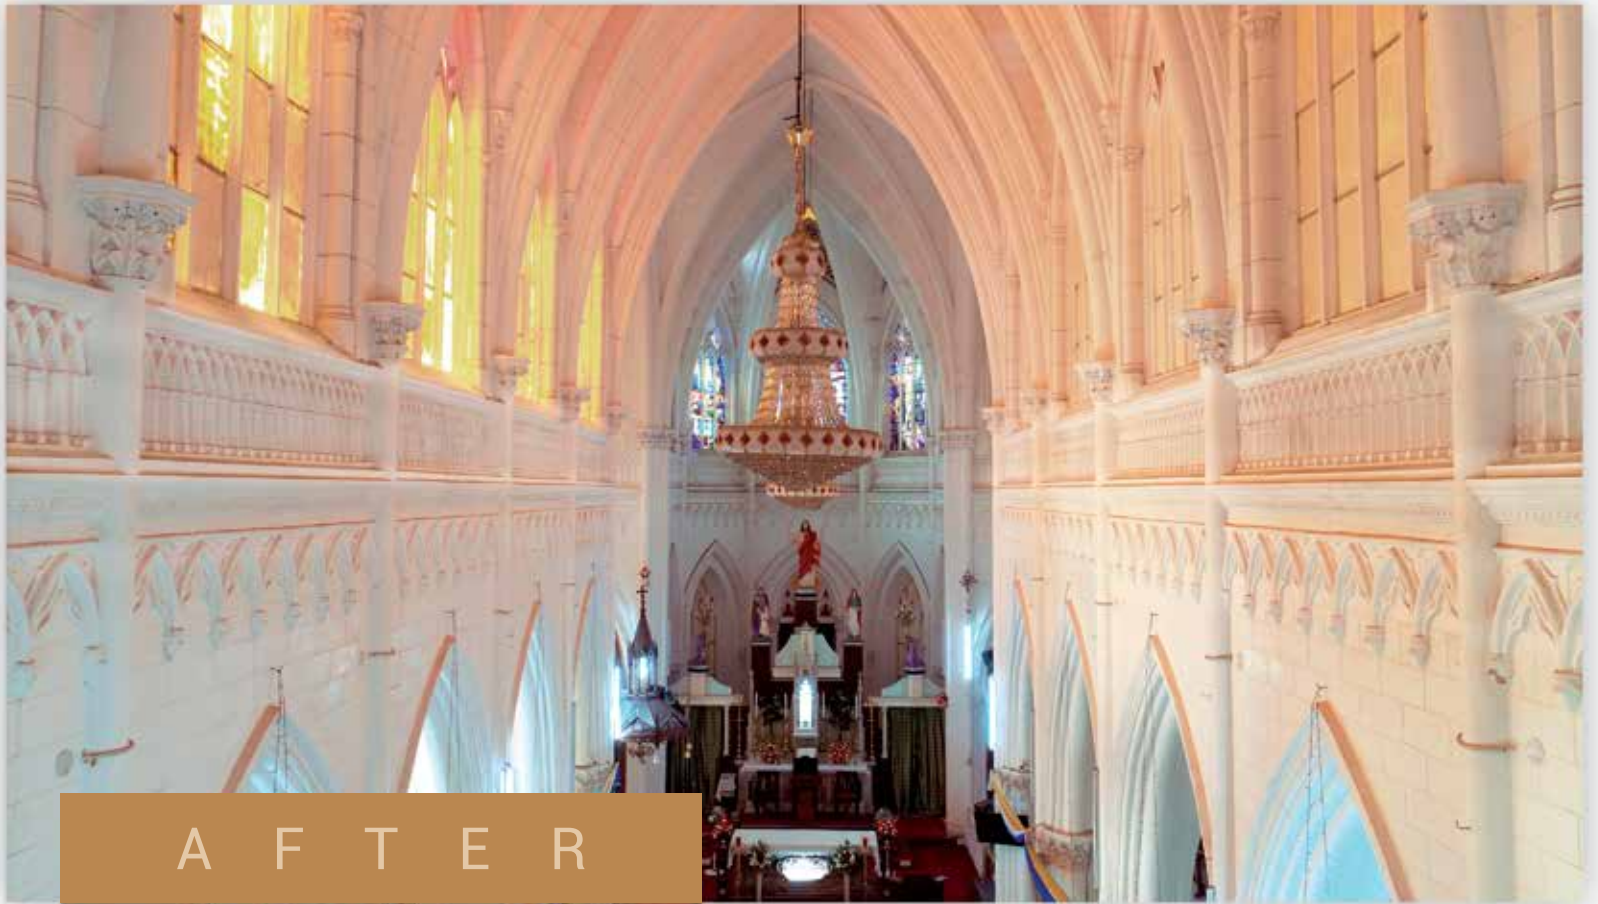
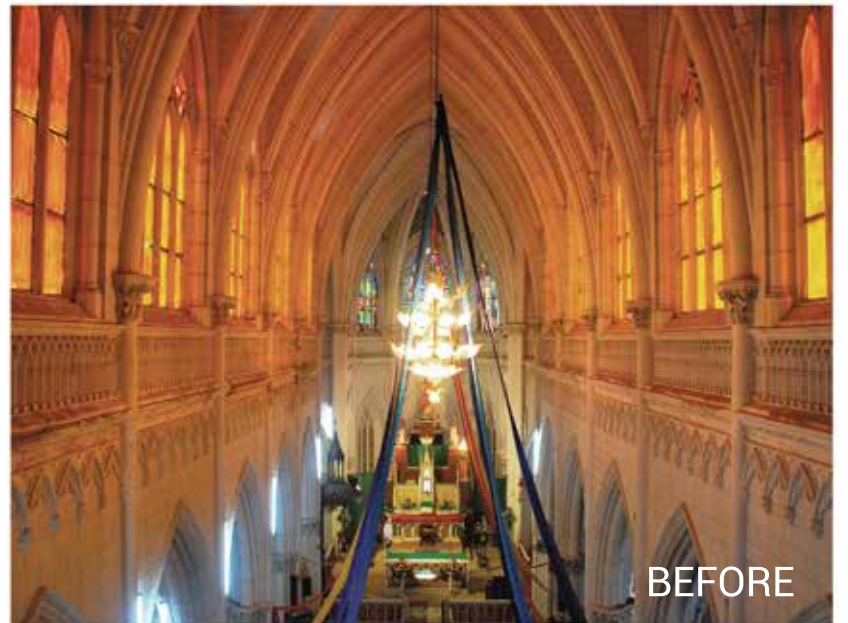
The architectural elements such as the altar, choir, the arcades and the triforium were restored step by step to address multiple problems such as water ingress, dampness and biological growth.

The stained glass at the rear end were checked for any previous interventions and dampness. The old chandelier was replaced with a new one which is more grand.
