TOWN HALL
&
OLD MUNICIPAL OFFICE
VISA KHAPATNAM

About Us

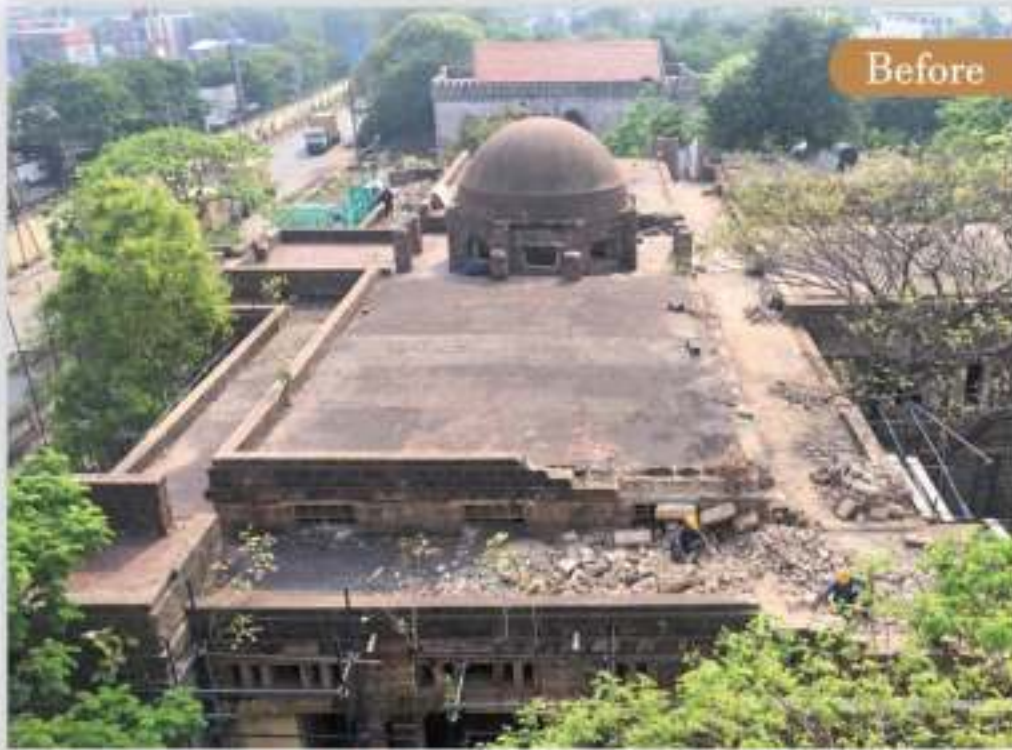
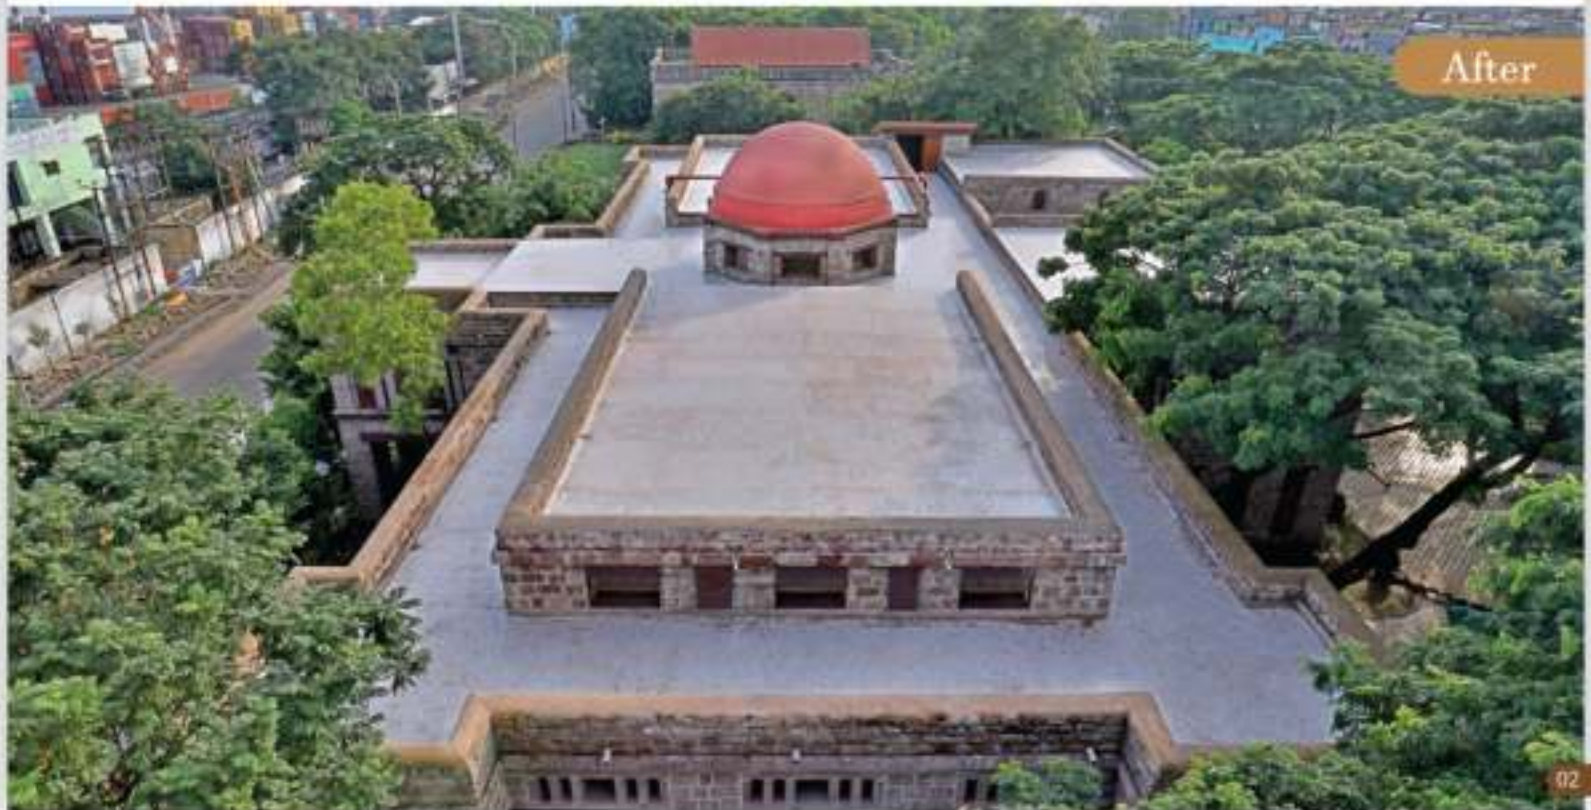
FLAT ROOF

The Dome of the Old Municipal Office being the central element, its structural restoration was necessary along with the slab around it.

The slab in some places appeared damaged which had to be restored back to avoid further damage. Besides structural restoration, the waterproofing was also necessary to arrest the leakages and dampness in the rooms below.

The slab was made water proof by using the China mosaic technique which includes laying of Brick Bat Coba before tile chips.

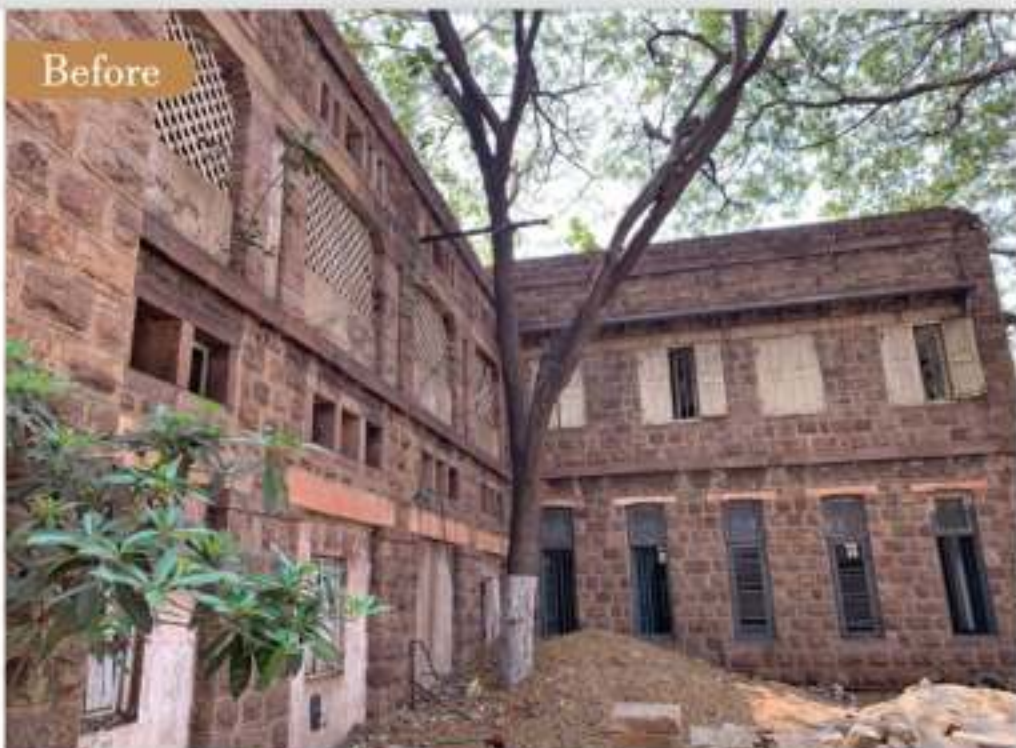
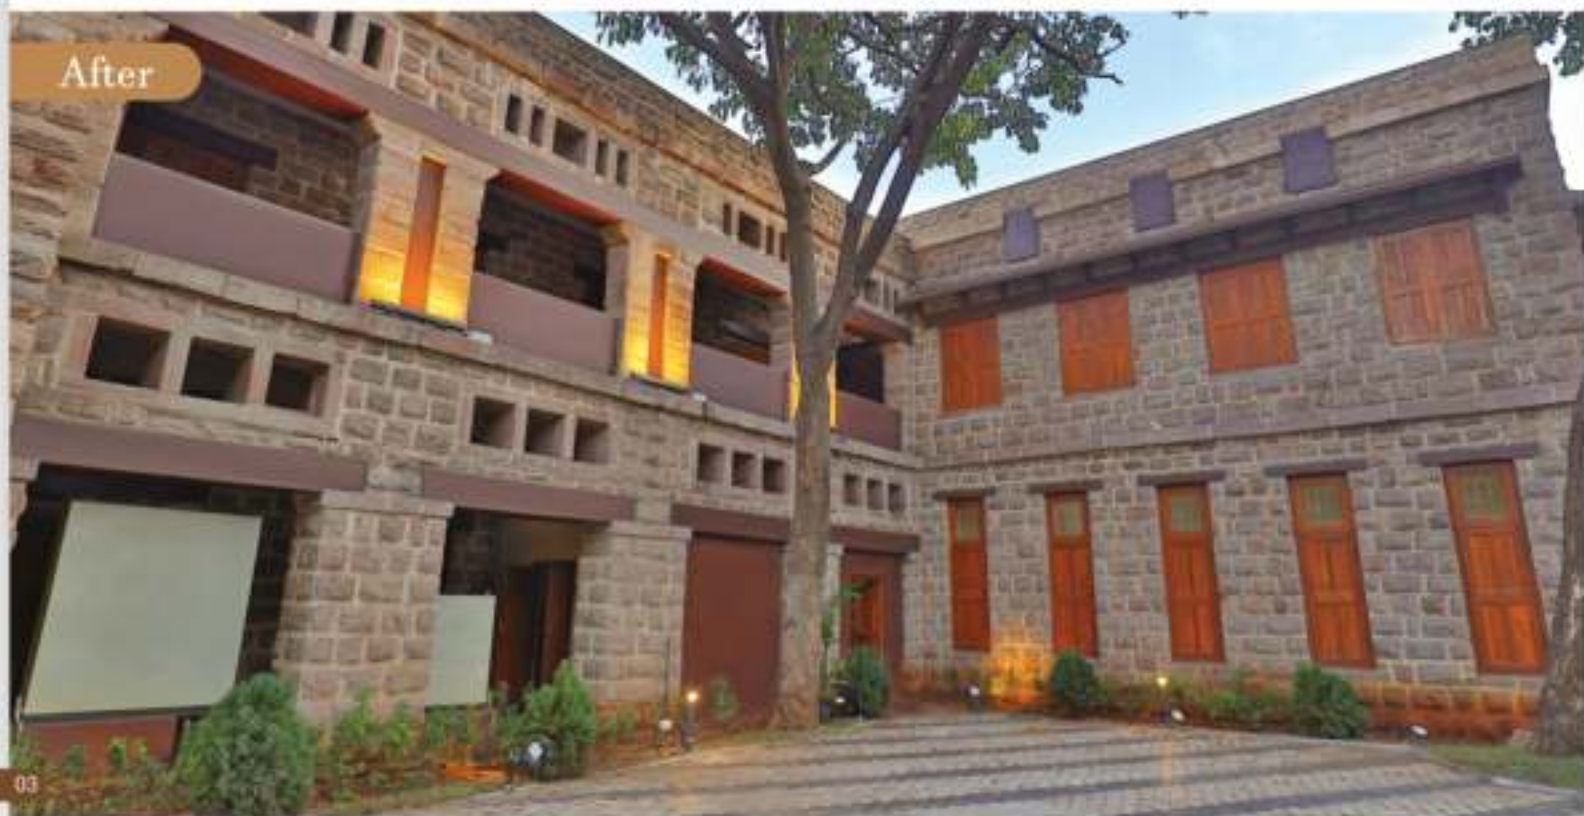
FAÇADE

The Façade of the OMO displays an ashlar stone masonry with neatly dressed stones and intervened by beautiful louvered windows. Unfortunately, several interventions took place over the years and eventually the building fell into disrepair.

The façade underwent fabric and structural restoration. The lintels were structurally restored to safeguard the structure. Some blocked spaces and interventions were also corrected.

The previous cement pointing was racked out and repointing was done with lime. A layer of waterproofing was done to restrict the growth of ficus and allow breathability to the stones. The polished windows further enhanced the façade.

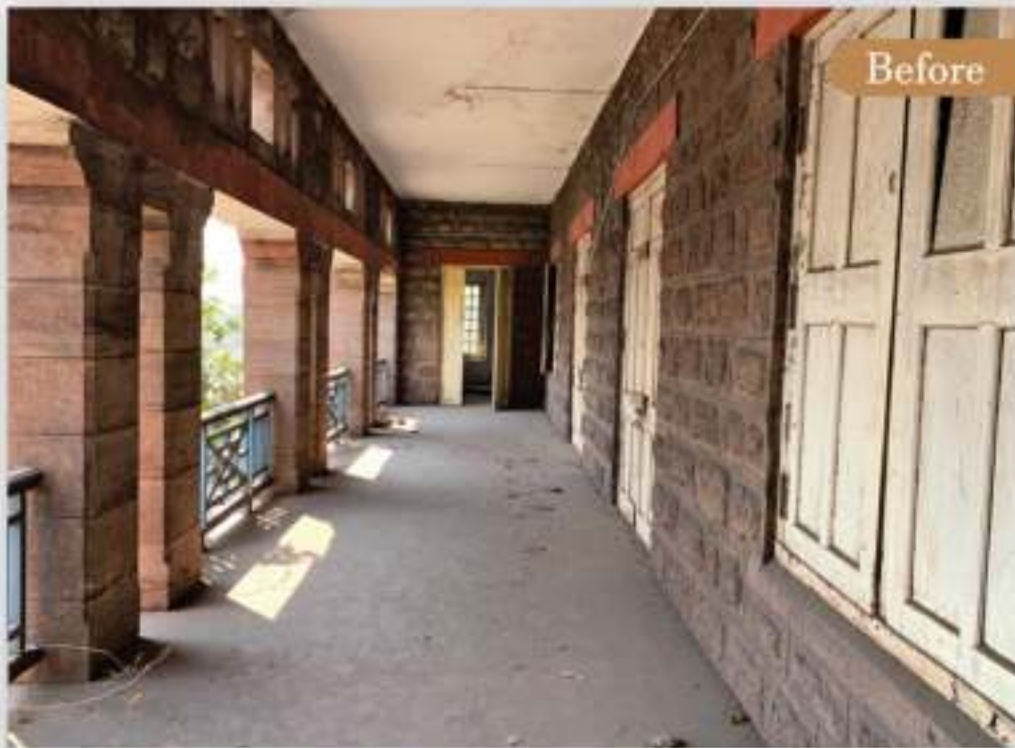
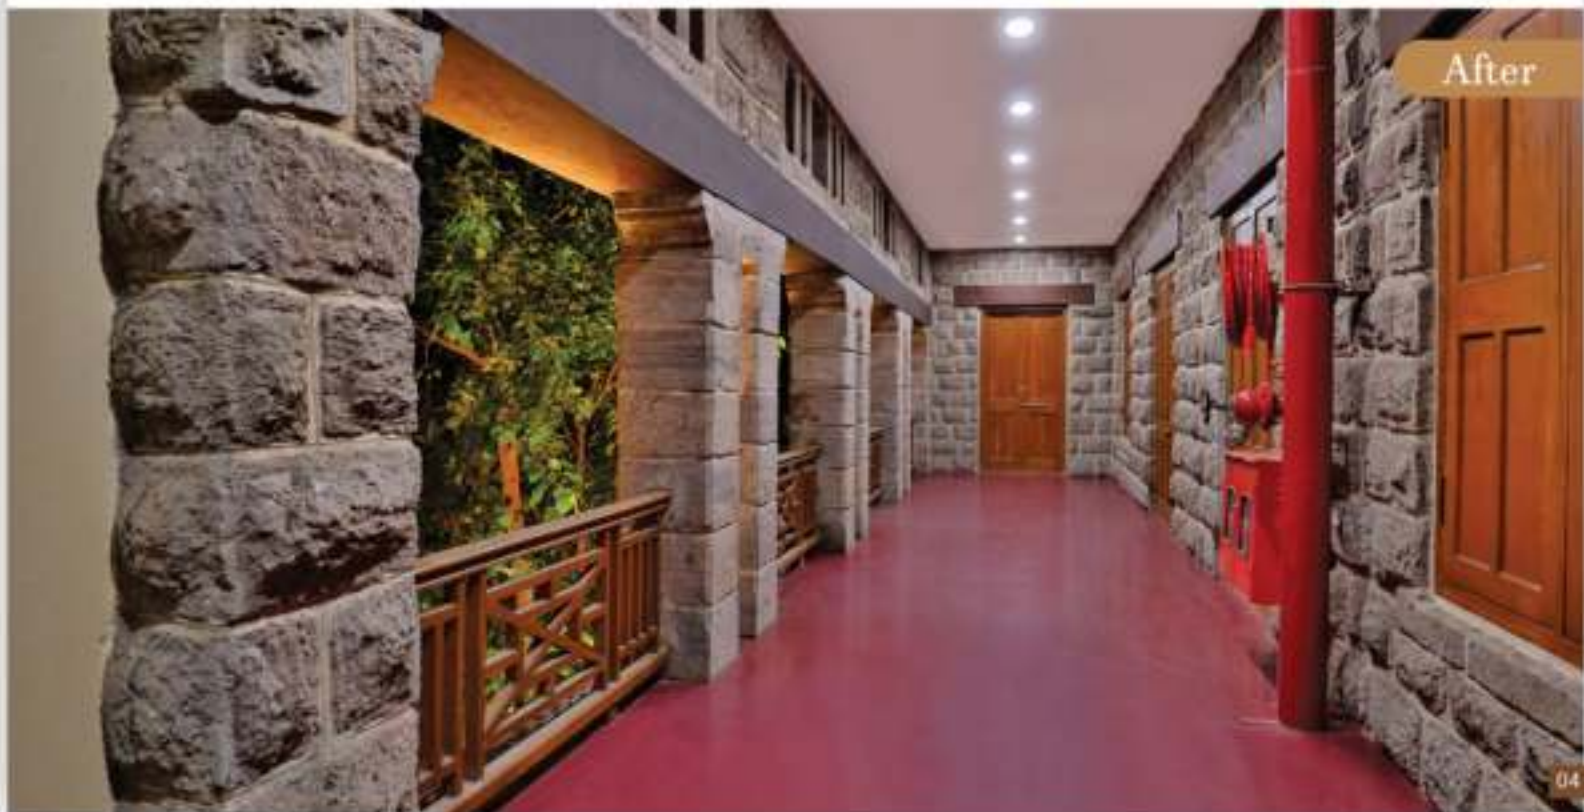
CORRIDOR

The Corridor is the first covered space which welcomes the visitors giving a glimpse of the restoration works internally. The stone masonry was treated, the flooring restored and repointing done with lime which was intervened with cement thereby affecting the stones. The lime being a traditional material bonds well with the stones.

The Doors and windows which were in a bad condition, were completely restored back and were melamine polished. The iconic wooden railings were also restored and replaced where required. All timber elements were treated with anti-termite treatment and polished. For safety concerns, the structure also compliances with the fire and safety norms. The lit corridor brightens up the space giving an appealing appearance.

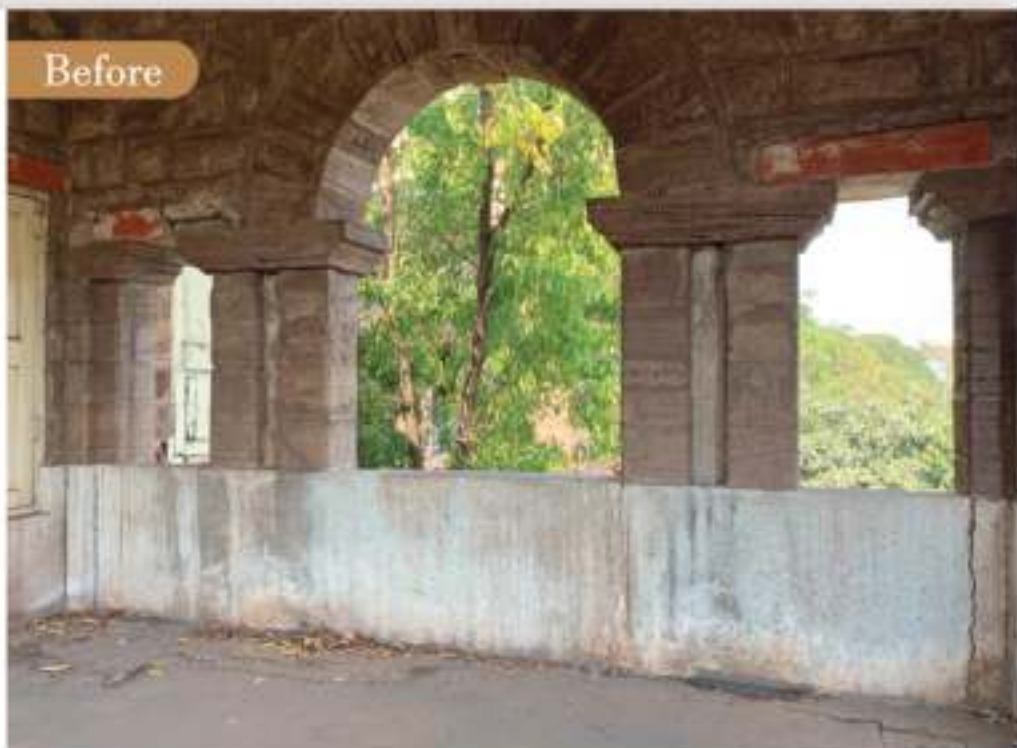
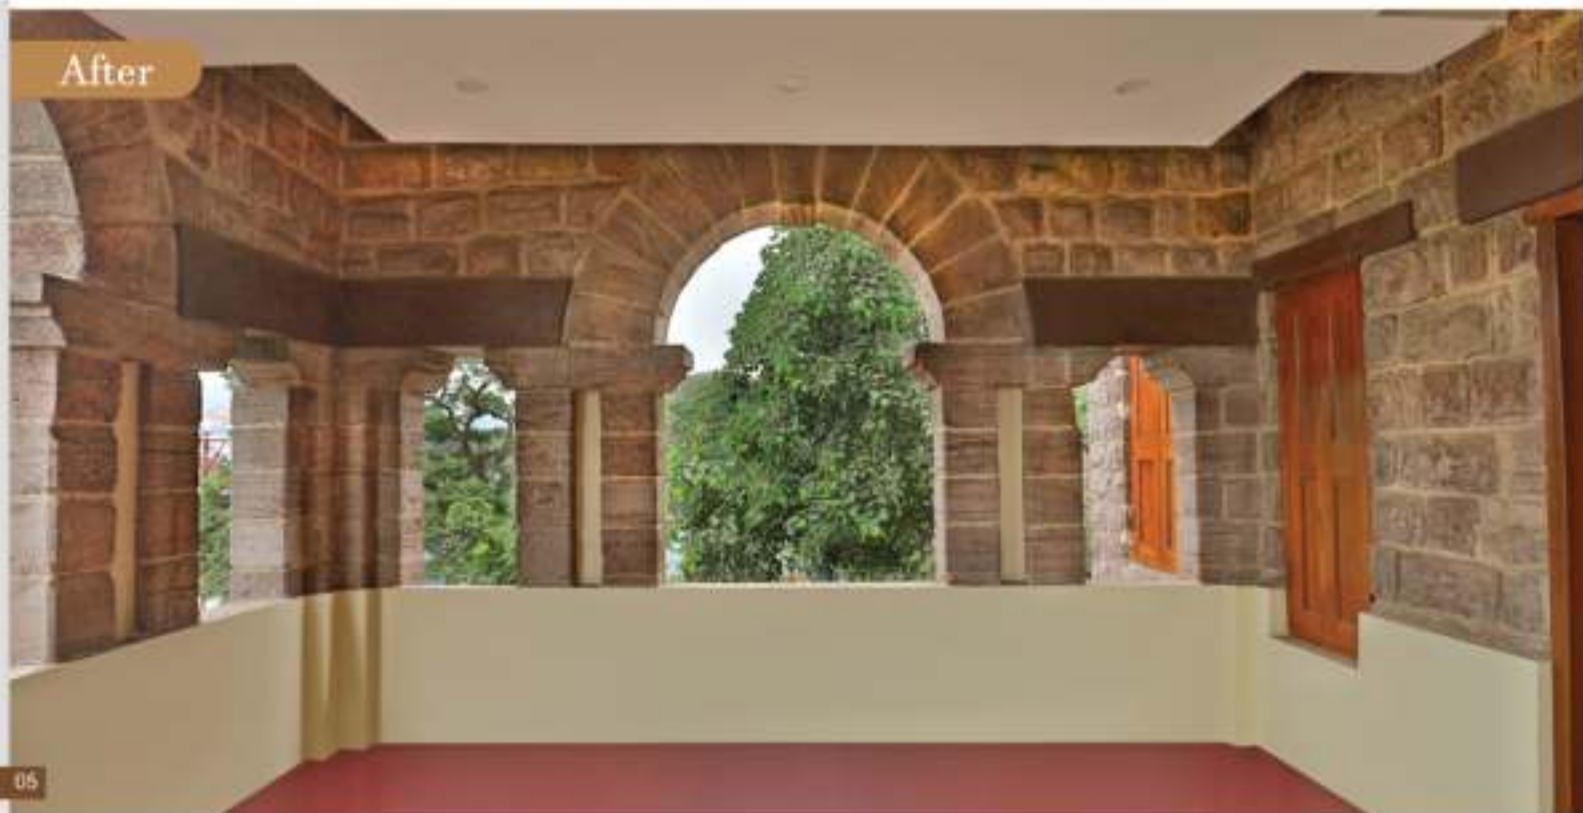
PORTICO

Structurally, the lintel of the flat arches were damaged and had to be restored to safeguard the structure.

The stone masonry of the columns and arches was restored back by cleaning and application of lime pointing. The doors and windows of the portico area too were restored back and polished which were painted previously.

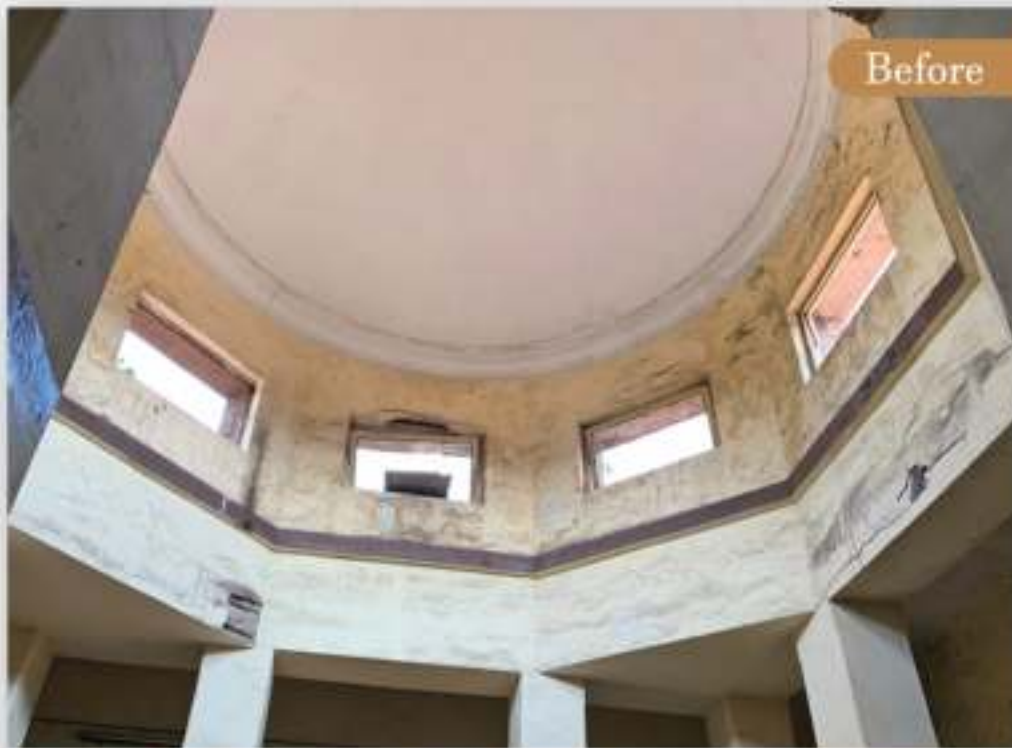
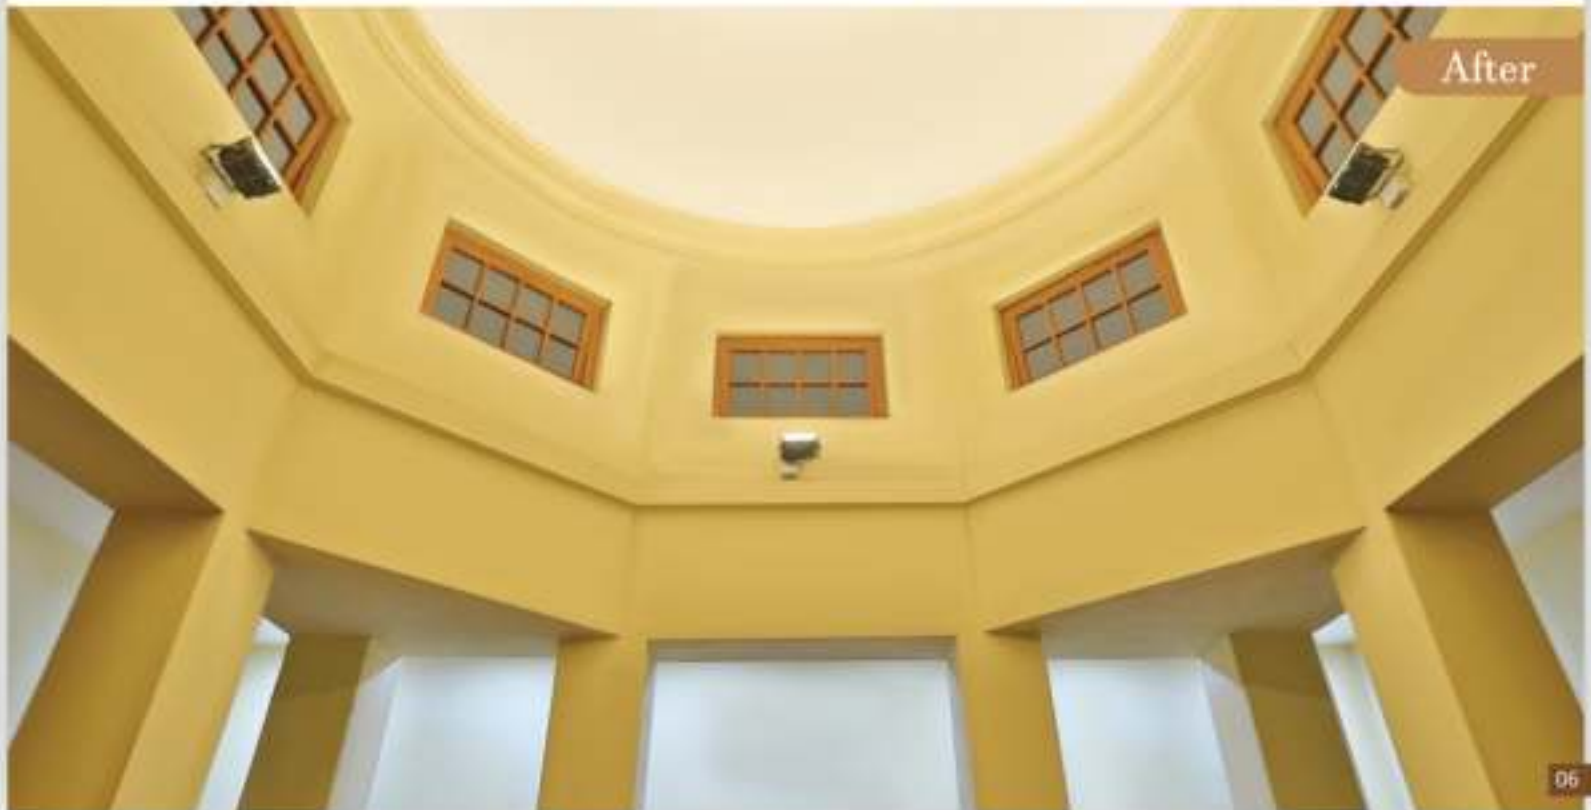
DOME

The Dome of the Old Municipal Office is one of its iconic element. To its utter dismay, the condition of the dome was not maintained well, the ventilator windows missing and the beams below the drum also damaged.

The paint layer of the dome area was also flaking. On the external side, the slab around the dome was restored and it possessed a structural threat.

Once the work commenced, the beam were restored, the ventilator windows were affixed and the entire area was repainted with a suitable paint which was breathable. Later this internal side of the dome was lit to enhance the entire area.

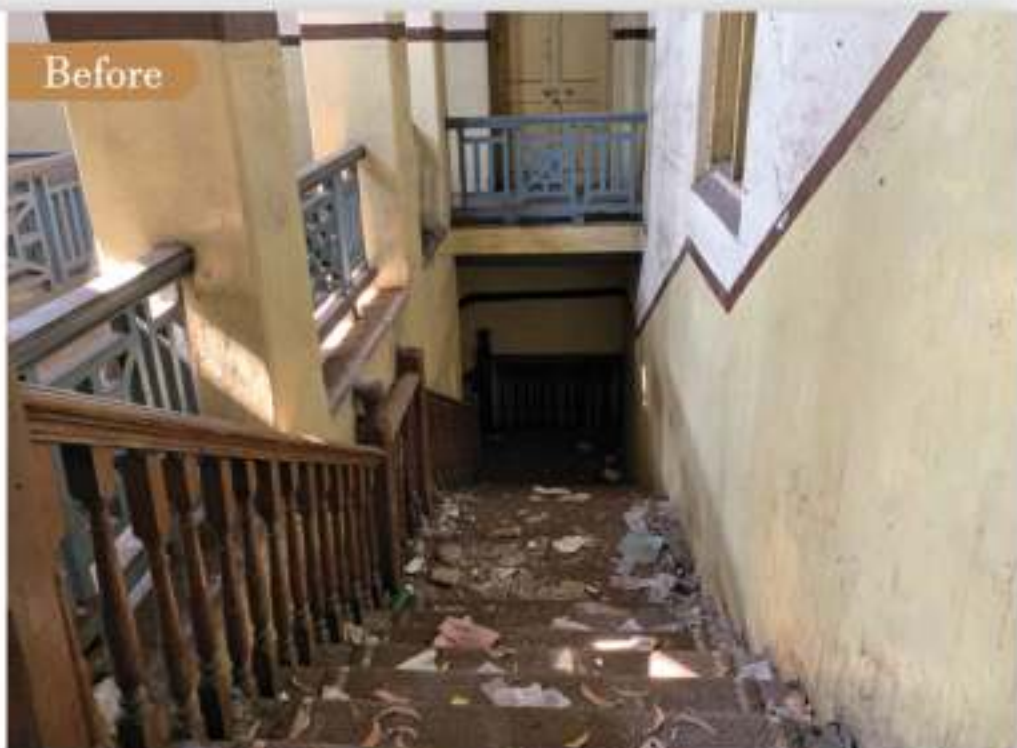
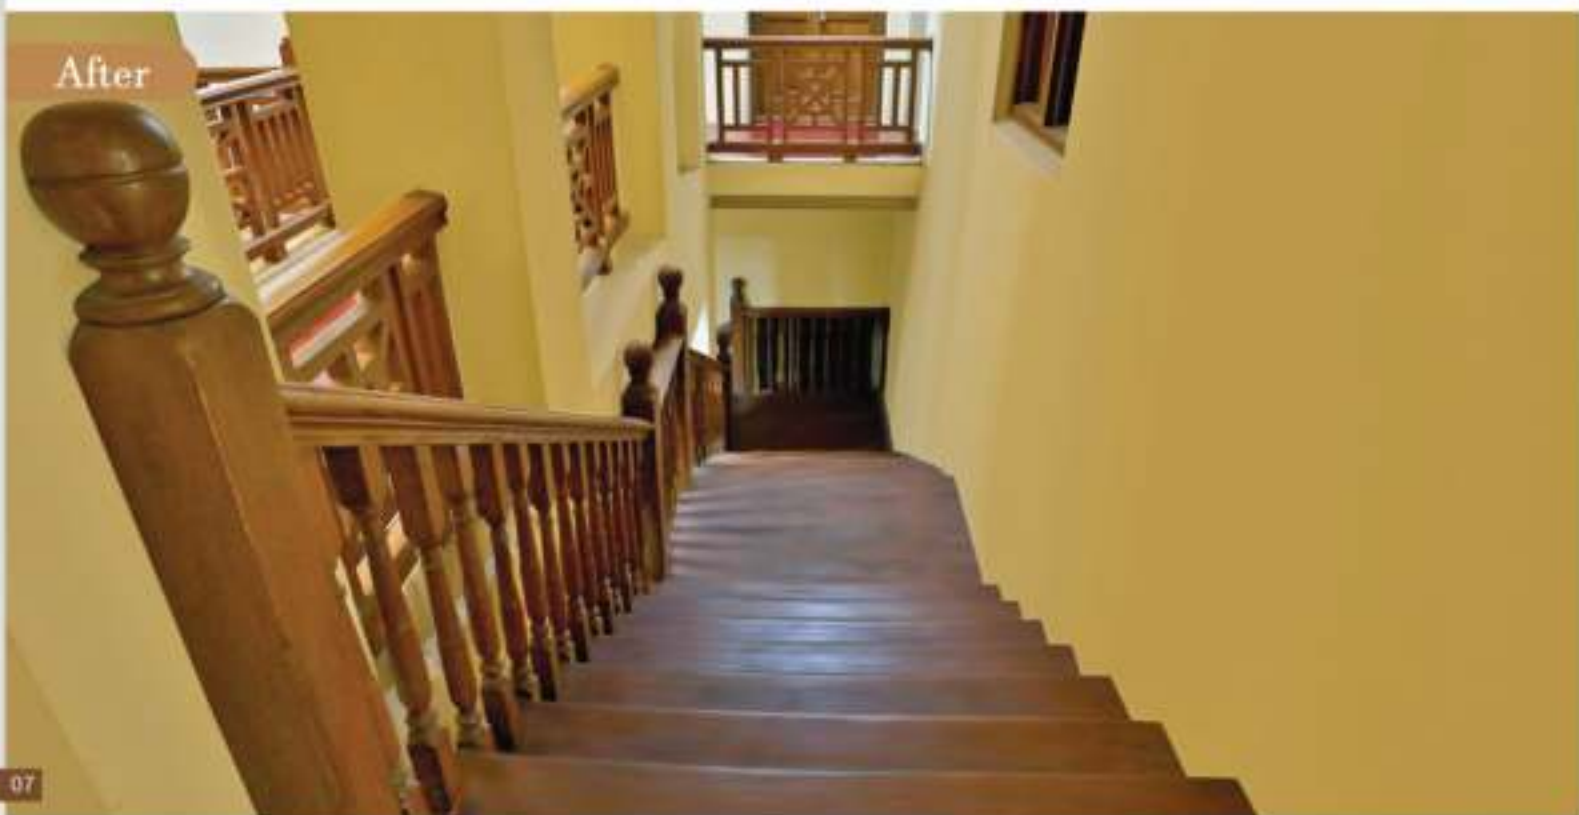
STAIRCASE

The timber steps leading to the ground floor which was in a state of disrepair due to under usage. The timber which was in a good condition was restored back after a thorough cleaning and polishing.

The paint was scraped off from the railings as the paint is not suitable for the wood and its removal was deemed necessary.

Thus, all the timber members were sustainably polished. Further, the side walls were also repainted after cleaning the previous flaking of the paint.

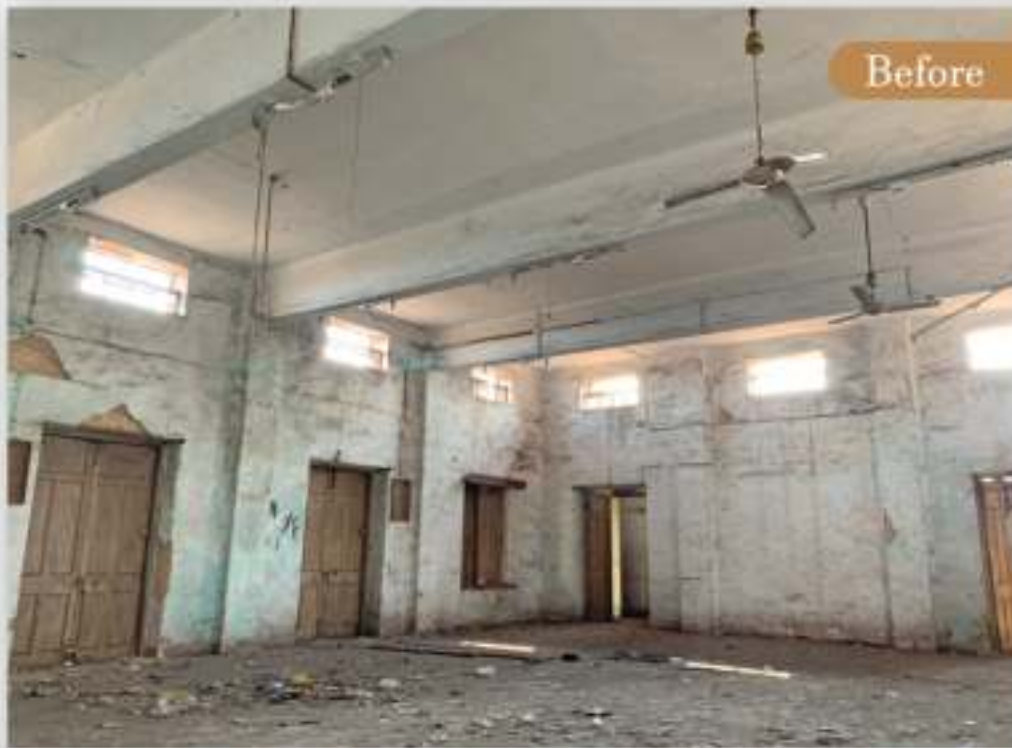
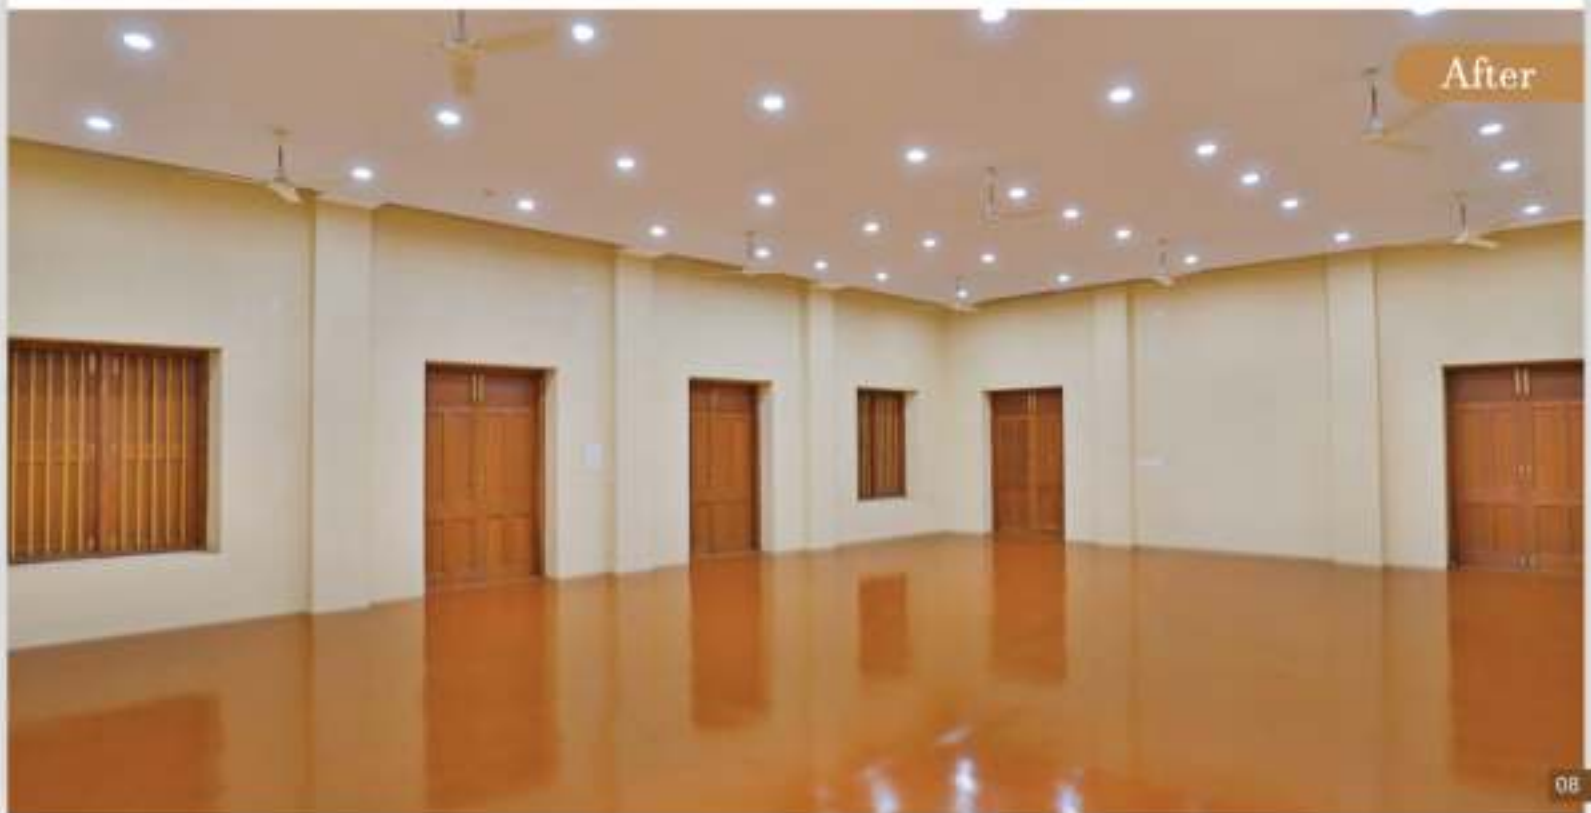
ROOM

The restoration for OMO was not just for the external face but also internally! The condition of the room was in a very critical condition due to under maintenance and paint layers applied over and over the walls which was a brutal intervention affecting the breathability of the stones and ultimately flaking of the plaster.

The internal revitalisation of this room was done by first scarping out all the paint off the walls, restoring the flooring. Later, the walls were painted with breathable paints, doors and windows restored and polished.

The light fixtures were fixed a new to brighten up the user space in the newly added ceiling for additional beautification.

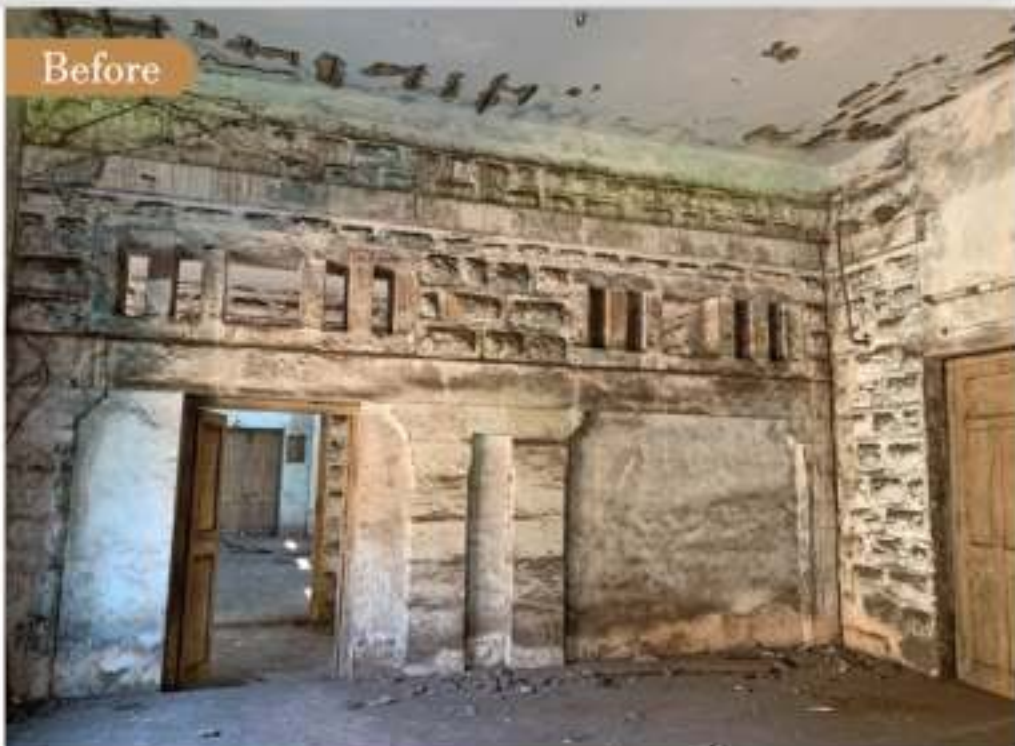
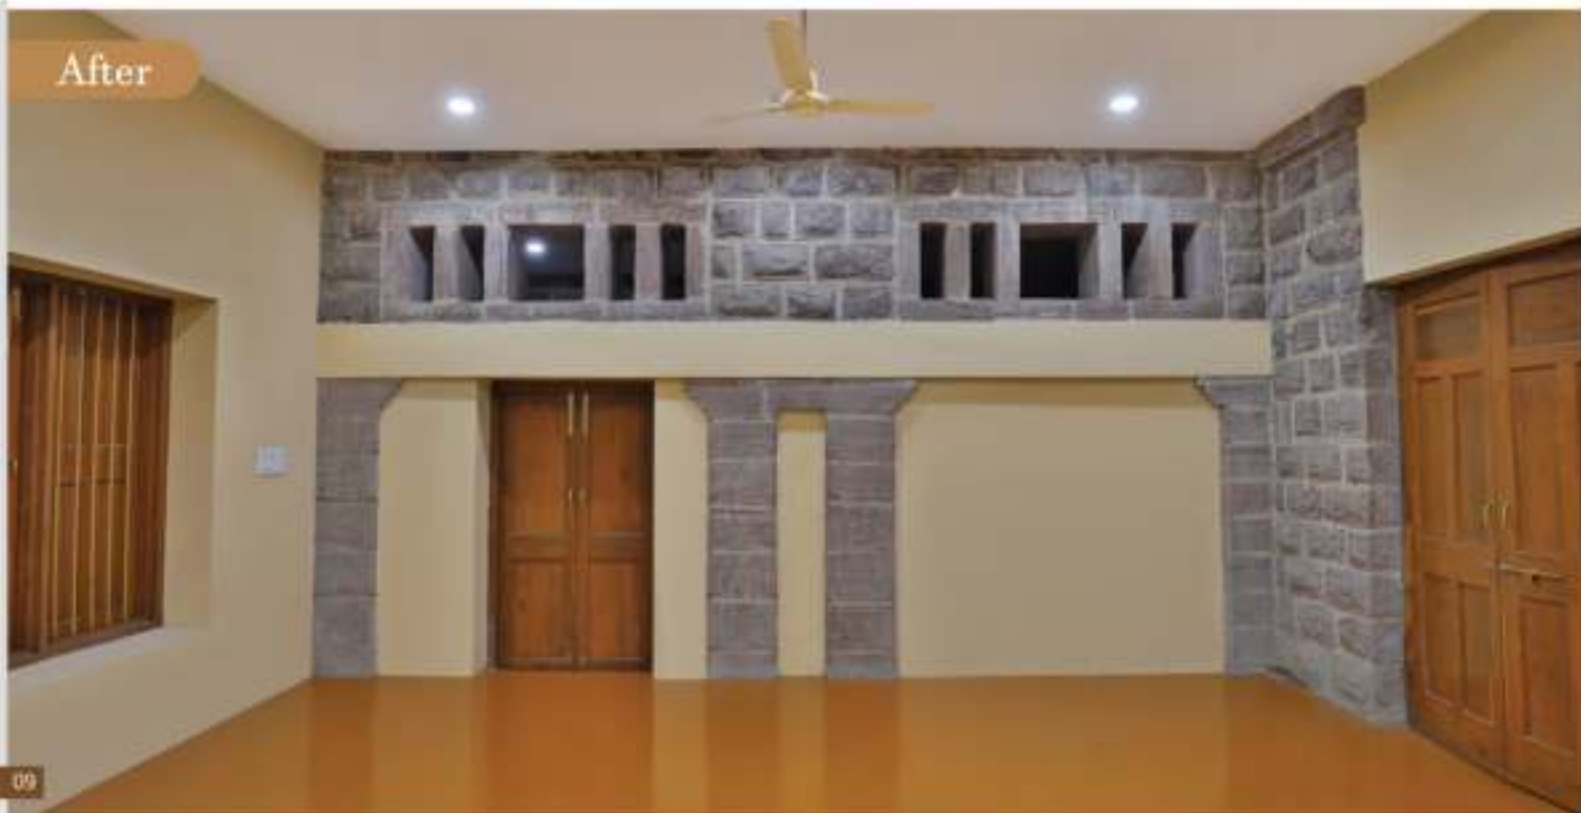
OFFICE ROOM

The office room was in a bad state owing to the under maintenance of the structure. The leakages and dampness had caused the slab to deteriorate and pose a threat to its users. An integrated restoration focused on exposing the stone masonry, repointing of lime and re-plastering using lime plaster.

This has brought the original layer of the office space. Besides, the slab was restored and covered with ceiling with illumination.

The painted doors and windows were also polished. The floor which had Indian Patent Stone was worn out and a layer of epoxy was poured over. This way the flooring was regained without adding additional weight to the floor.

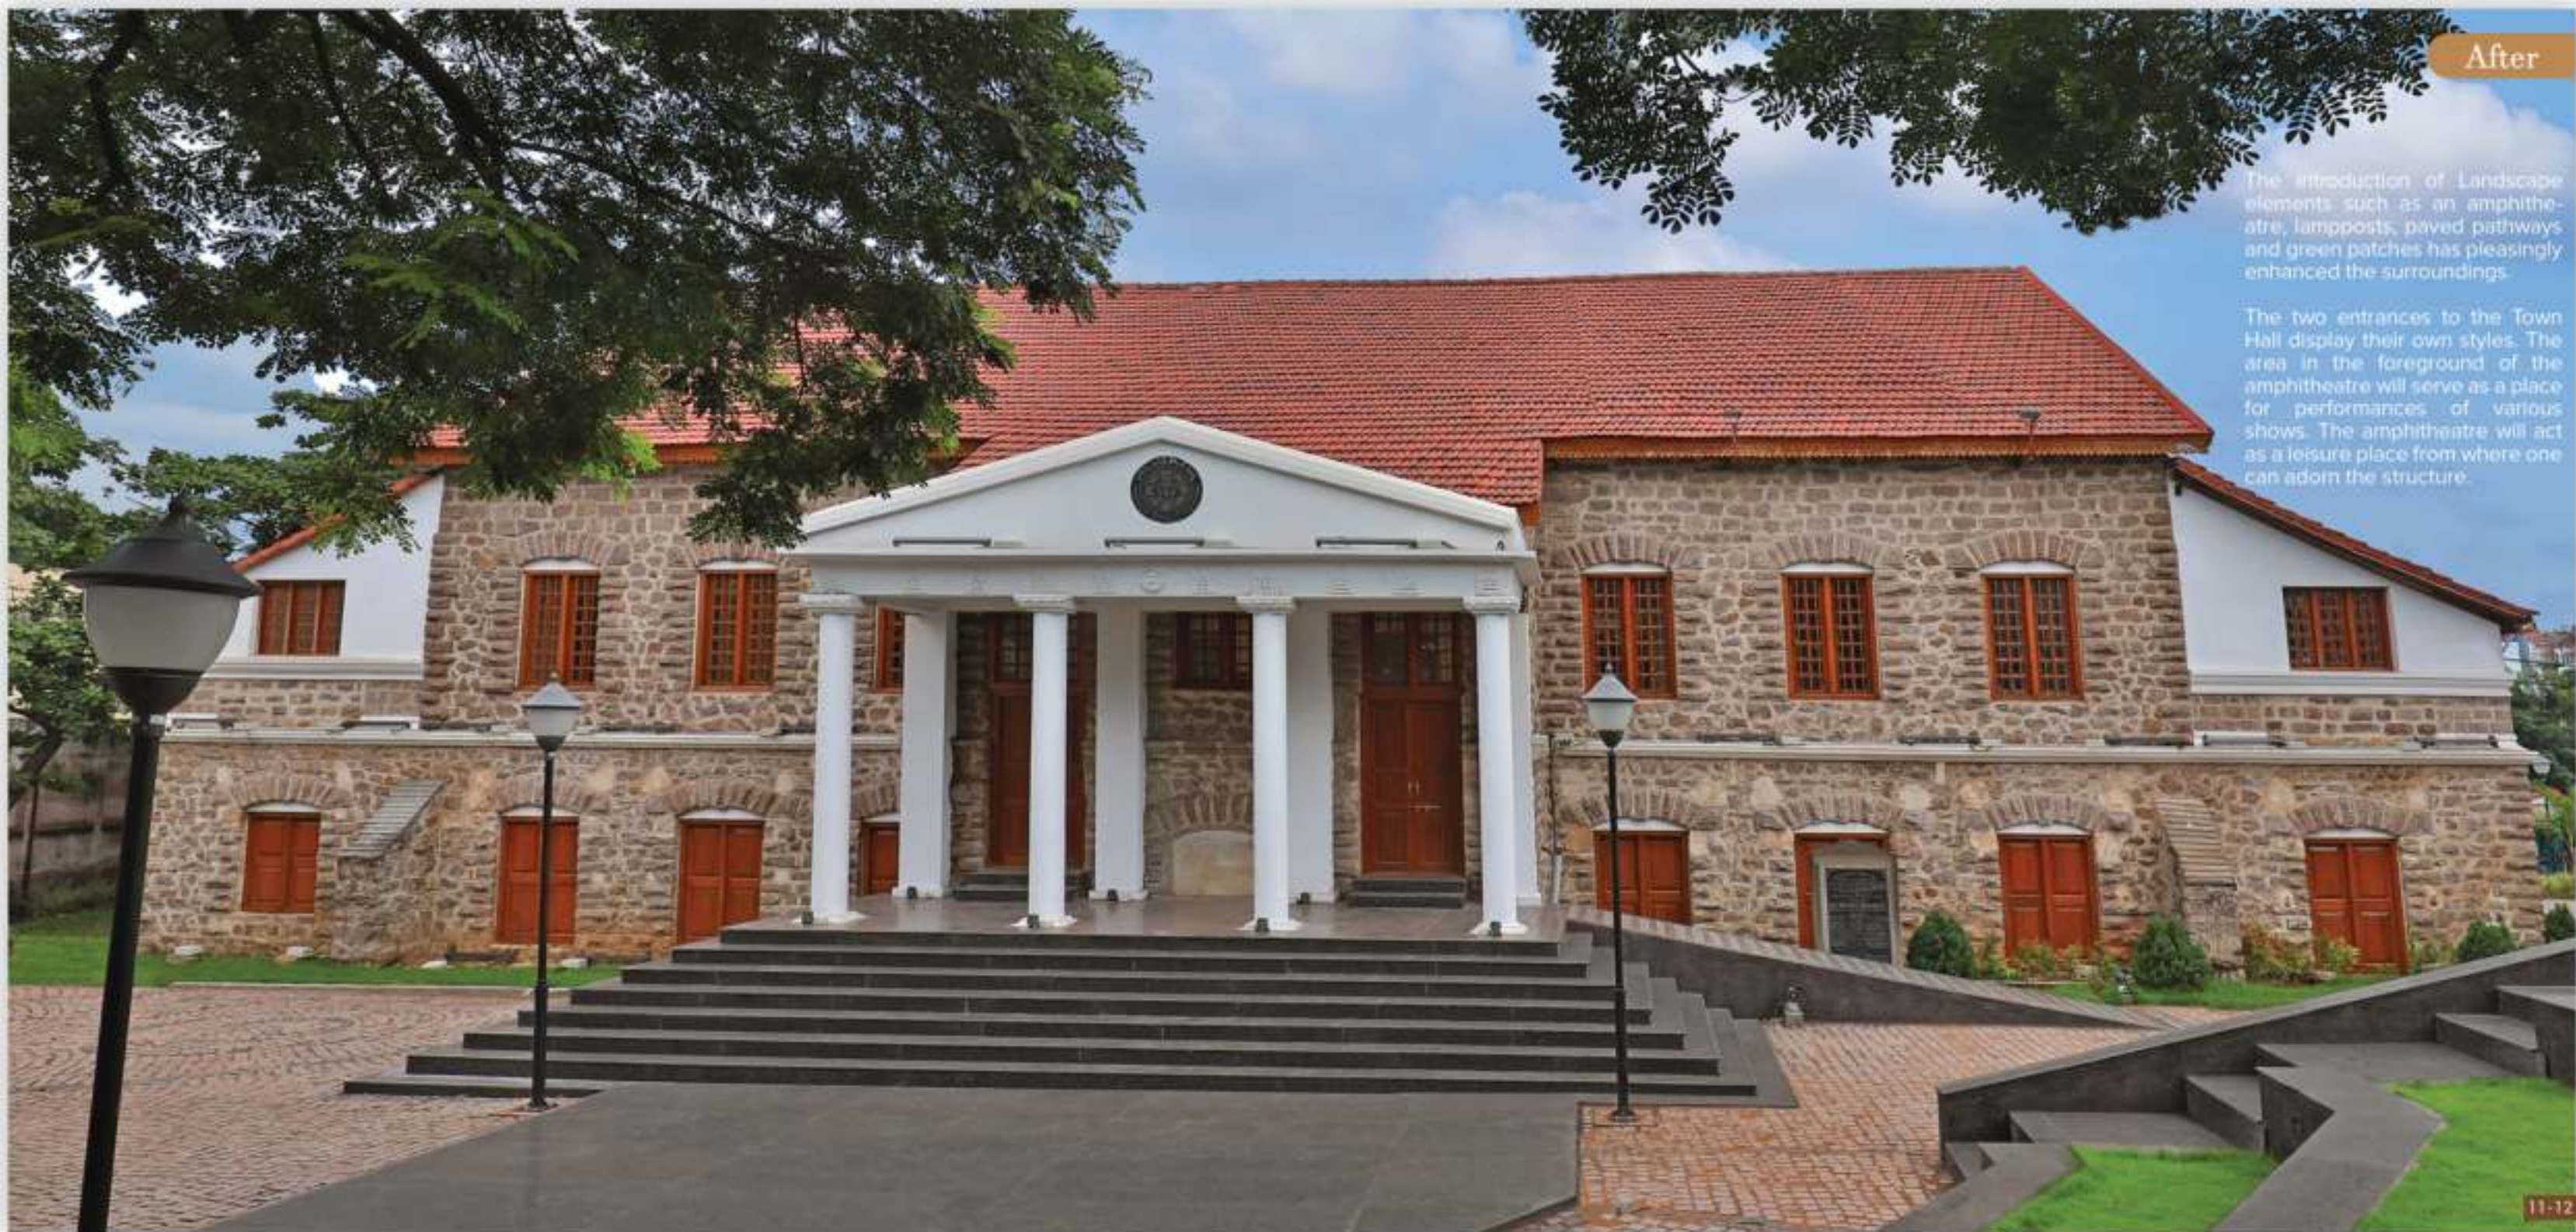
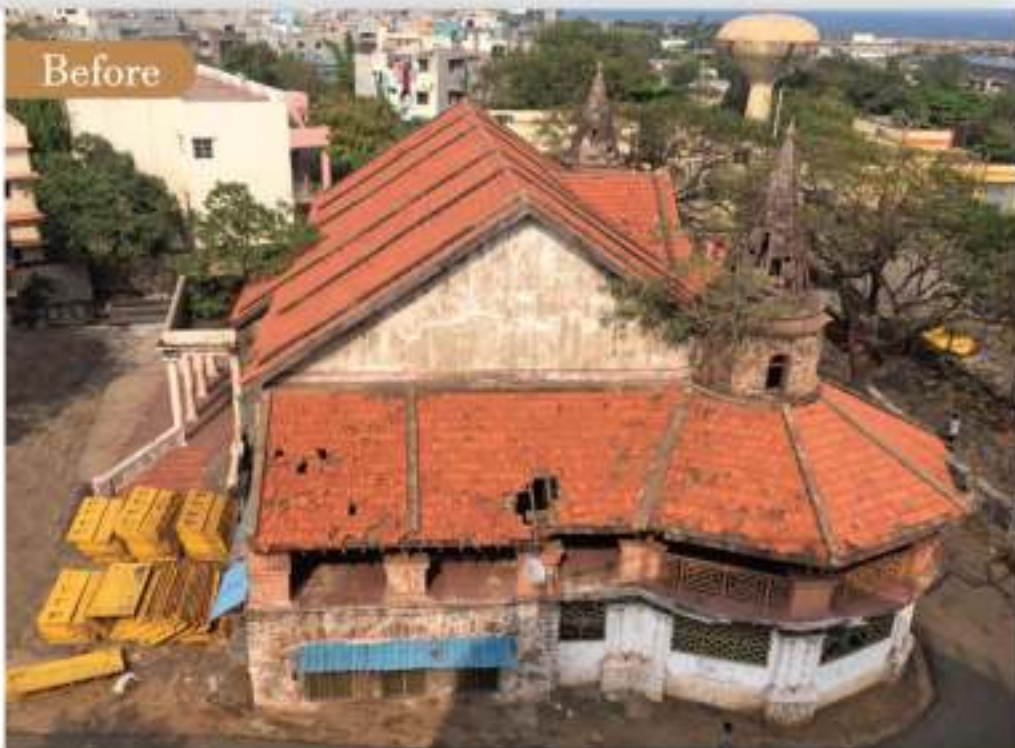
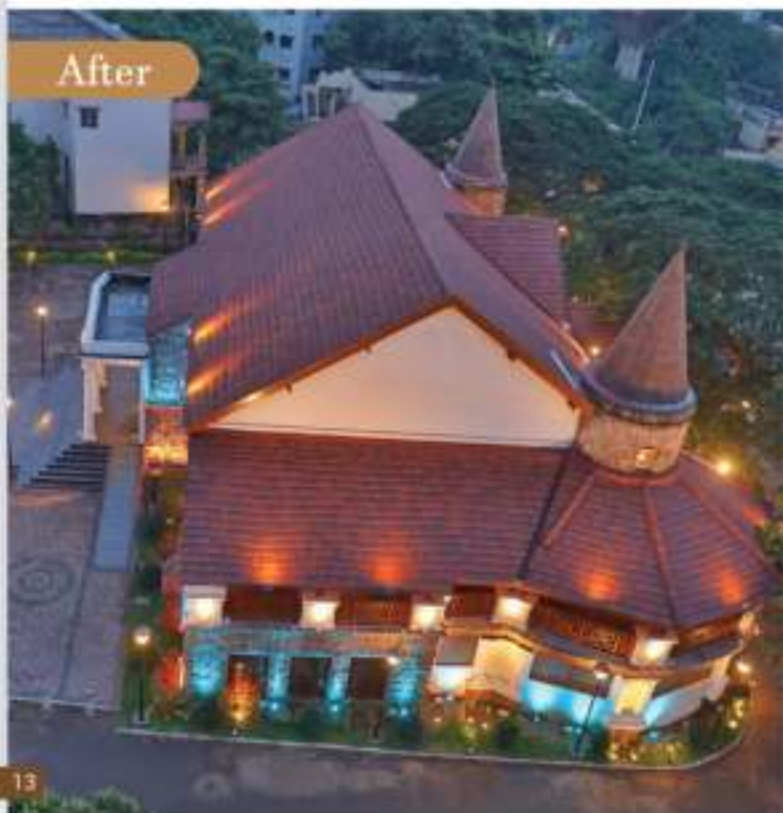
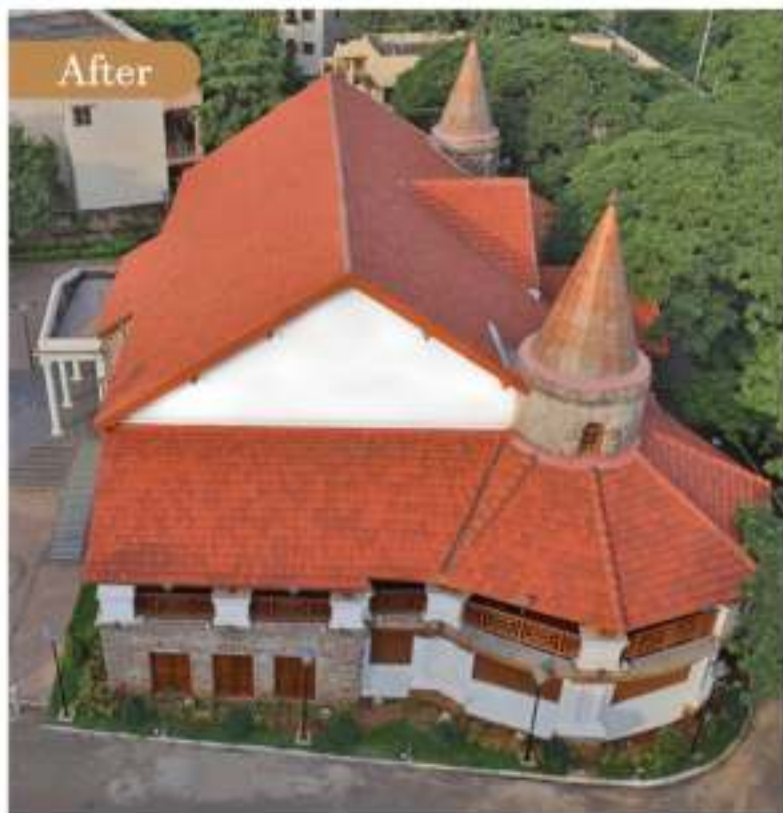
BIRDS EYEVIEW

The drone image offers an exquisite bird's eye view offering a visual treat. The pre and post restoration images clearly indicate the restoration efforts. The pitch roof, the walls, the doors and windows as well as the surroundings were landscaped.

The leakages through the pitch roof had seeped into the walls below. The plight of the structure made it unfit for the users.

Thus, the structural and architectural issues were addressed which has revitalised the structure.
