TOWN HALL
&
OLD MUNICIPAL OFFICE
VISA KHAPATNAM

About Us

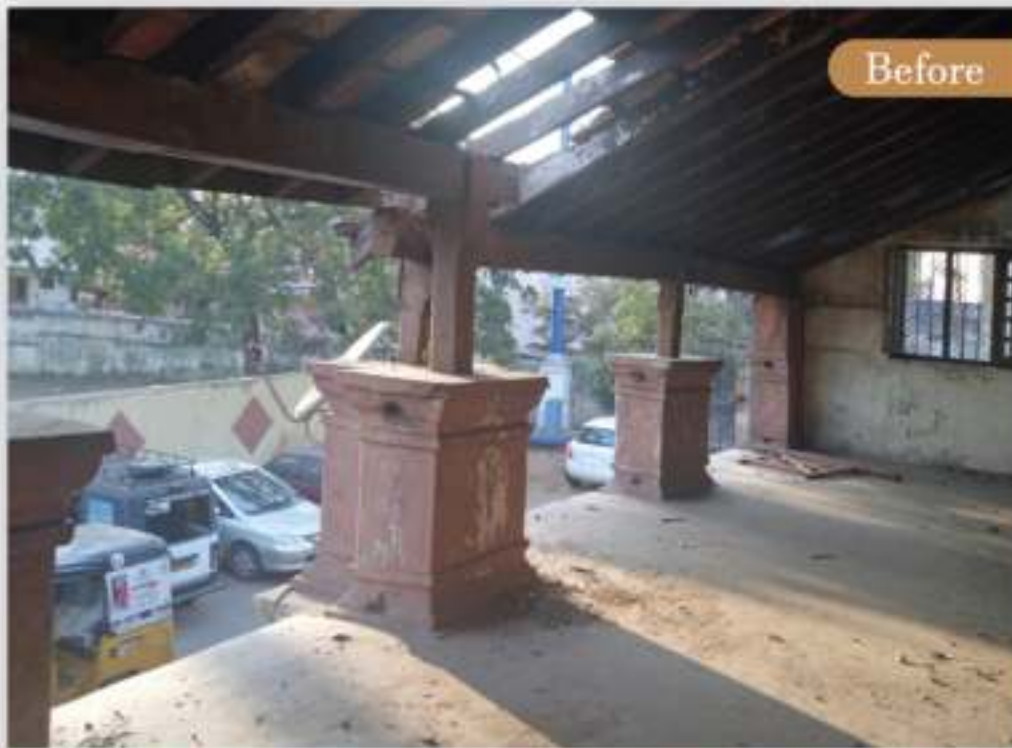
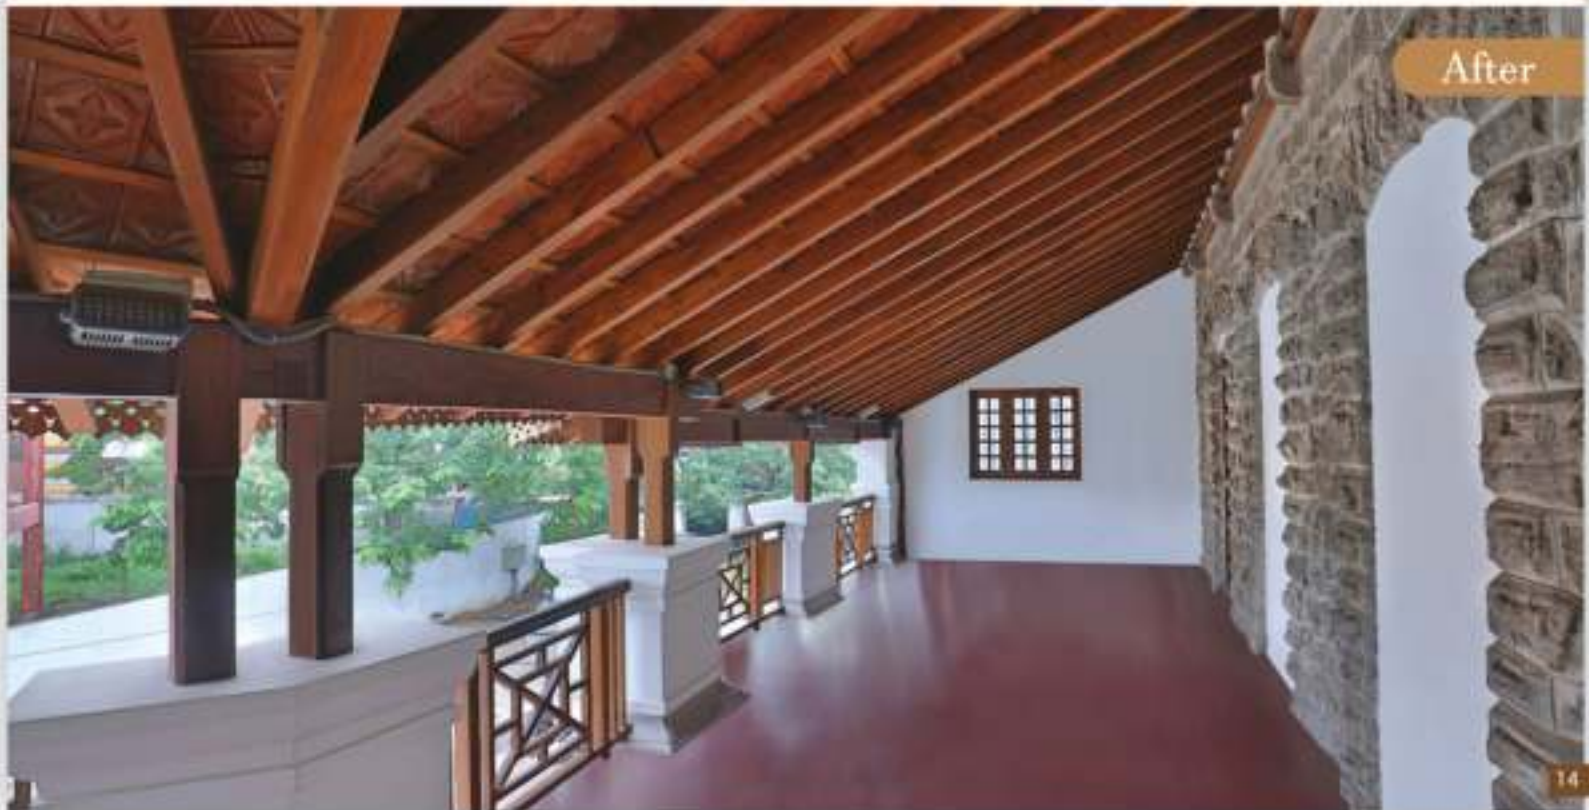
CORRIDOR

The corridor at the entrance of the Town Hall was in a bad condition with damaged railings, severely deteriorated roof and tiles, dusty floor, all a result of under maintenance.

The walls were painted whose layer was also flaking. Later the flaking paints were scraped off and a fresh layer of lime plaster was applied with added natural additives. Simultaneously, the roofs were restored and made watertight. As the previous tiles were shattered, the new tiles had to be placed.

The timber trusses were treated with preservative treatment for making them termite proof along with the eaves board. The flooring, timber railings and windows were repaired.

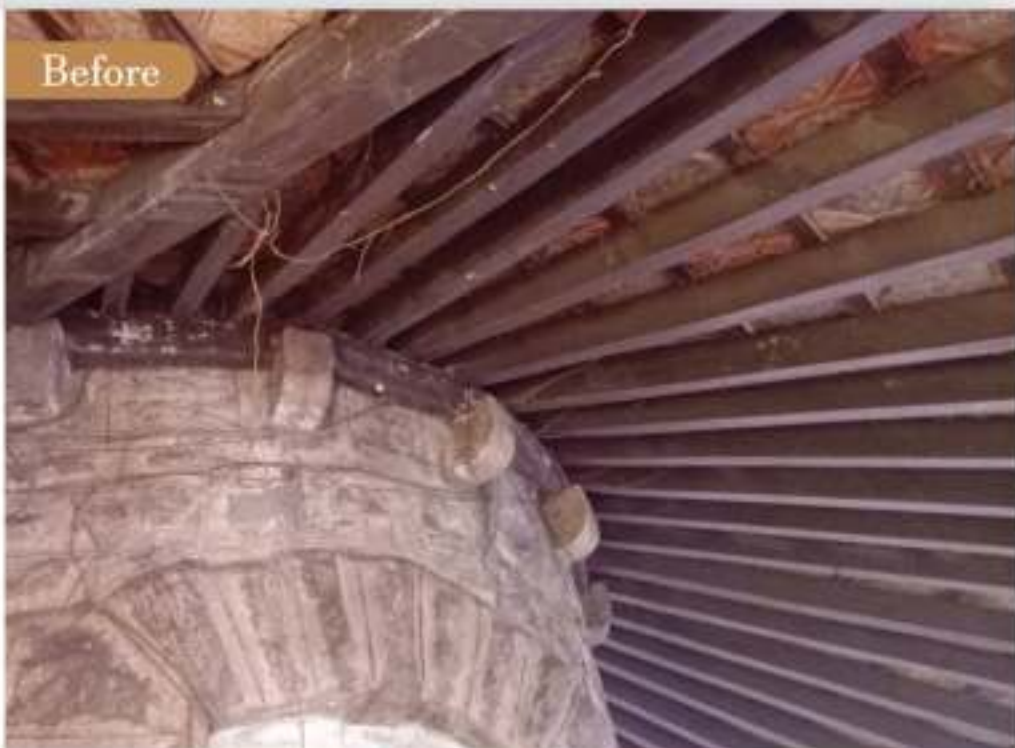
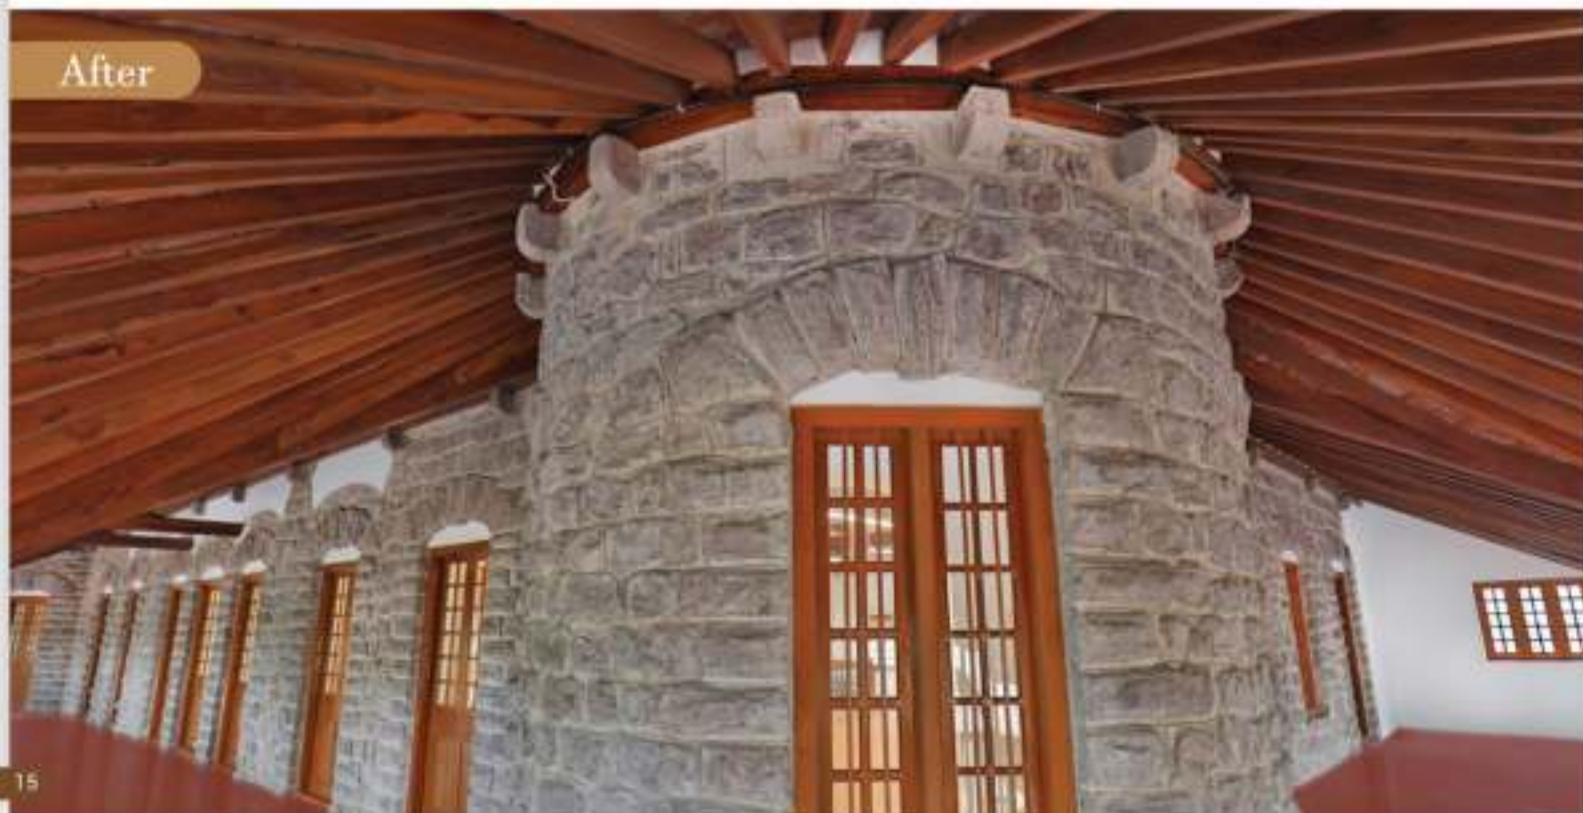
CORRIDOR

The rafters of the pitch roof carry most of the load and thus its stability is most important. The timber rafters were decayed and in bad condition. The rafters which were in better condition were reused and only those which were in a bad condition were replaced. These members were treated with anti-termite treatment and later polished.

The deteriorated tiles of the roof were also replaced. The stone walls were repointed with lime and the doors and windows restored.

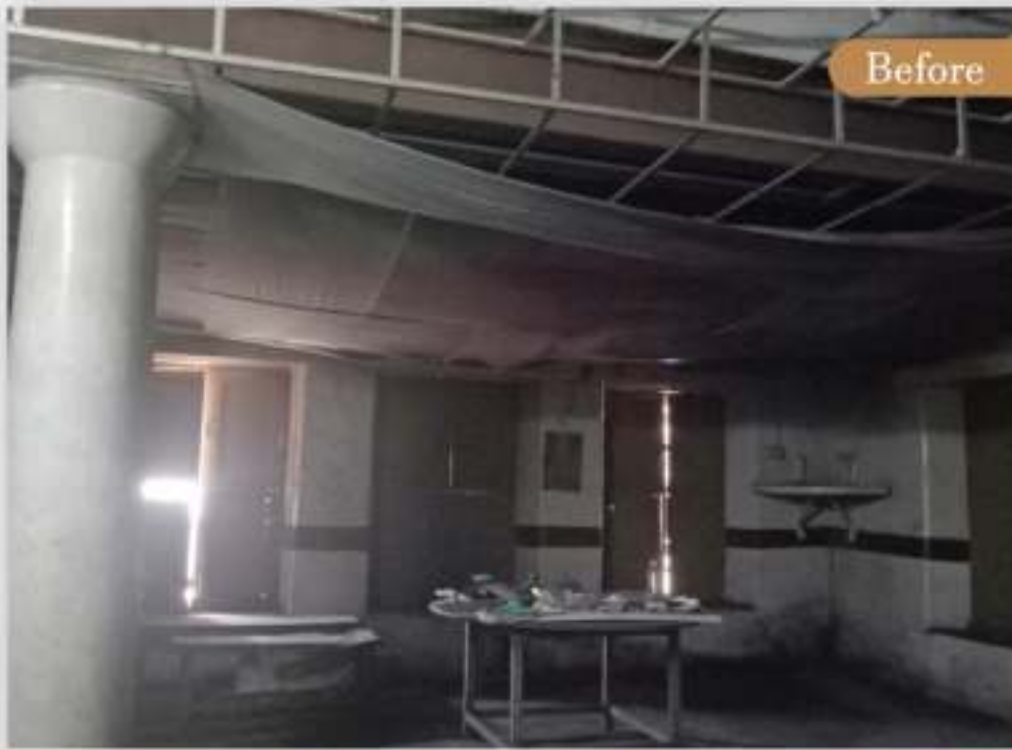
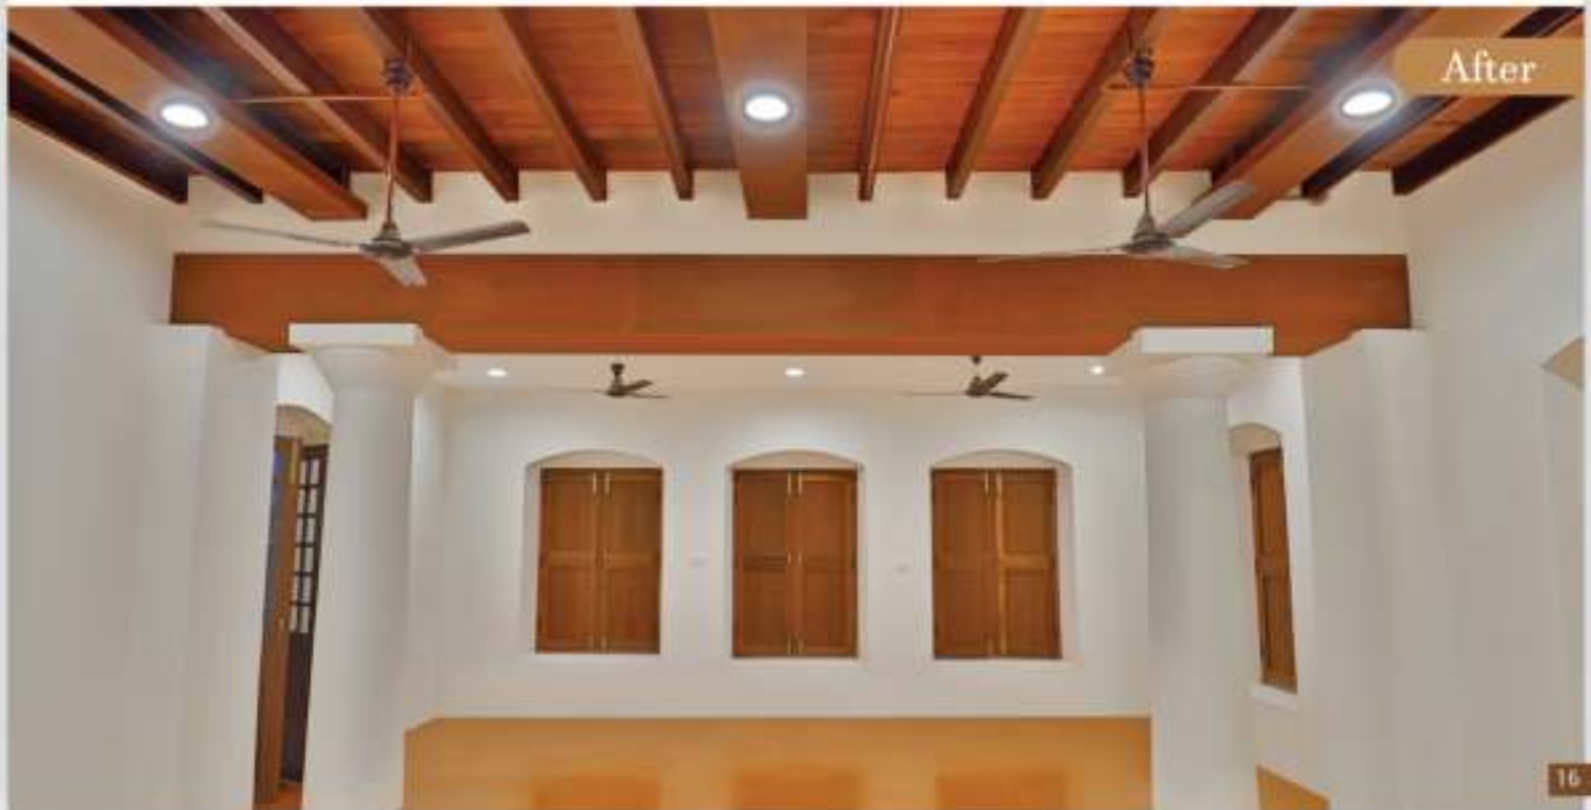
ROOM

The room in the Town Hall is a beautiful example of vernacular architectural style displayed from the elements such as the tapering columns with pedestal, rafters, lime concrete flooring and the segmental arched windows. Woefully, the condition of the room prior to restoration was very critical due to under usage.

The walls were painted as opposed to plastering. The restoration focused on the re-plastering of the walls with lime. The damaged timber rafters were restored and replaced as per the existing conditions.

The epoxy flooring (bi-epoxy) in the shade of yellow and the light fixtures overall lights up the entire space. The ceiling boarding and the rafters were polished.

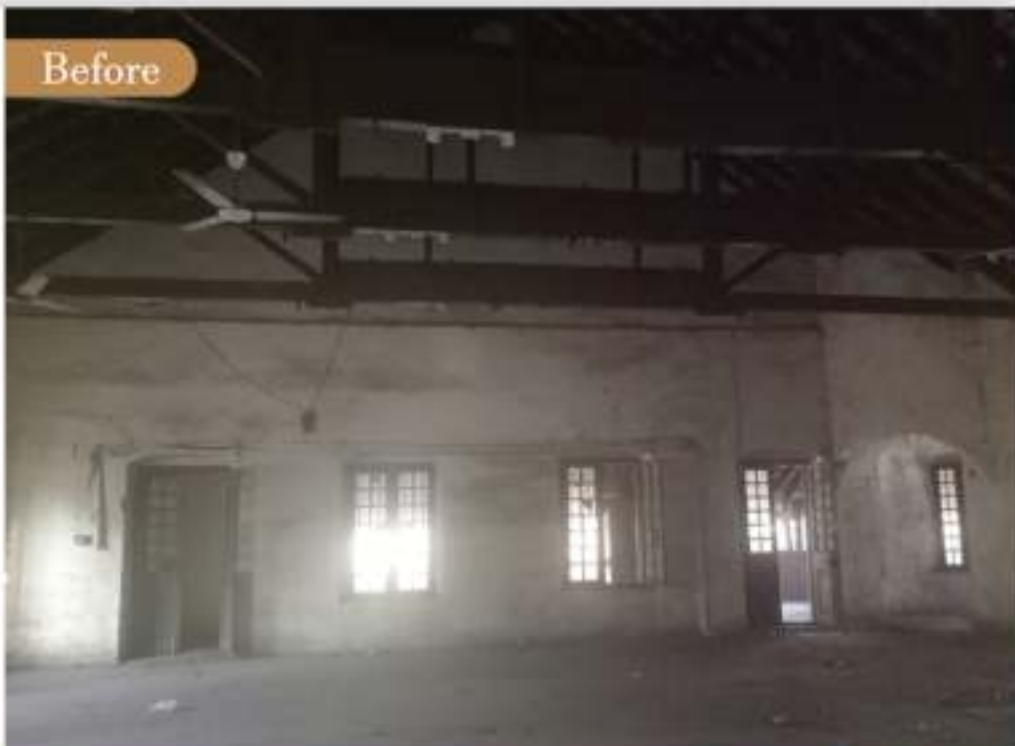
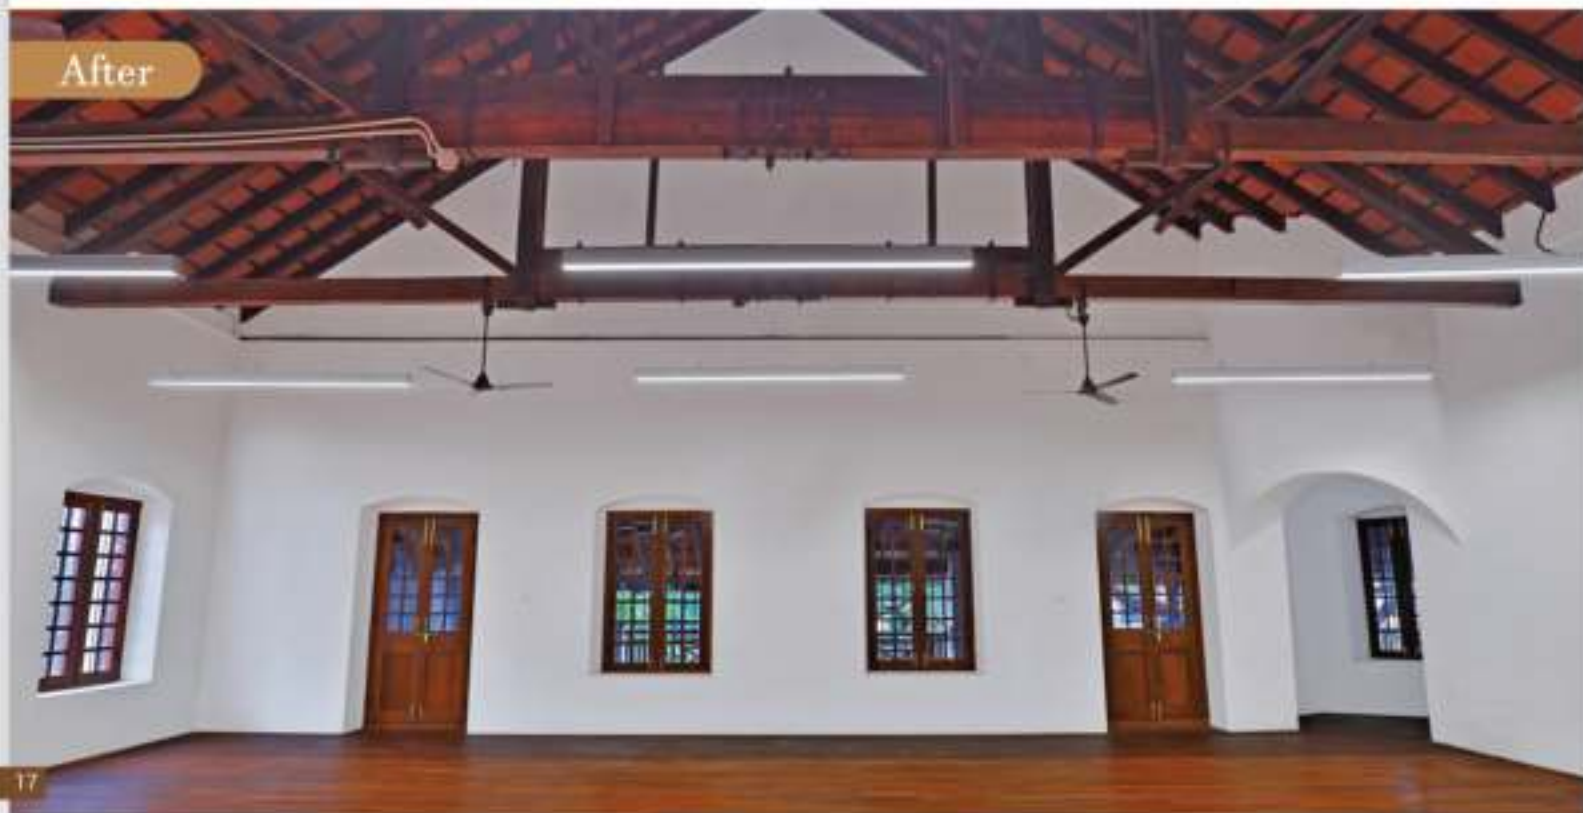
HALL

The condition of the roof was critical and leaky. Besides, the plastered walls and flooring were dusty and damaged. The roof was initial element that was targeted to be restored. Following that, the walls were re-plastered using the traditional lime plaster method.

The doors and windows were repaired as required. Towards the end, the existing wooden flooring was restored and polished. Finally, the addition of new light fixtures breathed new life into the hall.

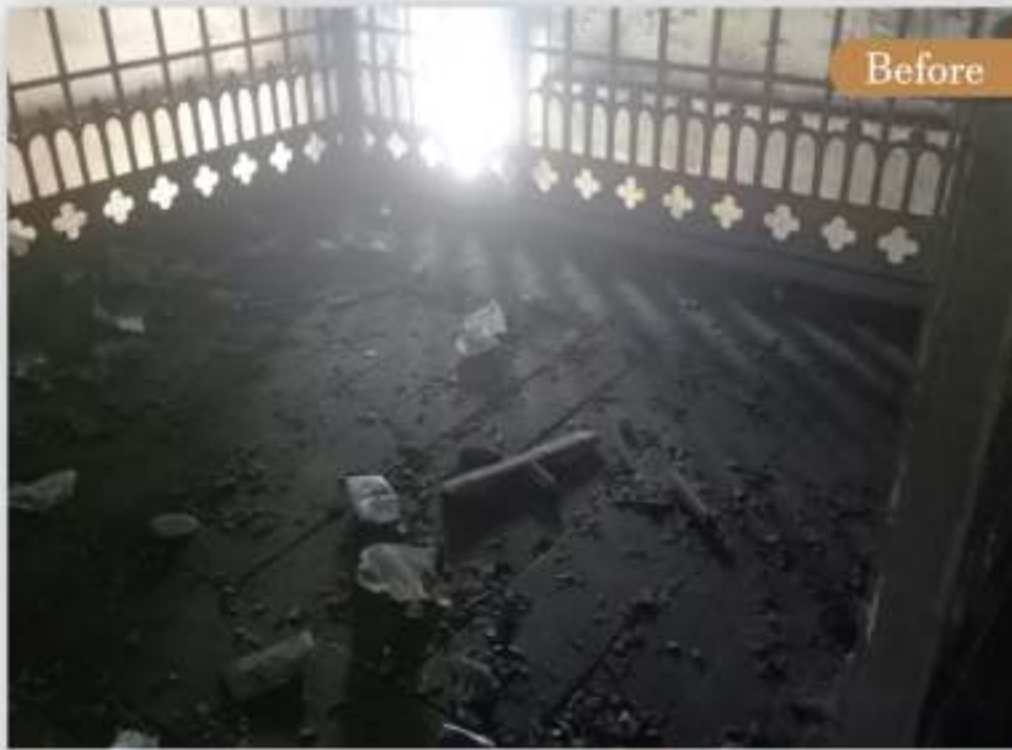
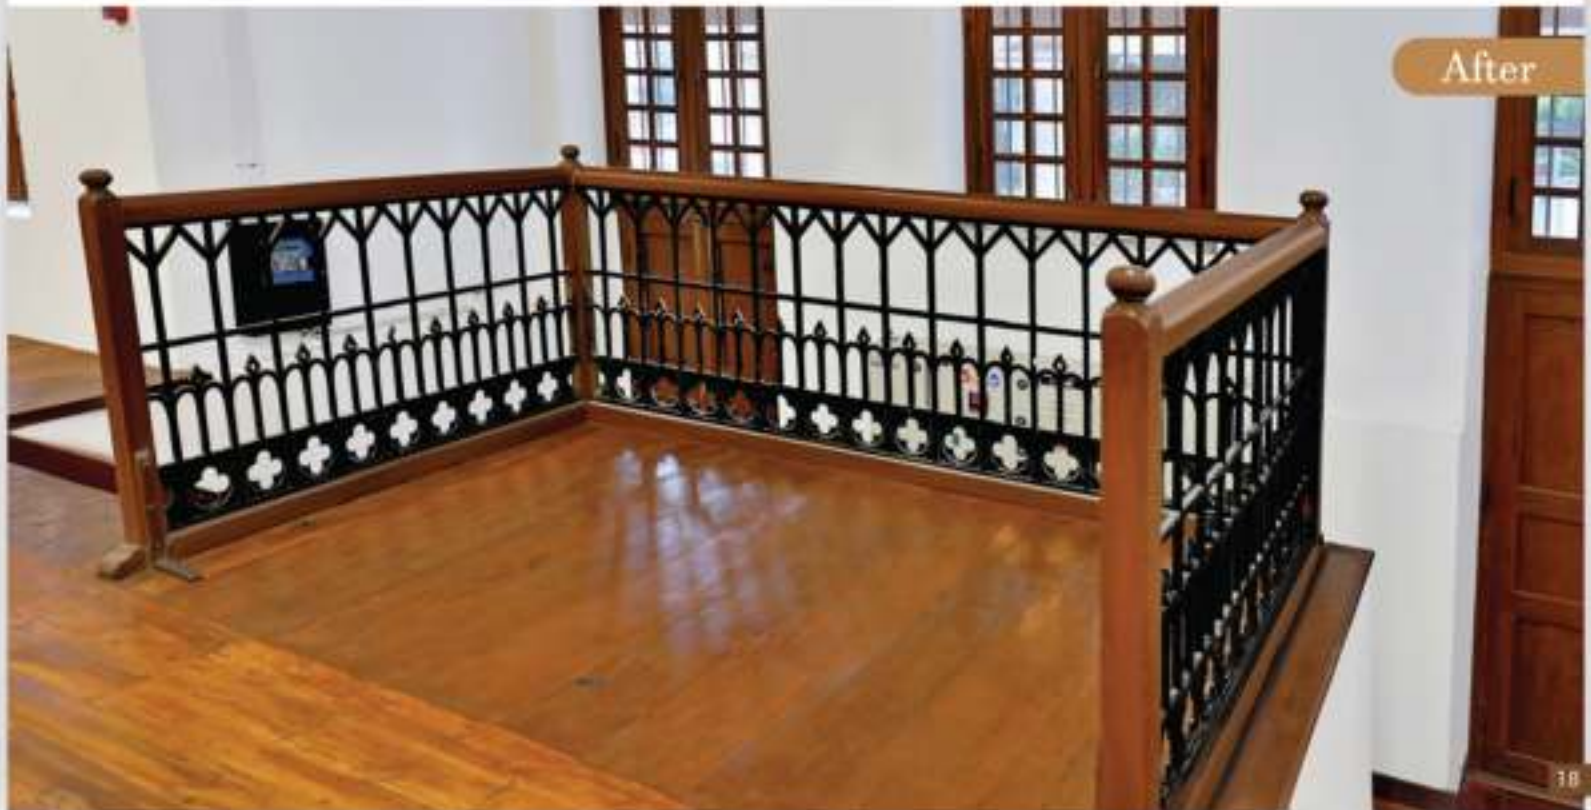
LANDING

The landing space of the staircase is made up of timber members. The wooden planks and the railing was checked for any defects and decay once it was cleaned.

The timber members were treated with anti-termite treatment and later polished to avoid infestation and improve its longevity.

The condition of the railing was relatively good and it was cleaned and repainted in black with oil paint once anti-rust was applied. Small pockets such as this add to the wholeness of the space.

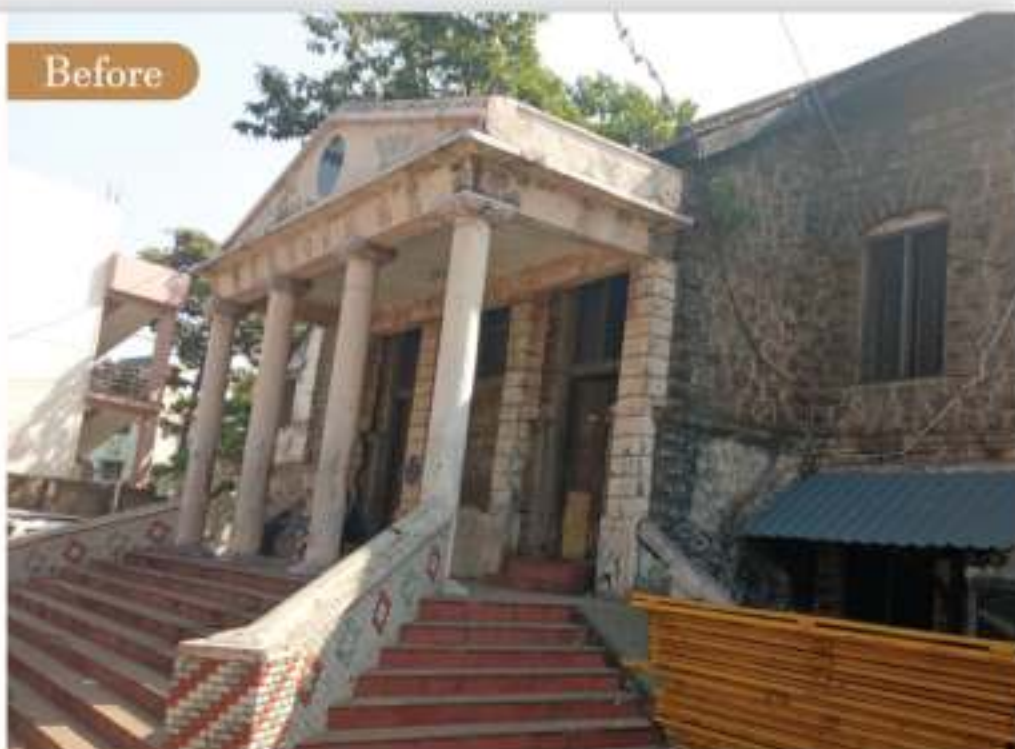
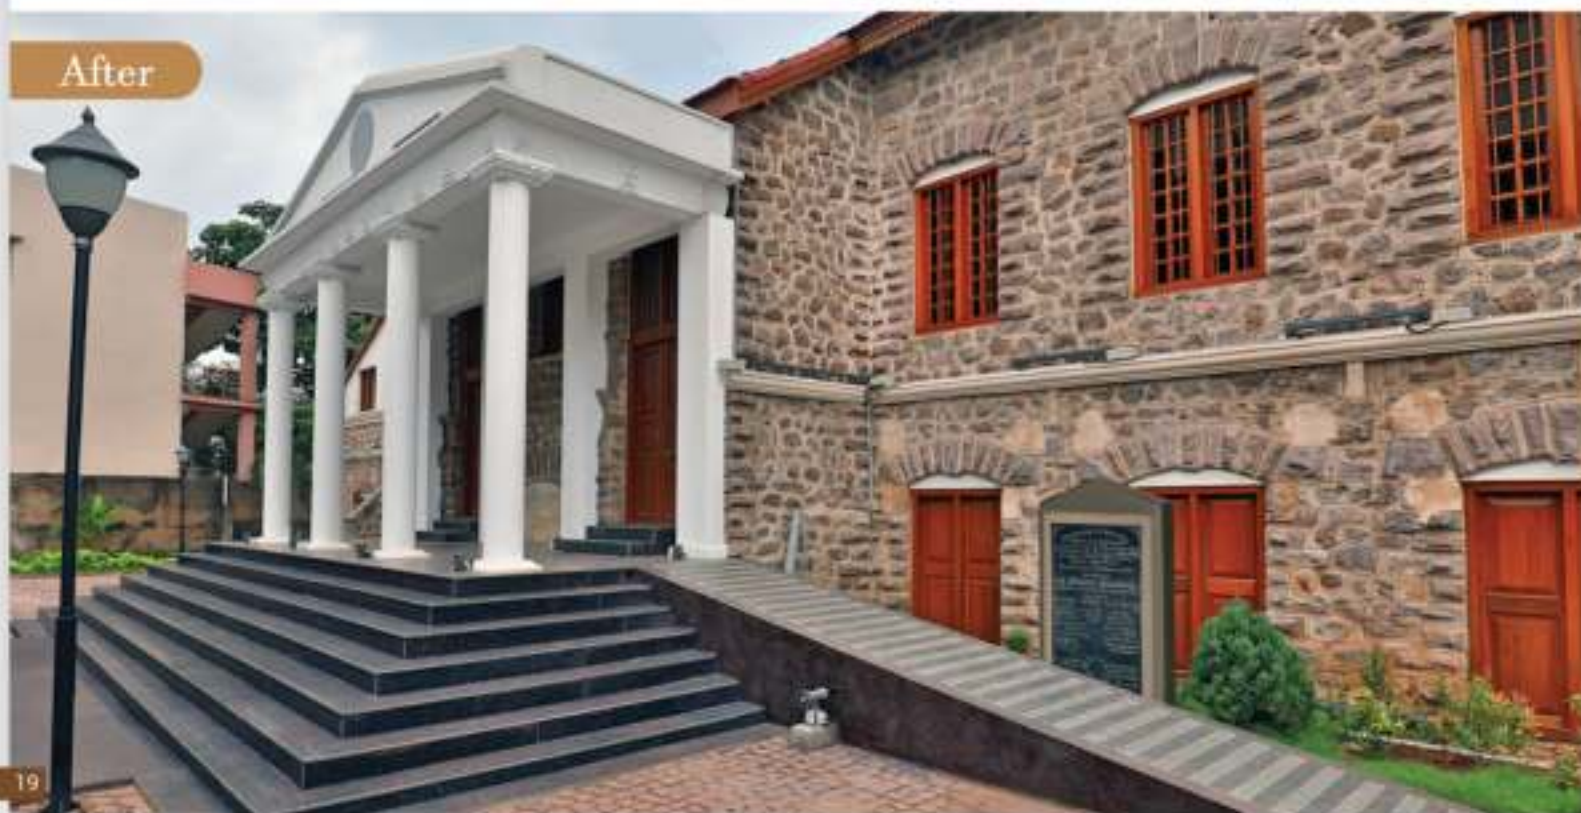
REAR FAÇAD

Over the years, the intervention such as addition of parapets insensitive paints and lack of repairs had brought a dullness to the structure. Some of the windows were also missing or were painted. The windows were replaced, a necessary intervention to suit the heritage.

Towards the end, landscape patch was introduced which compliments the structure subtly.

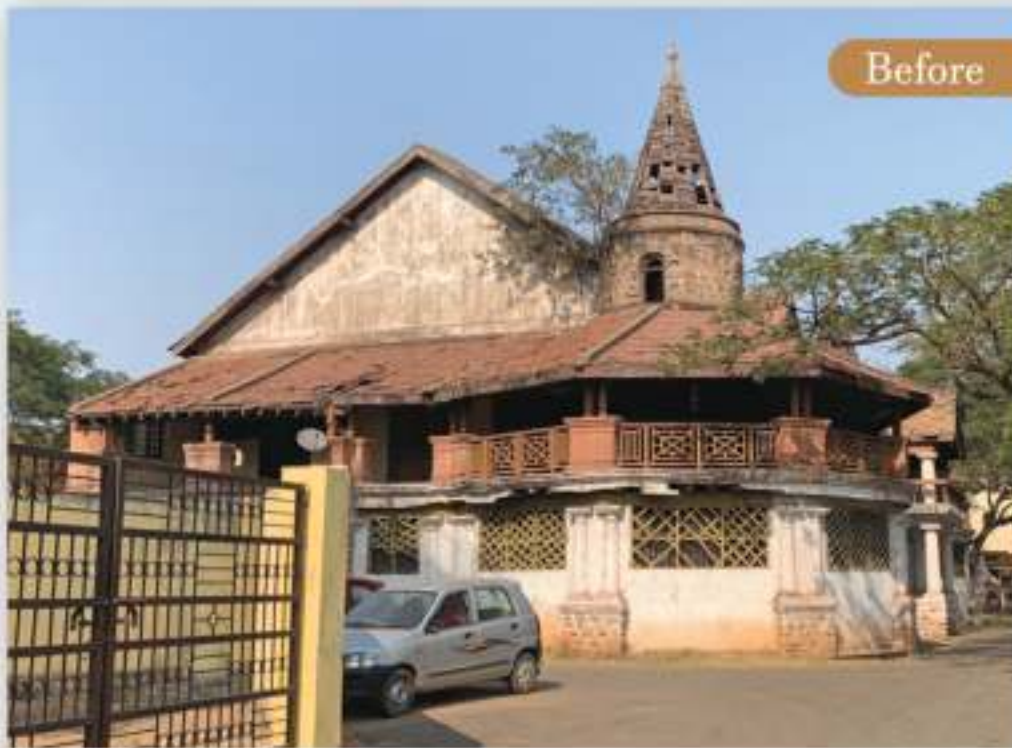
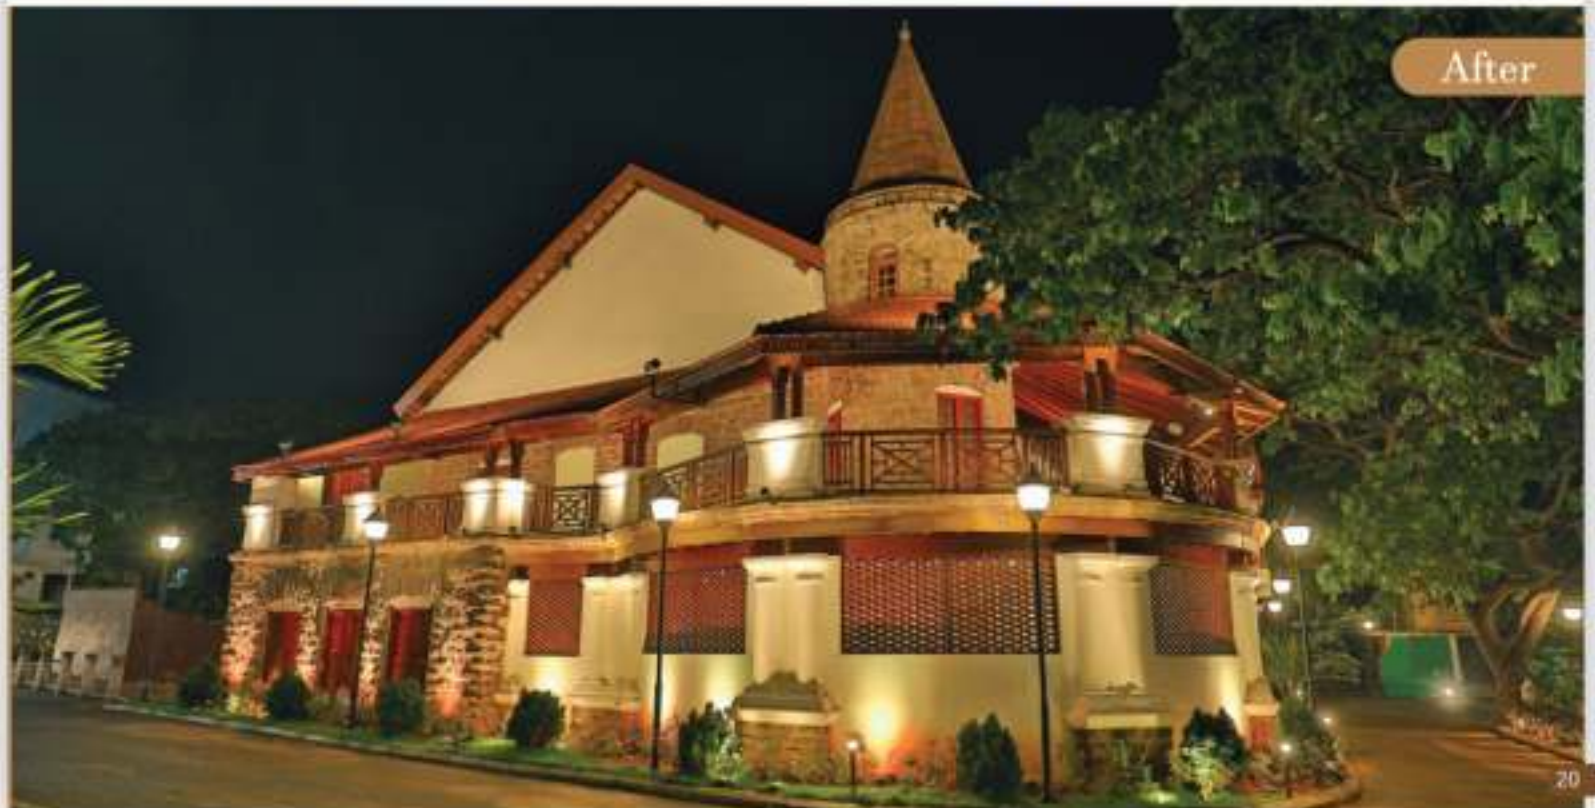
FAÇADE

The three major elements viz the stone, timber and lime give the structure its face. The pitch roof and its conical element is a very eye catching as a top spire. The pitch roof at various levels was treated to curb leakages and avoid dampness.

Overall, the facades were applied water proofing layer to avoid algal and ficus growth.

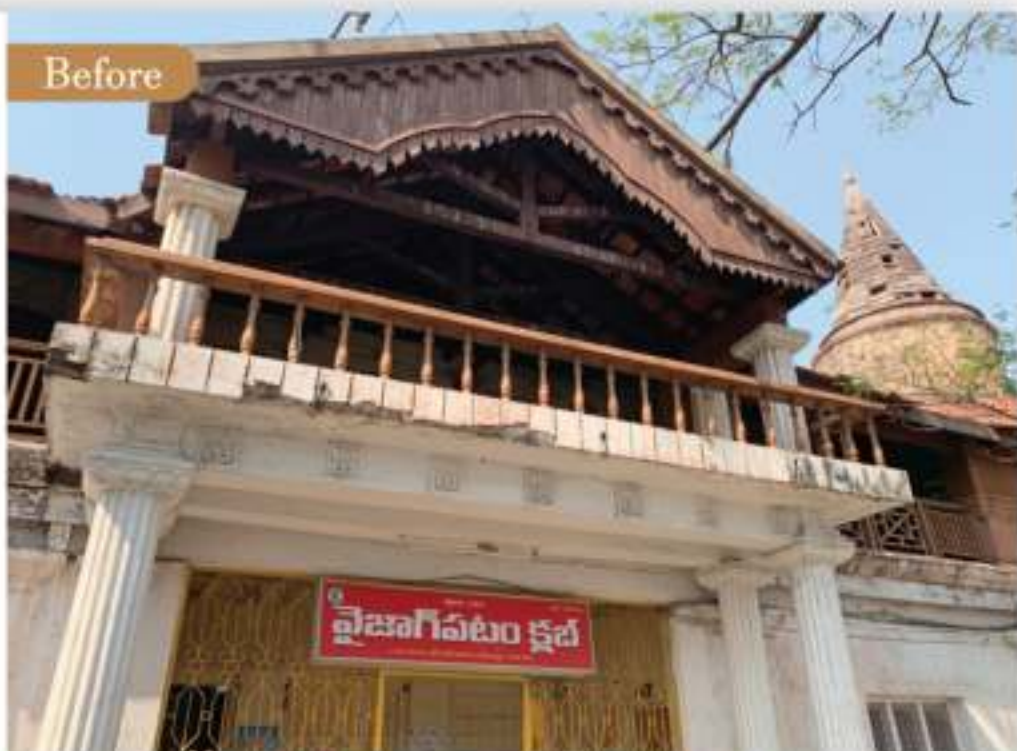
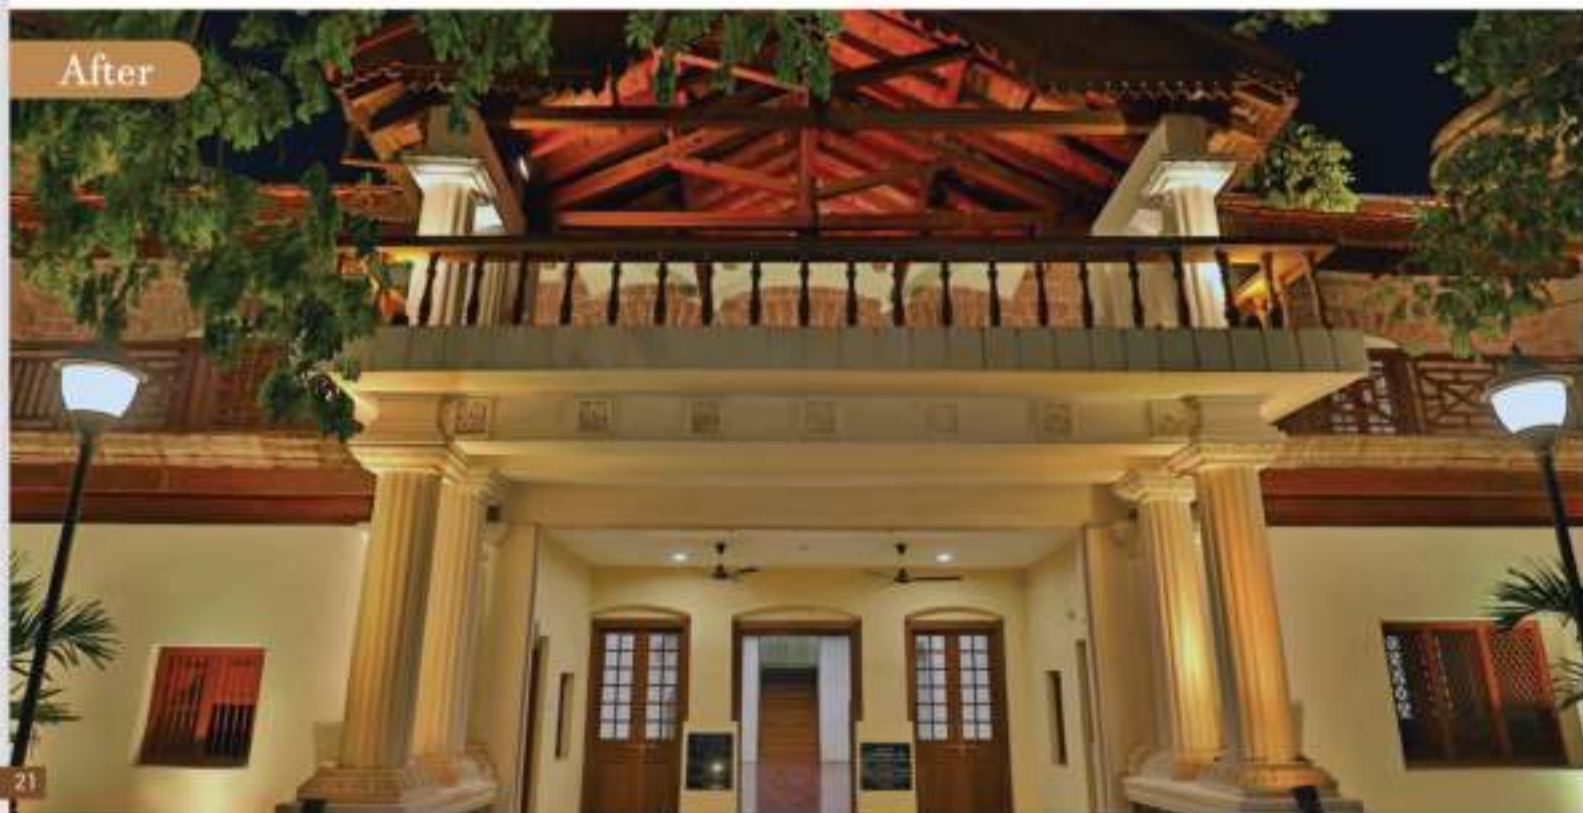
ENTRANCE PORCH

The entrance of the Town Hall is its face and briefly describes the building. The amalgamation of the European architectural elements along with the Indian elements adorn the entrance. These elements required special restorative methods to retain. The façade is a beautiful display of timber along with the plastered surface, sadly which was painted and showed flaking.

The beam of the balcony was repaired as a part of structural repairs. While a special focus was put on the plastering of the entrance. The fabric which was originally plastered was painted and which had to be scraped off. The lime re-plastering was done using the natural additives to strengthen the lime and the technique used was Araish Plaster. Thus, the grandeur of the entrance was achieved.

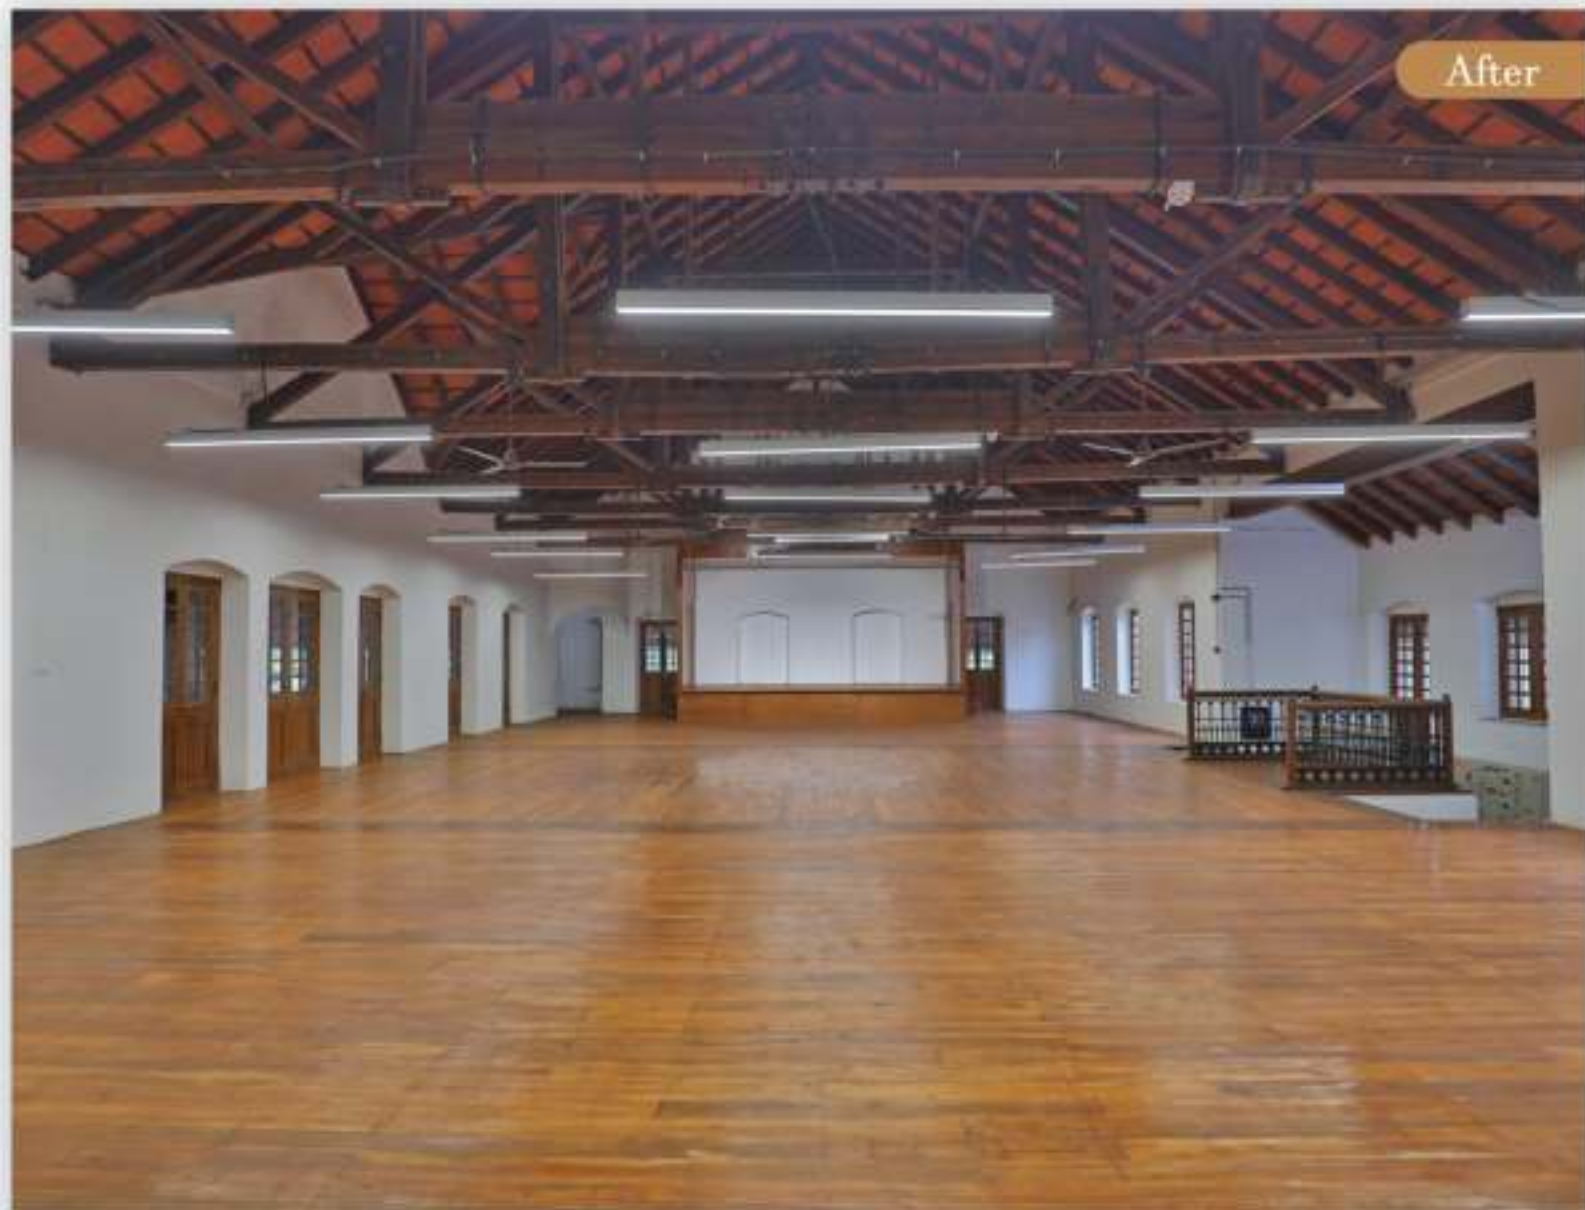
HALL

The internal condition of the hall was as grave as the external. The roof caused leakages due to its deteriorated condition. The walls of the hall were damp due to moisture trapping which was a result of the painted walls as opposed to the lime plastering. The floor was also in a very bad condition.

The restoration of the internal hall focused on mending the pitch roof to curb the menace of dampness. Meanwhile, the walls were plastered using the Araish Plaster. The flooring was repaired with epoxy. The windows were specially polished with melamine. The stage which is the central attraction was repaired as it stood in a very shattered manner. The timber rafters too were restored and the lighting fixtures and fixed anew.
