# Chamarajeshwara Temple

*Chamarajanagara - Karnataka*

The temple trust and the care taker of the 'Chamarajeshwara' temple has dedicated yeomen services in maintaining the temple and have ensured that this religious legacy is preserved and handed over from one generation to another. Having seen the wear and tear of time and after undergoing various climatic changes, 'Chamrajeshwara Temple' looked completely out of shape in the year 2017 and was on the verge of colossal deterioration but with timely intervention of the Archaeology department of Karnataka, Temple's Charitable Trust, restoration work began in the year 2017 and was completed in the year 2018.

The task of restoration was humongous and the responsibility was bestowed upon 'Savani Heritage Conservation Pvt. Ltd. Being the recipient of 7 international awards and having the expertise and experience of restoring several heritage sites, the credentials were more than enough to entrust the responsibility for "Chamarajeshwara" temple. It is a matter of pride for the locals in Chamrajnagar and devotees across the country as the 'Chamrajeshwara Temple' that stands today is restored, revered as before and in regal state.

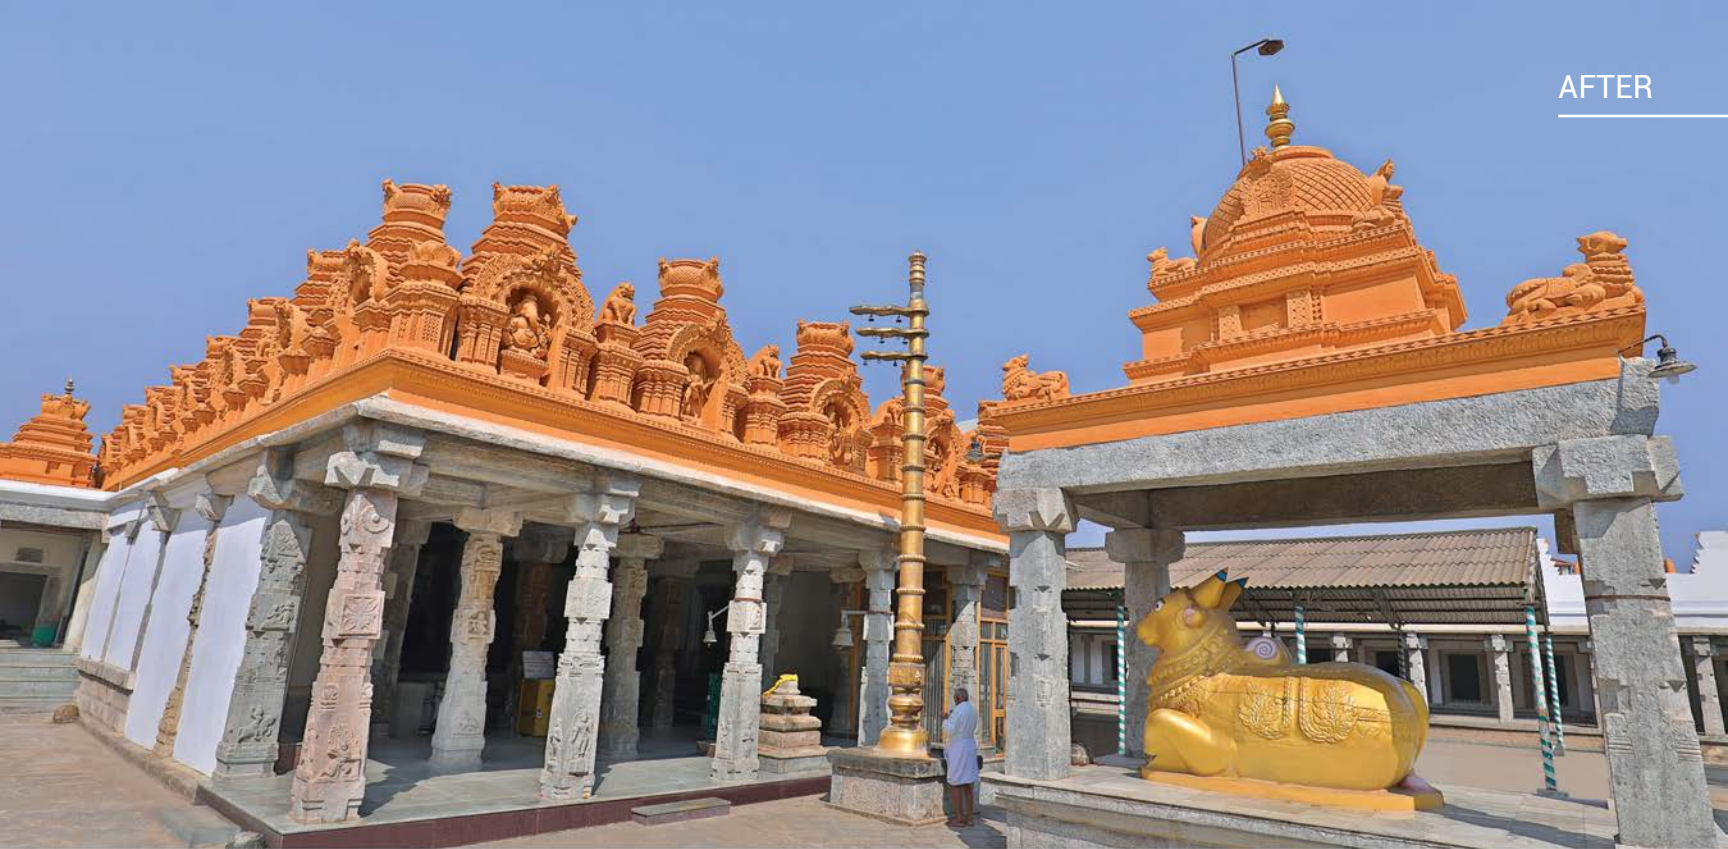
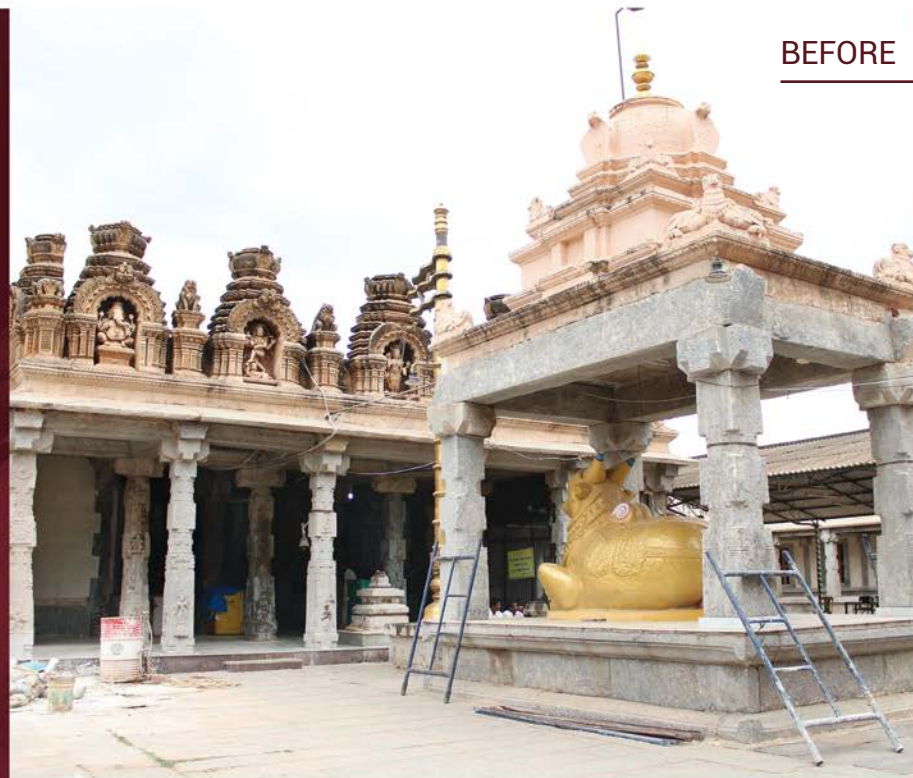
AFTER

The temple premises houses a nandi (bull) pavillion at the main entrance, facing the main shrine of the temple complex. The stone masonry was earlier lime washed and hence needed to be scraped off to retain its stone surface and later the roof was treated for waterproofing.

The art work of the prabhavalis was done in lime mortar, to restore its historic appearance which adds to the aesthetic character of the temple.

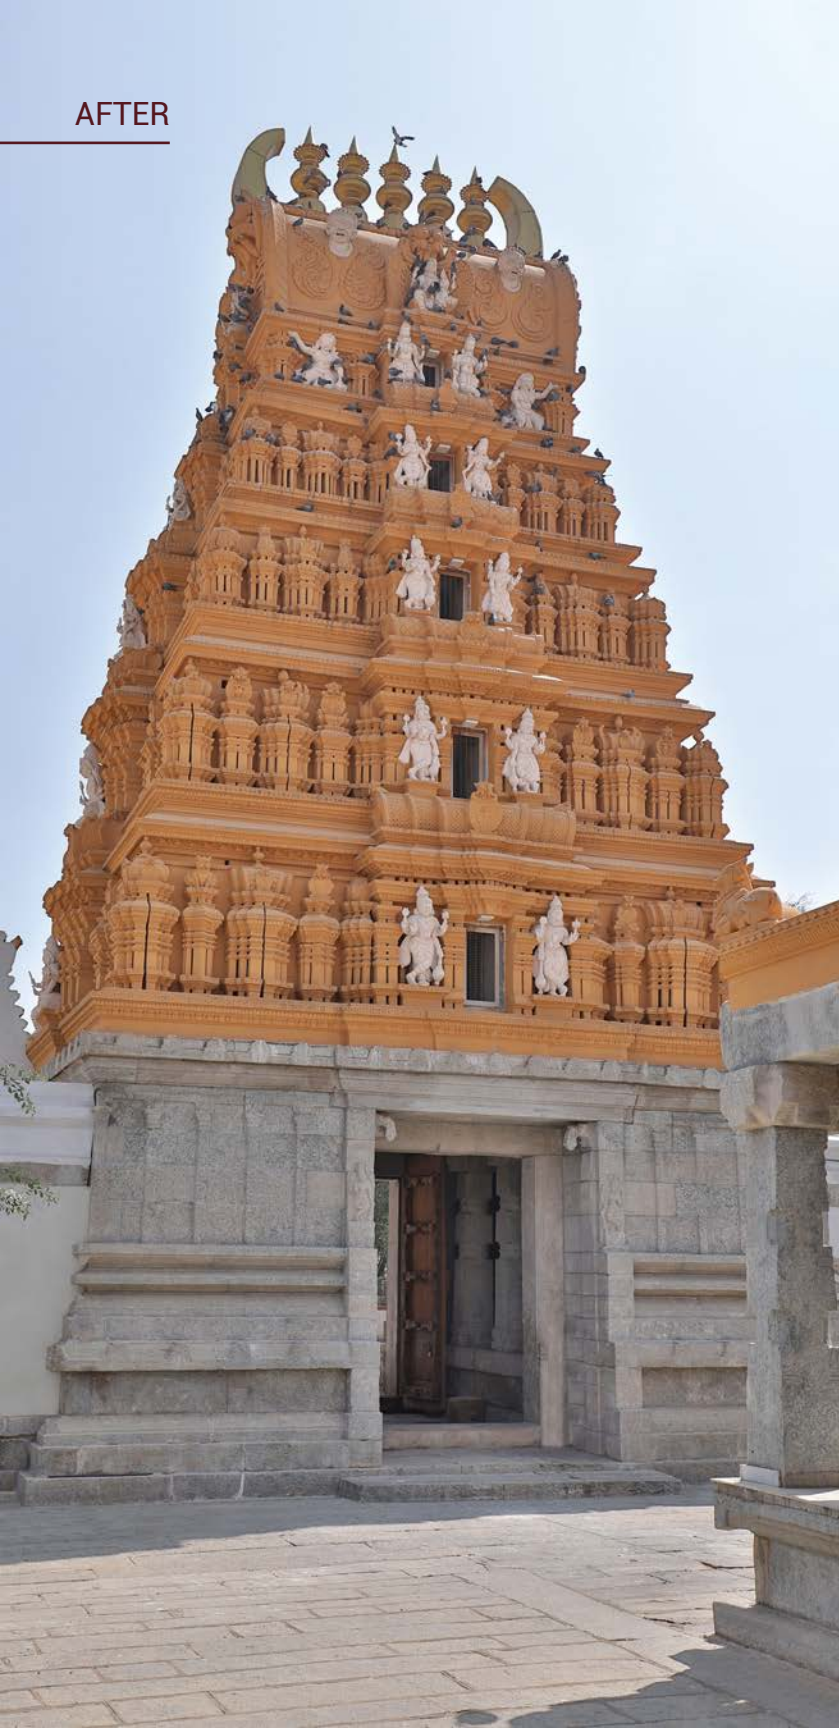
AFTER

The plastered layer of the Padavarga & Adhistana below the Vimana was de-plastered to expose its original carved layer. While the vimana is adorned with heavy art work which was majorly soiled. This intricate art work was redone with an addition of ochre yellow dye into the lime plaster to match the original one.

The human sculptures at different levels of the vimana were lime plastered in white to create a contrast and break the monotony of yellow shade throughout.

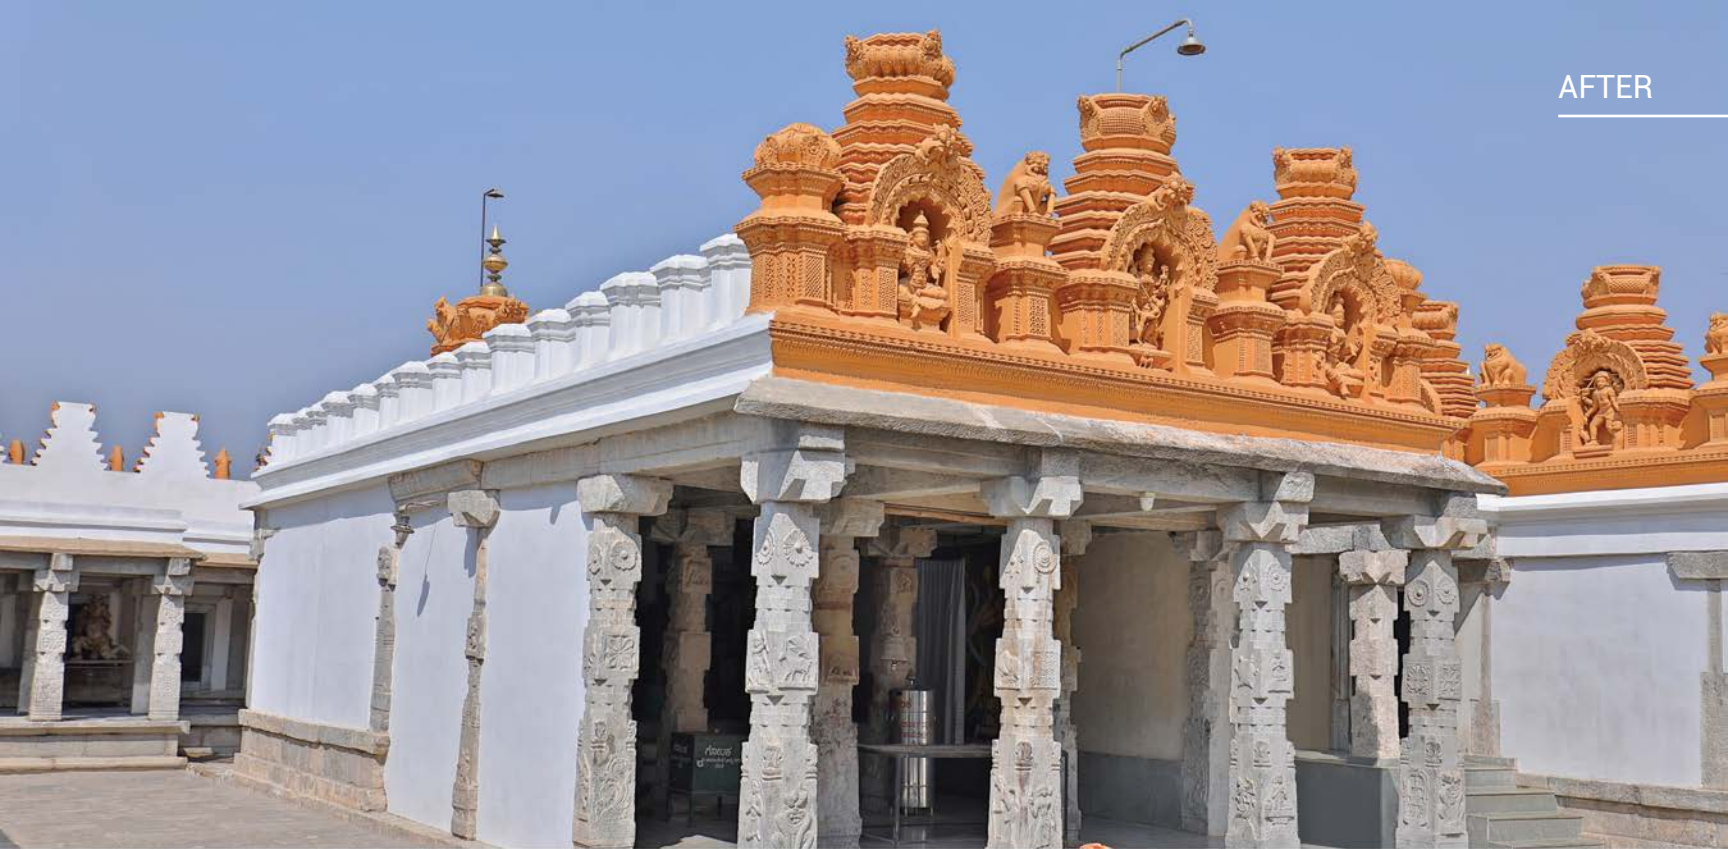
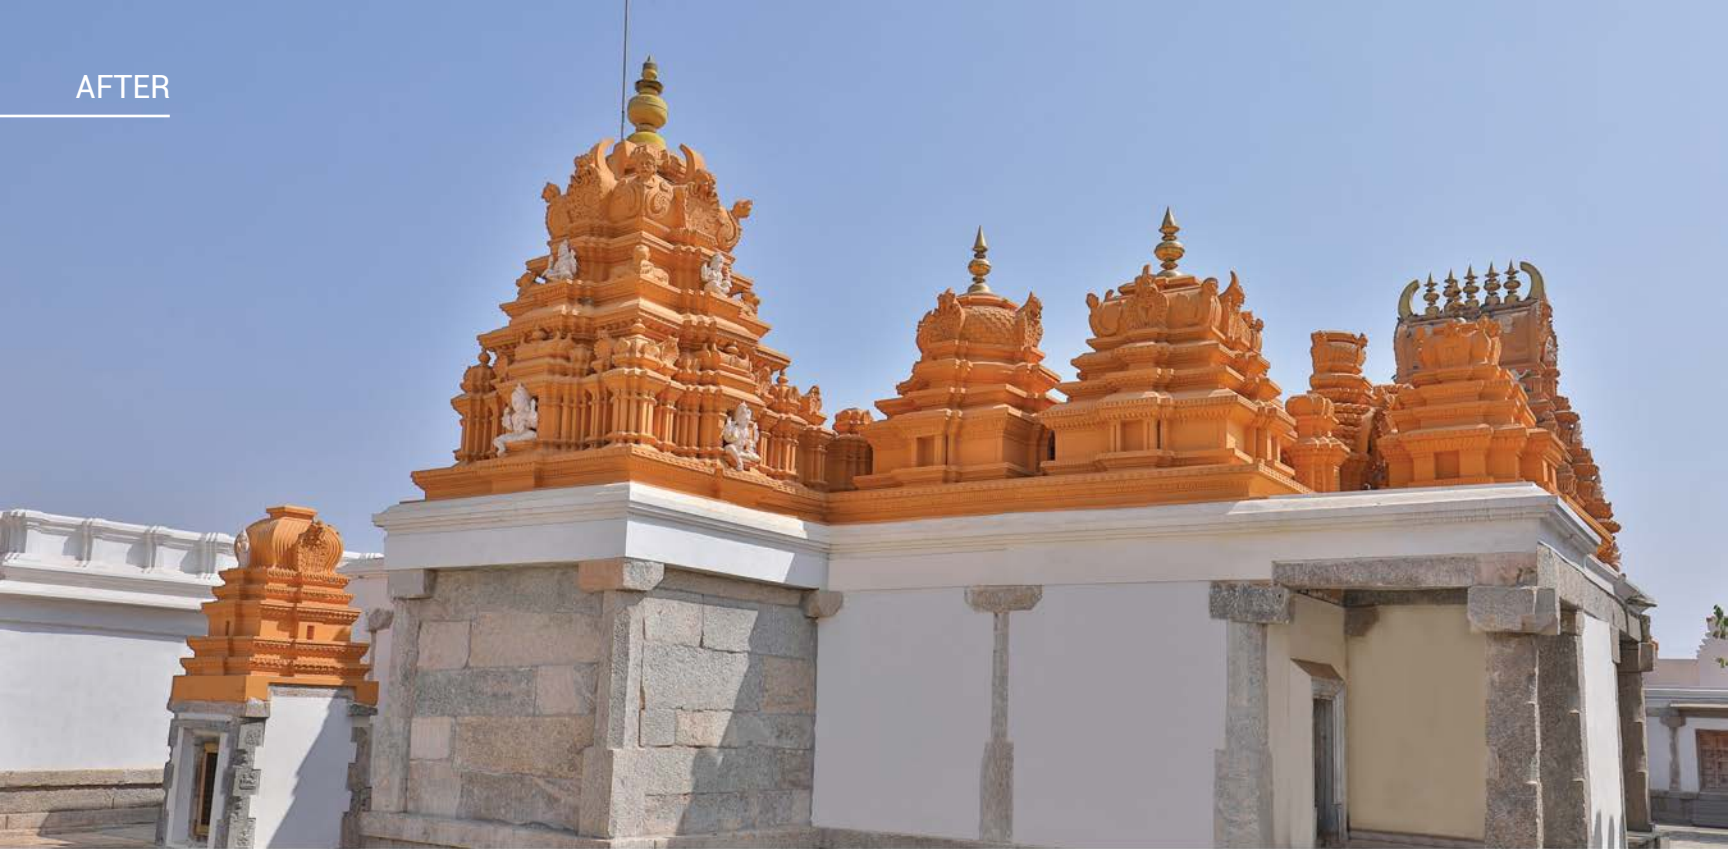
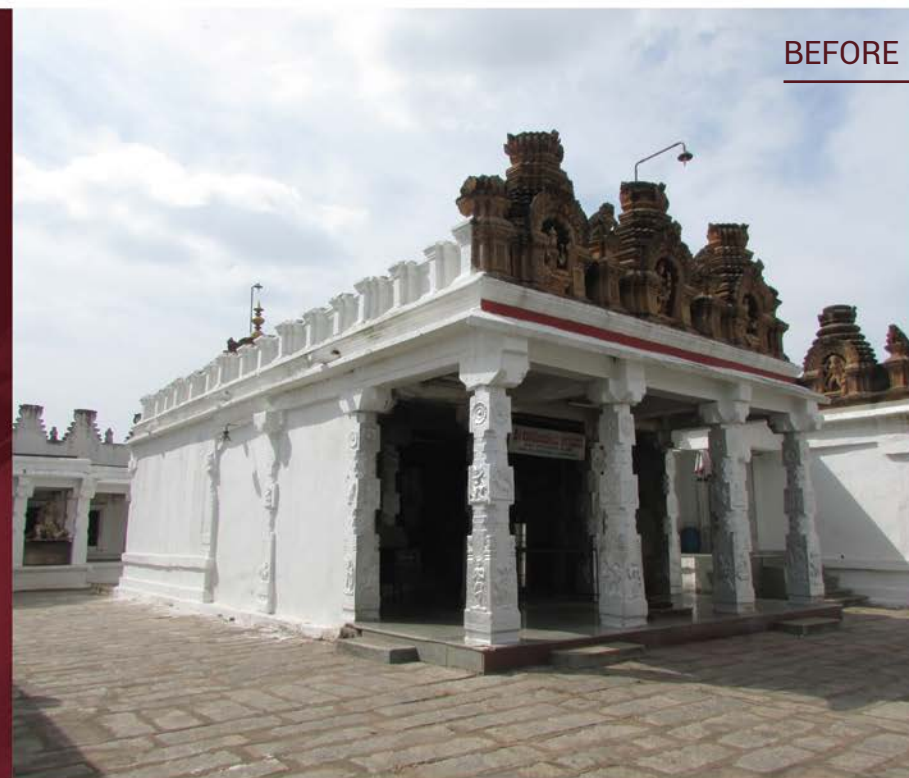
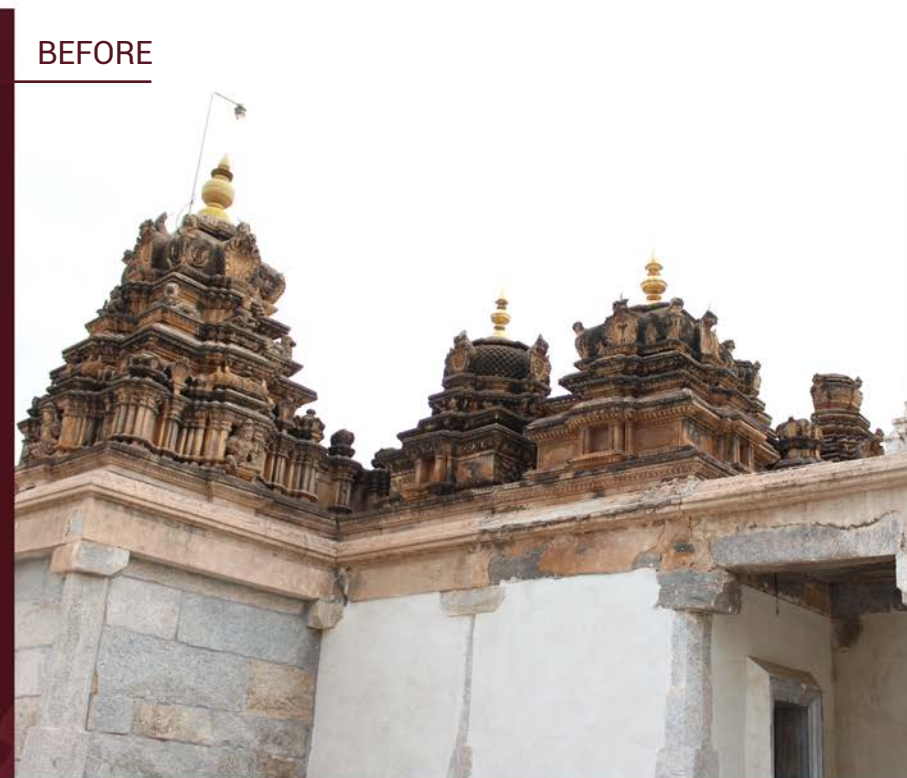
AFTER

The art work in the crevices over the roof appeared to be soiled and dampened. The layers gathered over the Dravidian style columns were scrapped off and were lime washed to facilitate the polished look. The removal of lime paint led to the crystallized display of the carvings on the column and on the stone surface.

The art work was covered with waterproofing layer while the merlons were lime plastered. The plinth of the temple structure too was cleared off the lime layer.

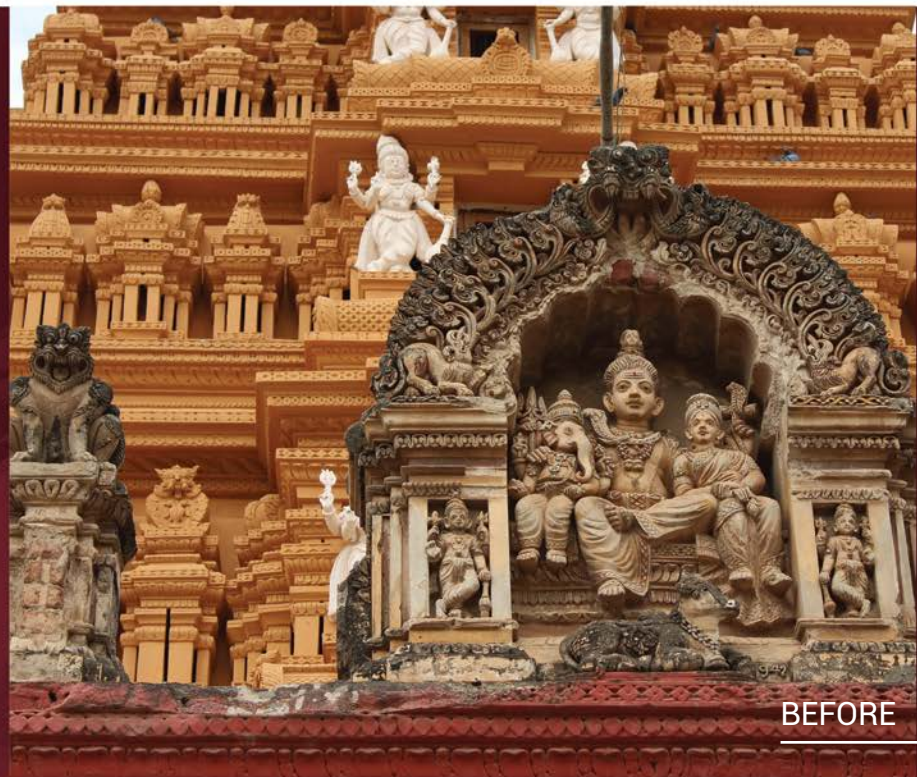
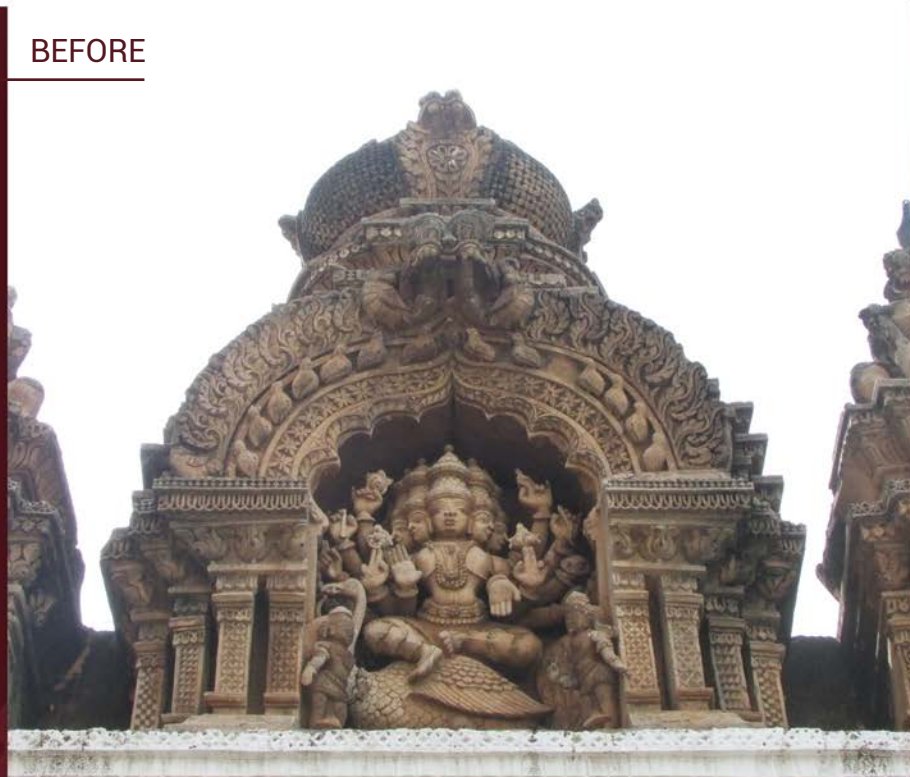
BEFORE

The prabhavali (the ornamental circular or oval ring) houses the sculpture of god and goddesses. The temple is dedicated to Lord Shiva and Goddesses Parvati and their sculptures hold a special significance and therefore its restoration was fundamental to the cause.

The sculptures were discolored due to water ingress and had developed a soiled layer and presented a disintegrated look hence the same was plastered in white lime to give a distinct standing from frame like prabhavali.

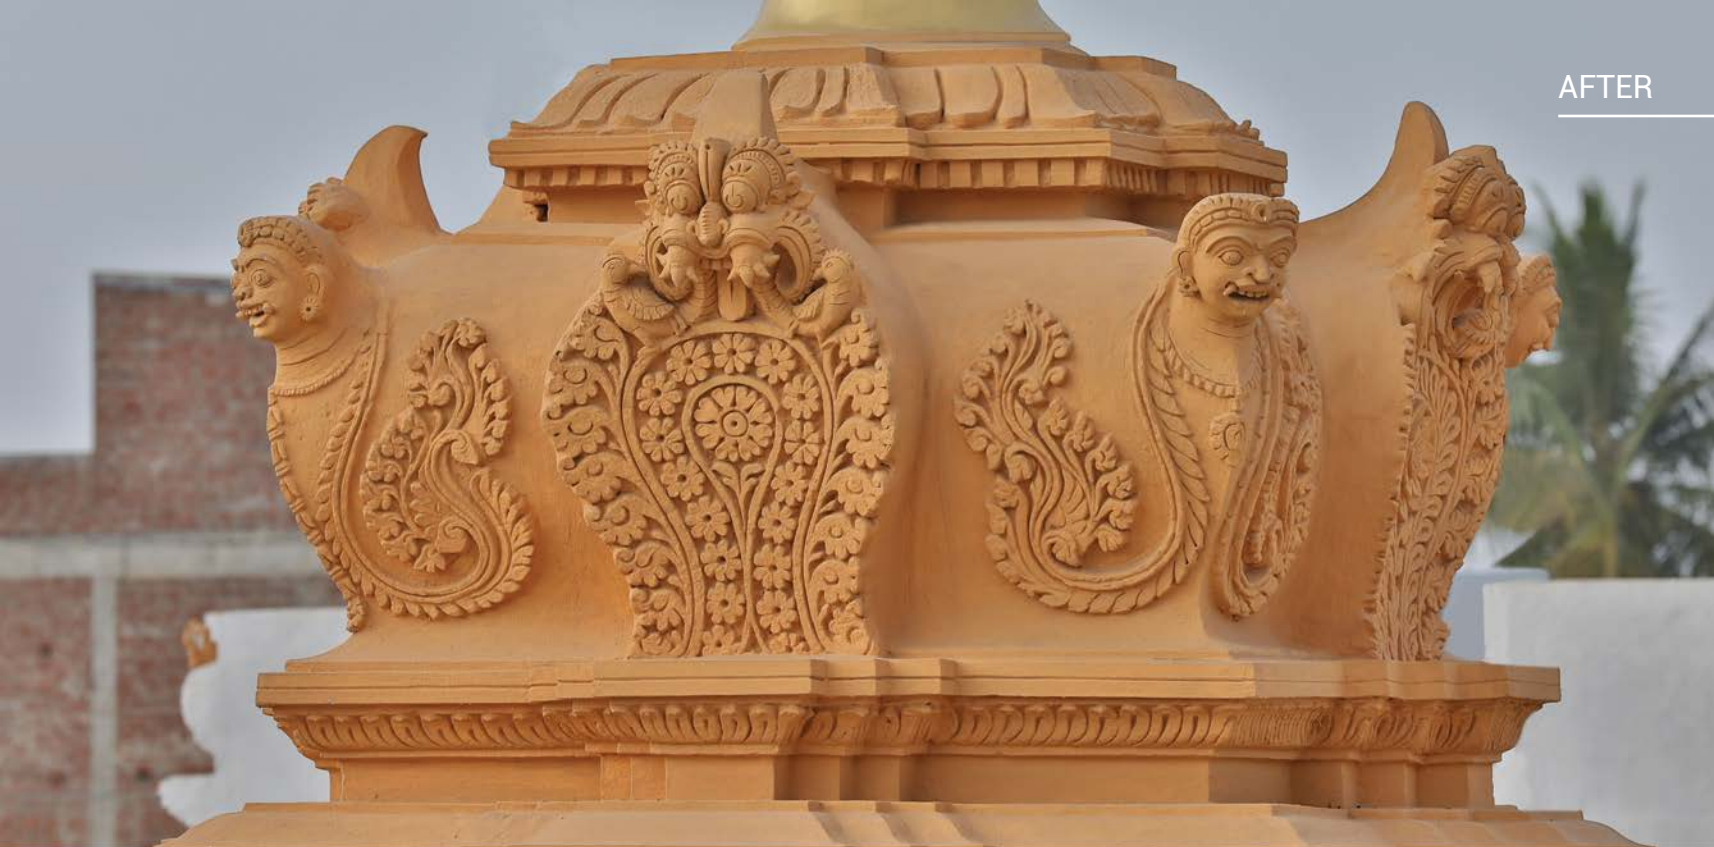
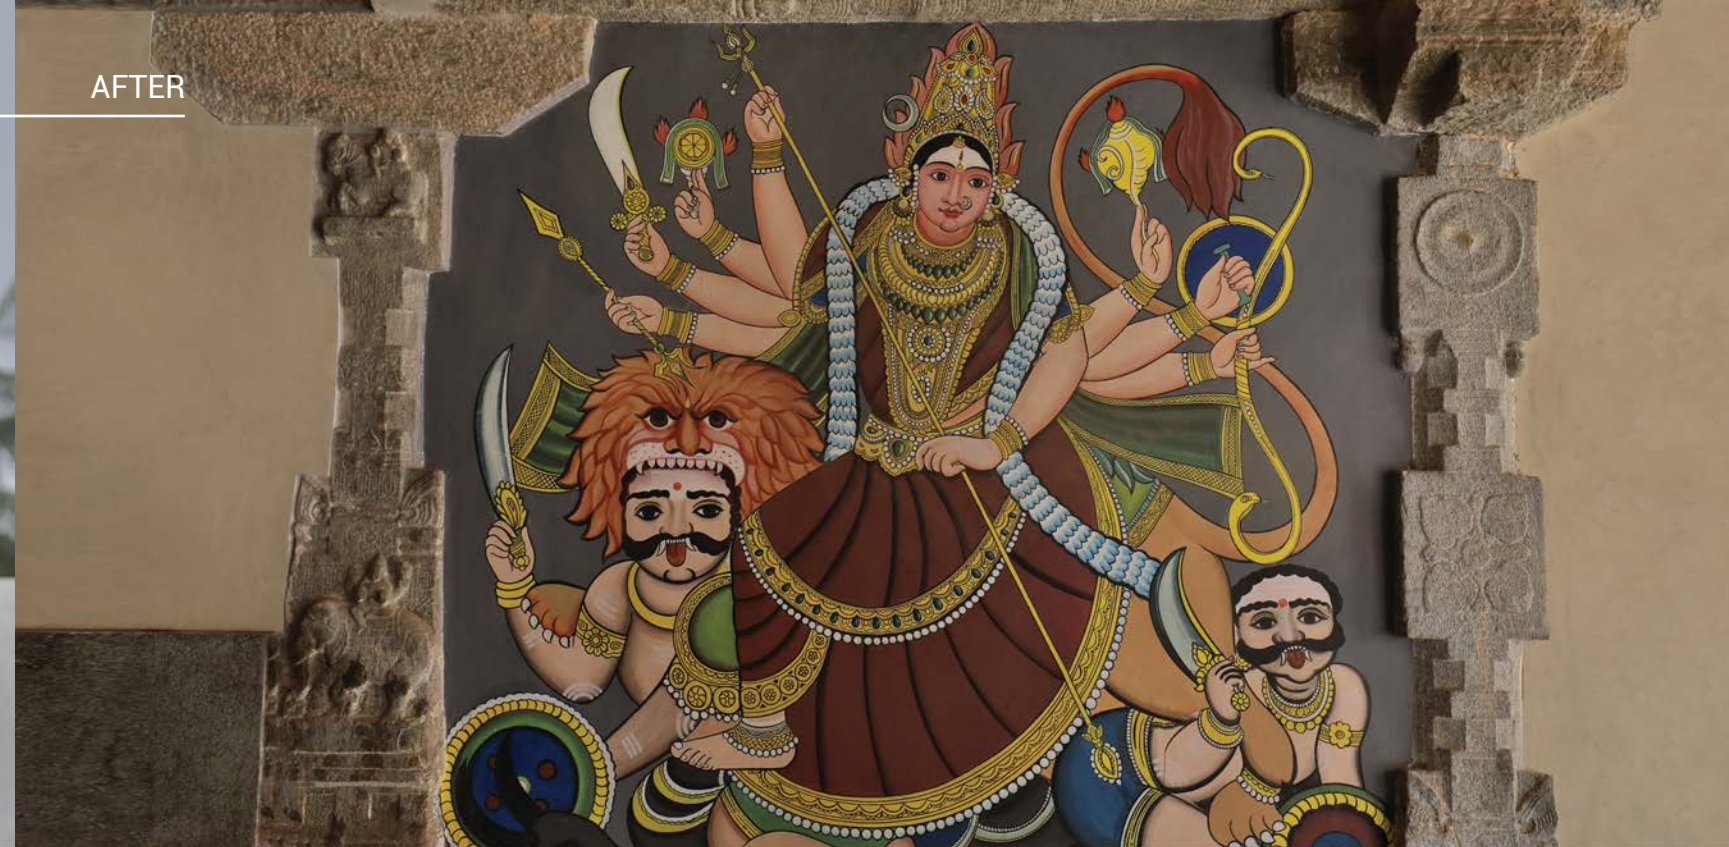
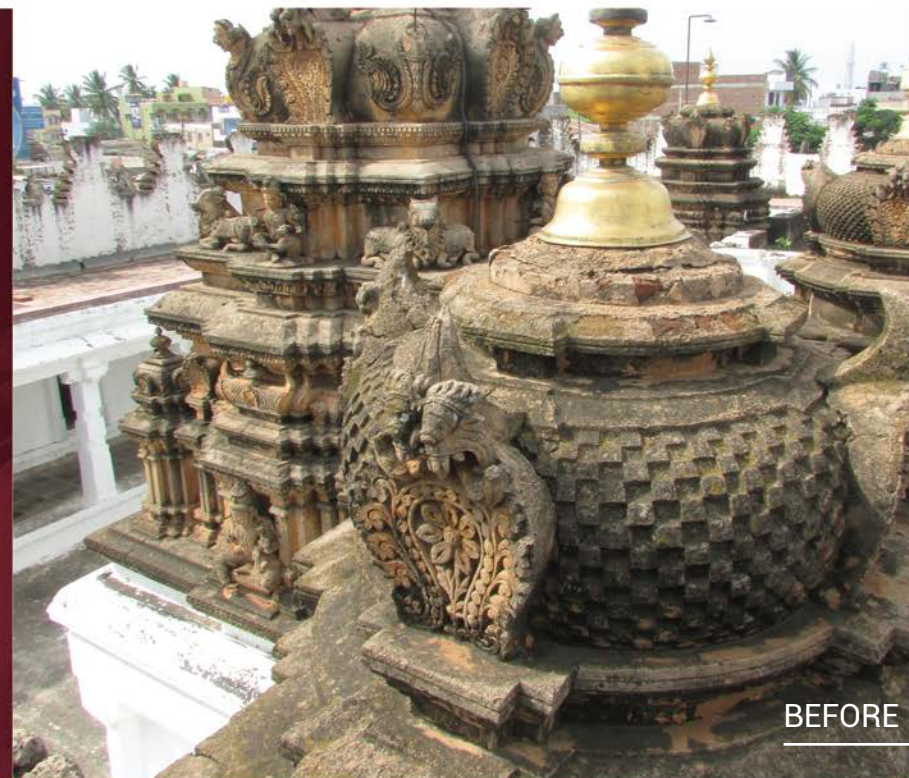
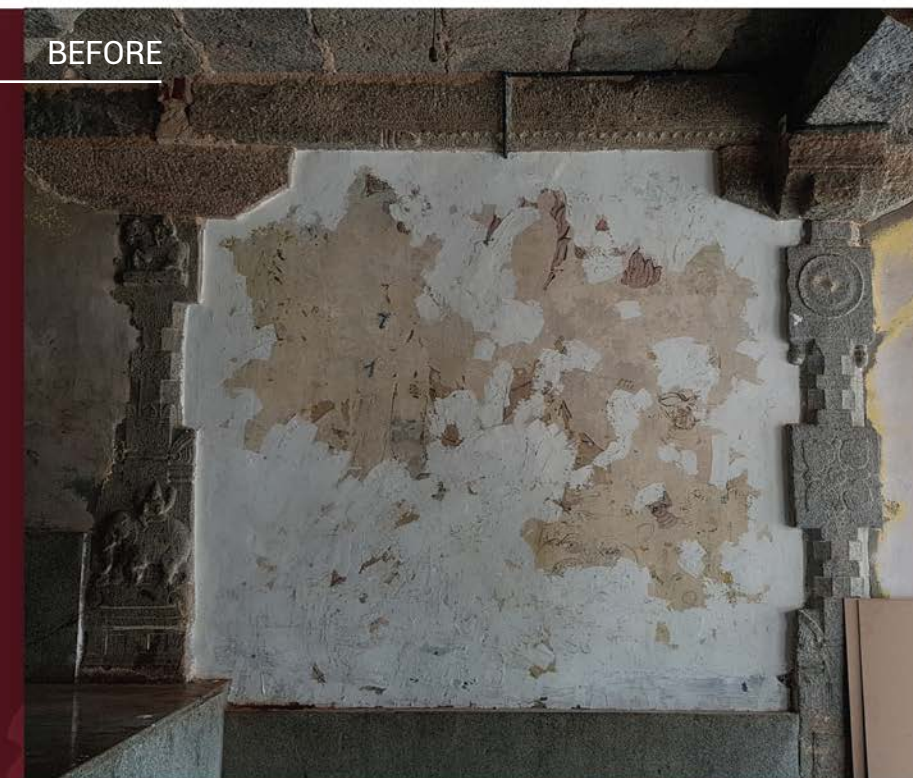
AFTER

The various Prabhavalis (framed art work) at the parapet layer are the characteristic elements of the temple and hence its repair was crucial. Moreover, it required delicate repair of the artwork making the task extremely challenging.

The process required meticulous cleaning and correcting of the disfigured sculptures. These sculptures are an identity of the Dravidian temples and therefore needed an extra efforts to be saved from water ingress.

Faces of the sculptures has a special significance as they are mythological figures and showcase stories from the mythology. The art work included various floral, animal and human figures.

The brick base over which the these sculptures are carved seemed damp with rain water ingress. The sculptures were cleaned and restored back to original state.

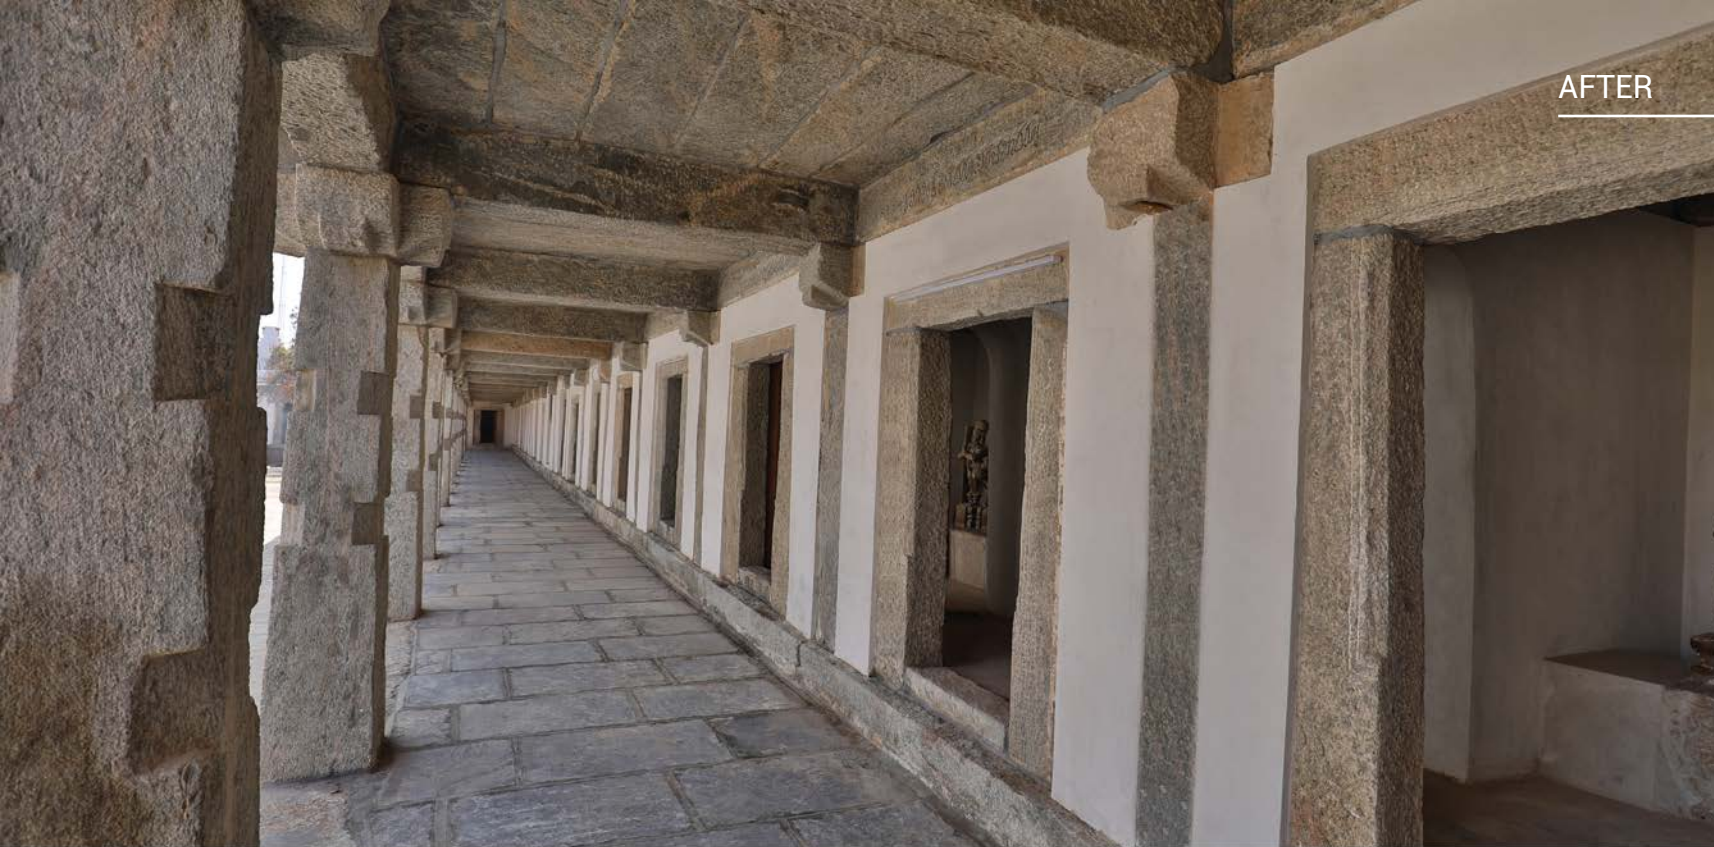
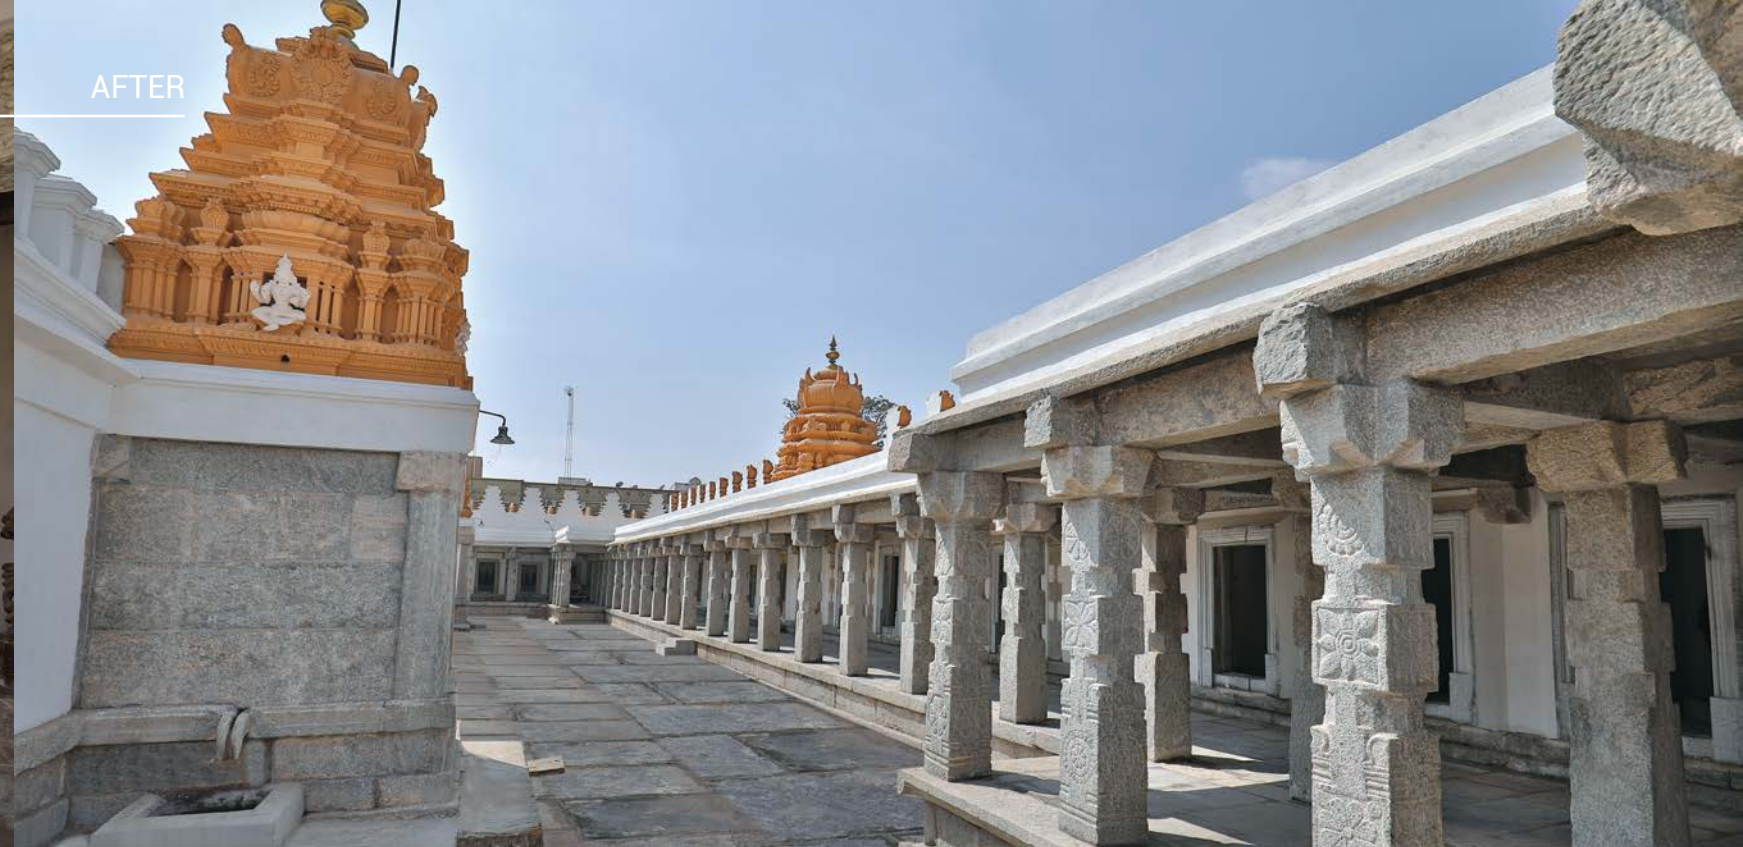
The Mukhamantapa displayed beautiful fresco works but was in highly deteriorated state due to dampness and negligence. These paintings were completed from the leftover traces of the paintings done previously.

The fresco paintings and the intricate art work restoration was carried out by specialised artists. The painting work was a delicate one but was successfully restored with utmost attention and care.

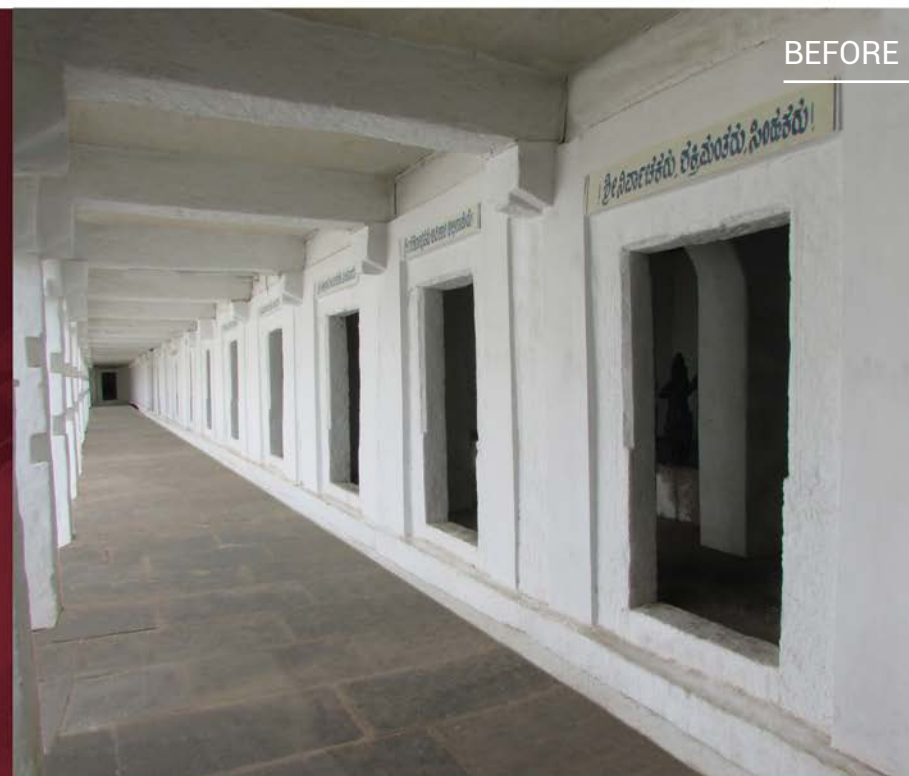
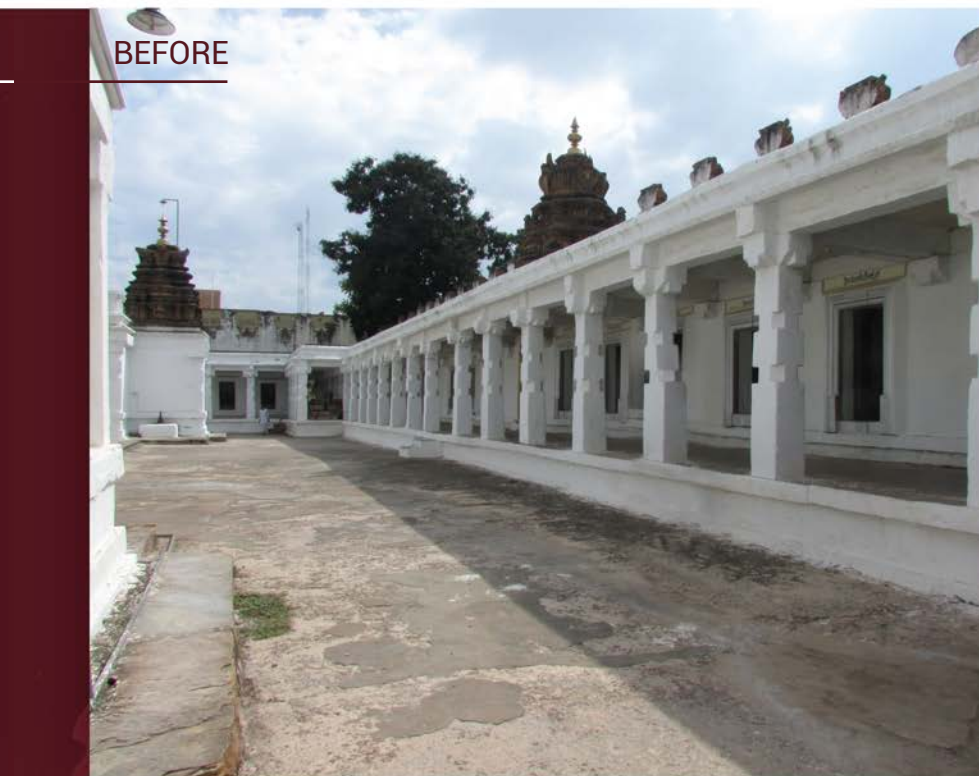
The corridor runs throughout the temple precincts and houses smaller shrines. The interior of these shrines were lime washed to maintain balance of the colours in contrast to the idols in black colour.

The joints were re-pointed, the flooring of the corridor and the channel running along the sides were cleared of accumulated dusts.

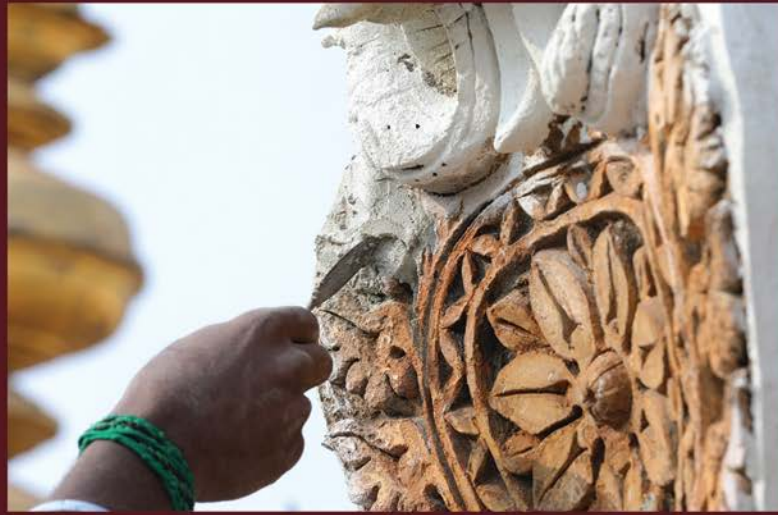
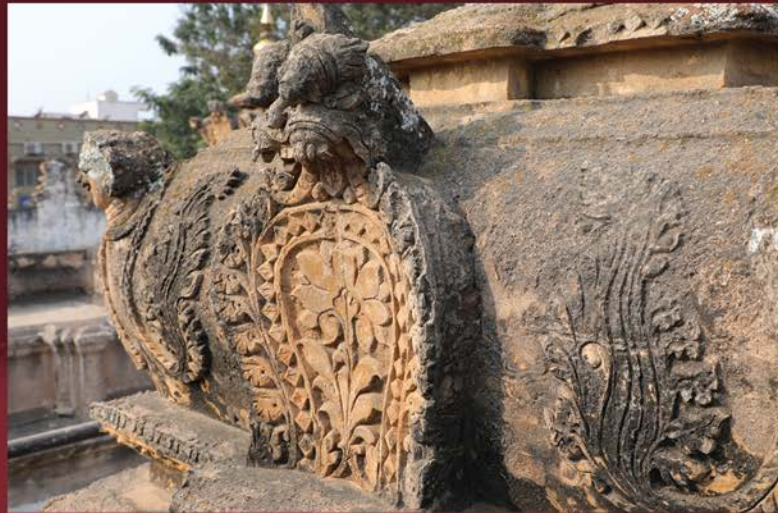
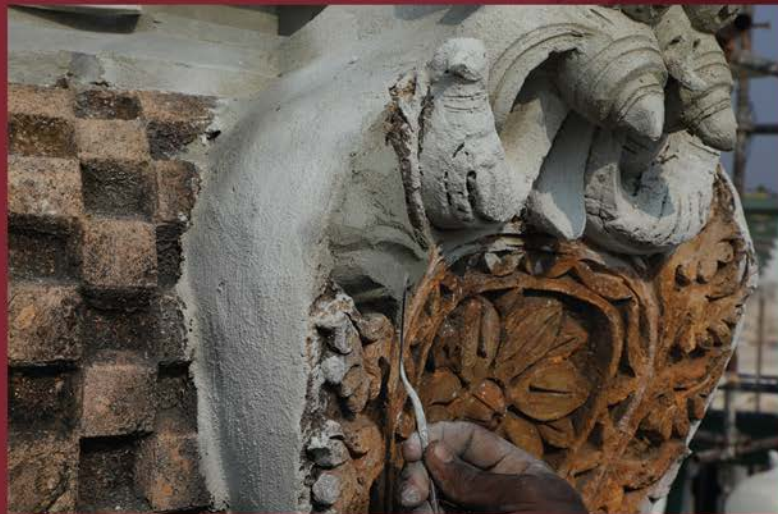
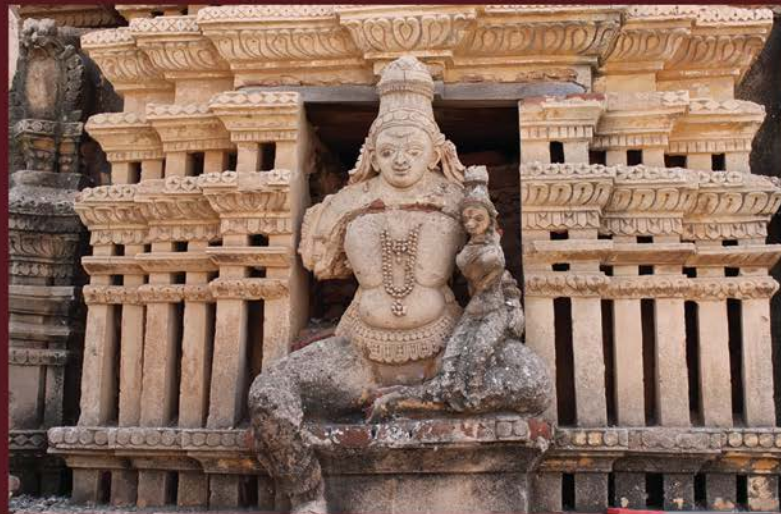
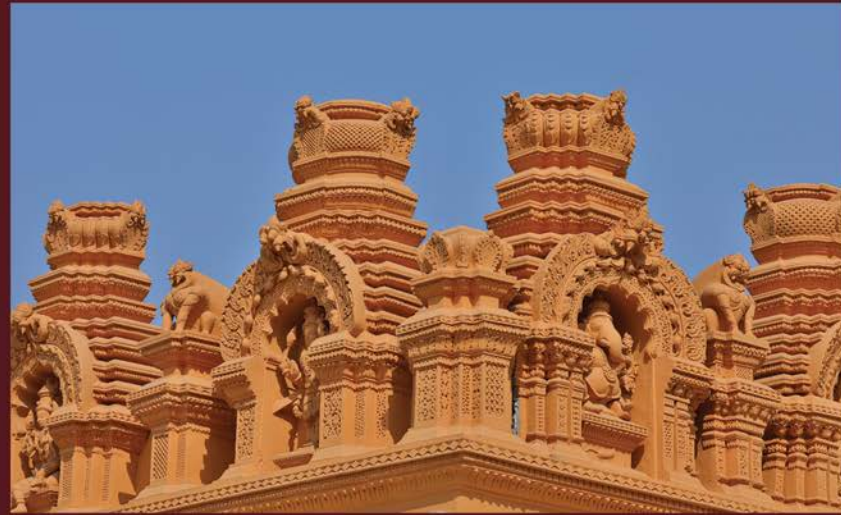
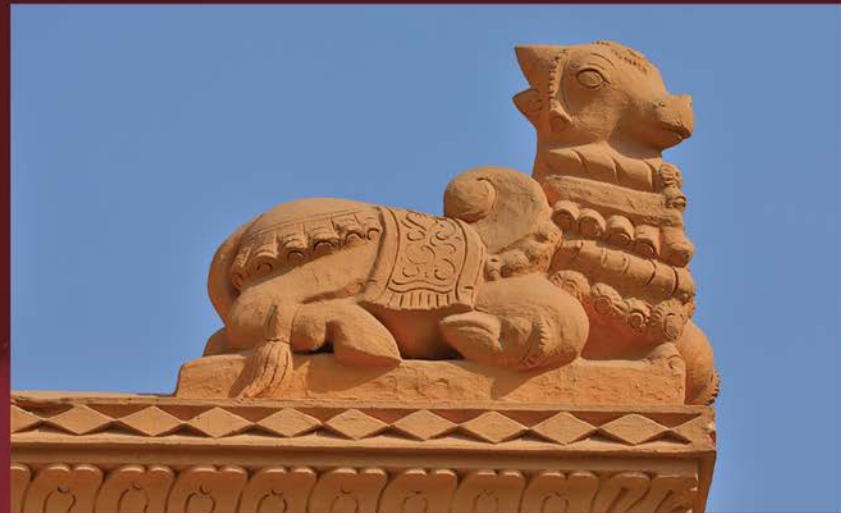
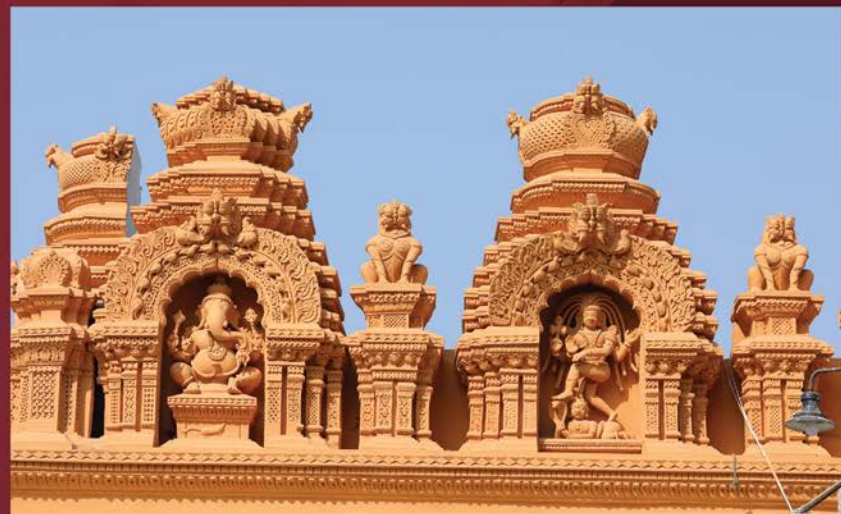
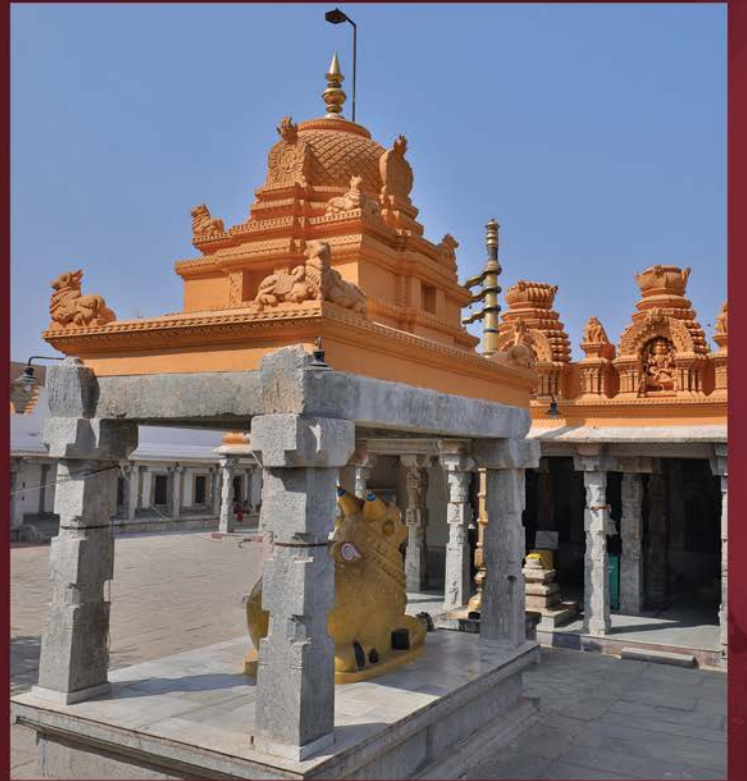
The running corridors are typical characters of Dravidian architecture. These corridors were throughout lime plastered previously which covered the stone carvings. Later, at the time of restoration, the lime plaster was cleared off from the structural members.

An alternating pattern of lime plaster and stone finish was adopted. The series of columns display a trabeate structural system of beams and columns which are typical of temple style of architecture.
