"Azadi Ka Tirth Sthal"

Andaman & Nicobar Islands

Our Story...

The extensive task of restoration and repairs of the cellular jail was undertaken by Andaman P.W.D. under the guidance of A.S.I. and Stambh Consultants. Proudly, "Savani Heritage Conservation Pvt. Ltd." received the opportunity and responsibility for the restoration of the national monument. We have strived to restore more than 150 heritage monuments and are obliged to work on a historic monument of national importance known as "Azadi Ka Tirth Sthal". It is the presence of the visitors that brings value to the heritage structure, ultimately leading to the efforts to maintain and care for the structure. We at Savani Heritage Conservation Pvt. Ltd. believe that restoring Cellular Jail is equivalent to paying homage to freedom fighters that were once imprisoned and have strived to gain independence for India. With this memorial, future generations of independent India will always remember their forefathers as heroes of freedom, and the saga of their sacrifice will be immortal for ages.

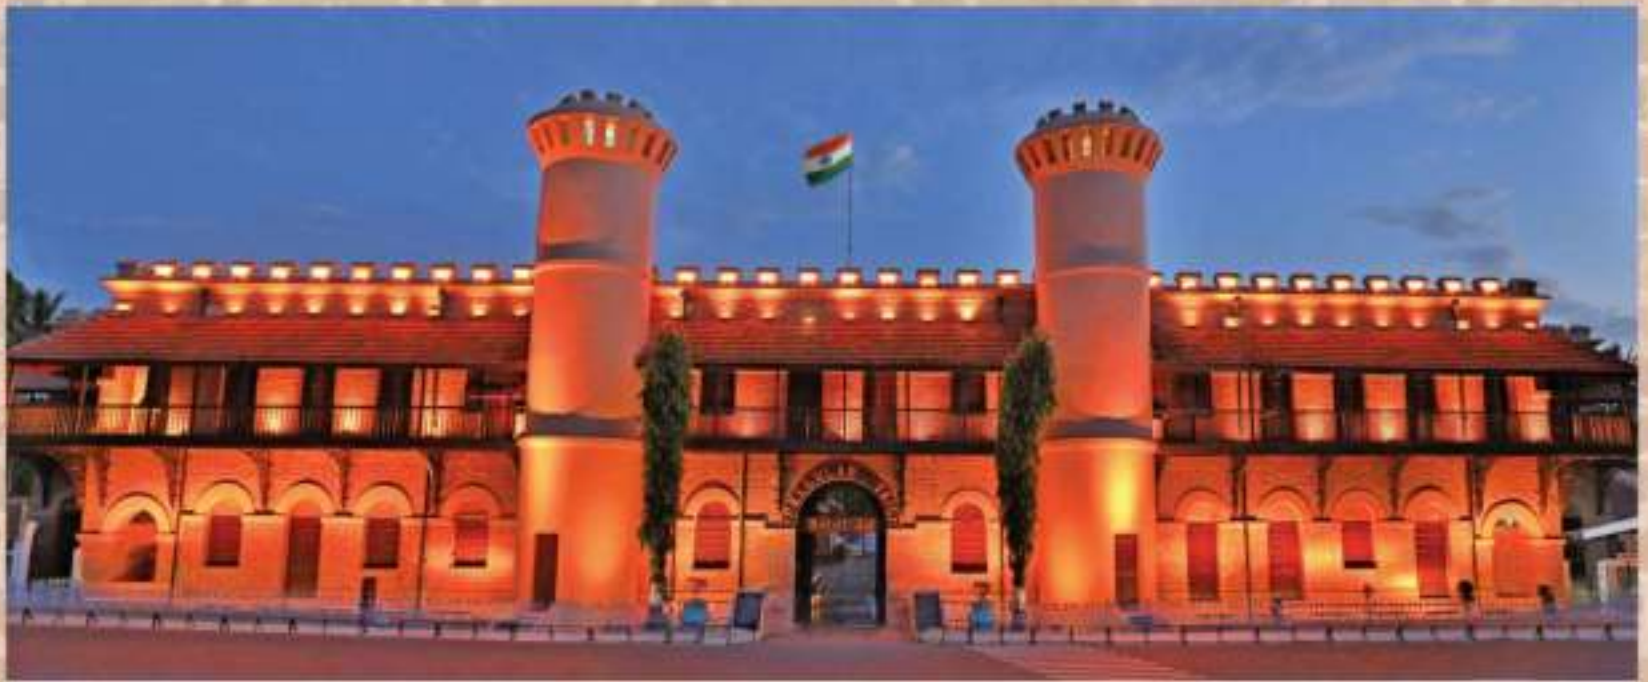
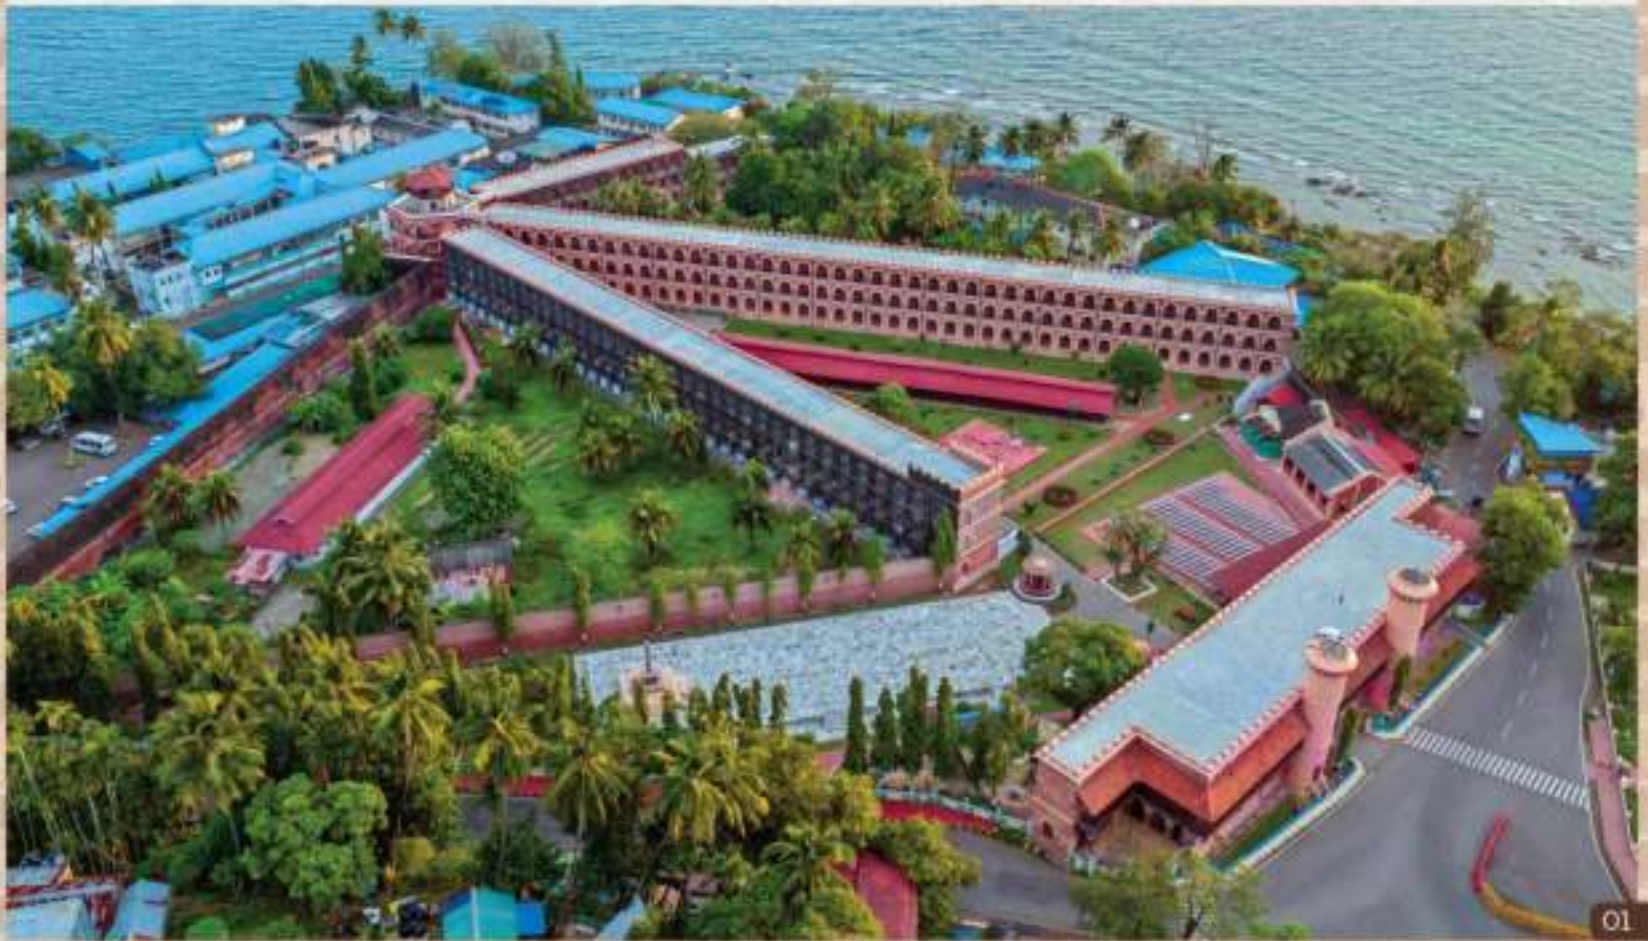
Built in 1906, the Prison was governed from the admin building, which stands today at the entrance. The front elevation of the Cellular Jail, which is the face of the monument, as it is the first structure viewed by the visitors.

The National Memorial's administration wing entrance is guarded by two towers, which are connected linearly to the admin block. The admin block, which was painted, was scrapped off to expose the original brick layer, which was consolidated with ethyl silicate to safeguard the brick facade. The roof and the windows of the admin block were also repaired by scarping off the paint layer and polishing later.

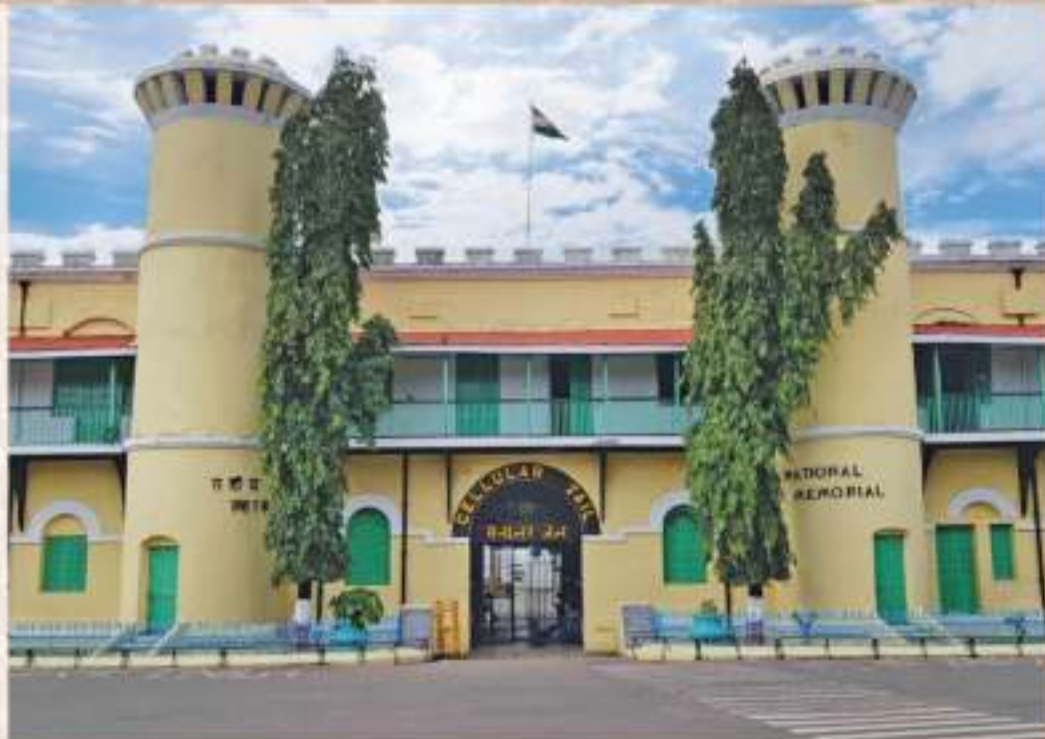
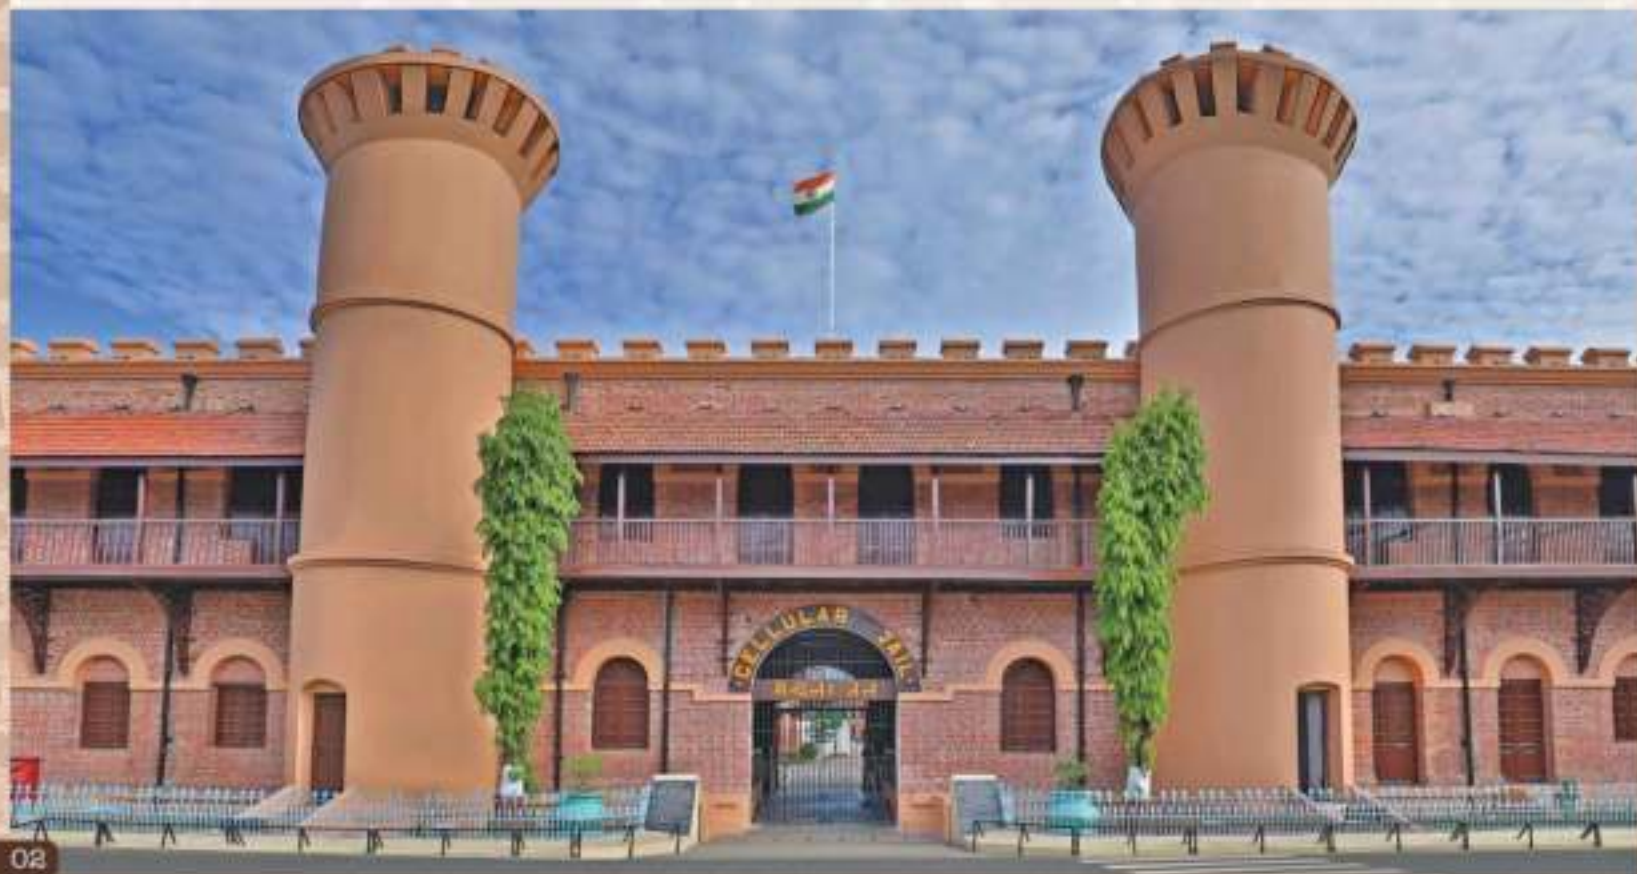
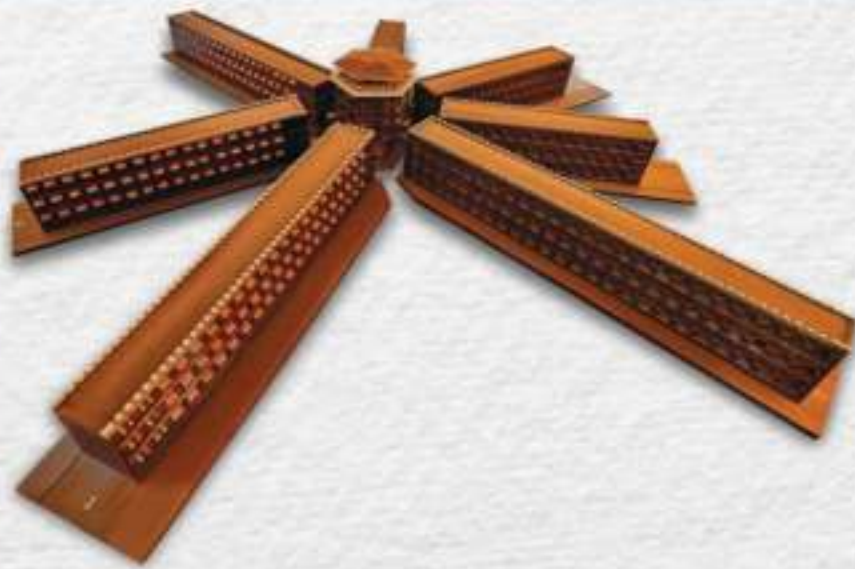
The visitors have to pass across the towers to enter the site.

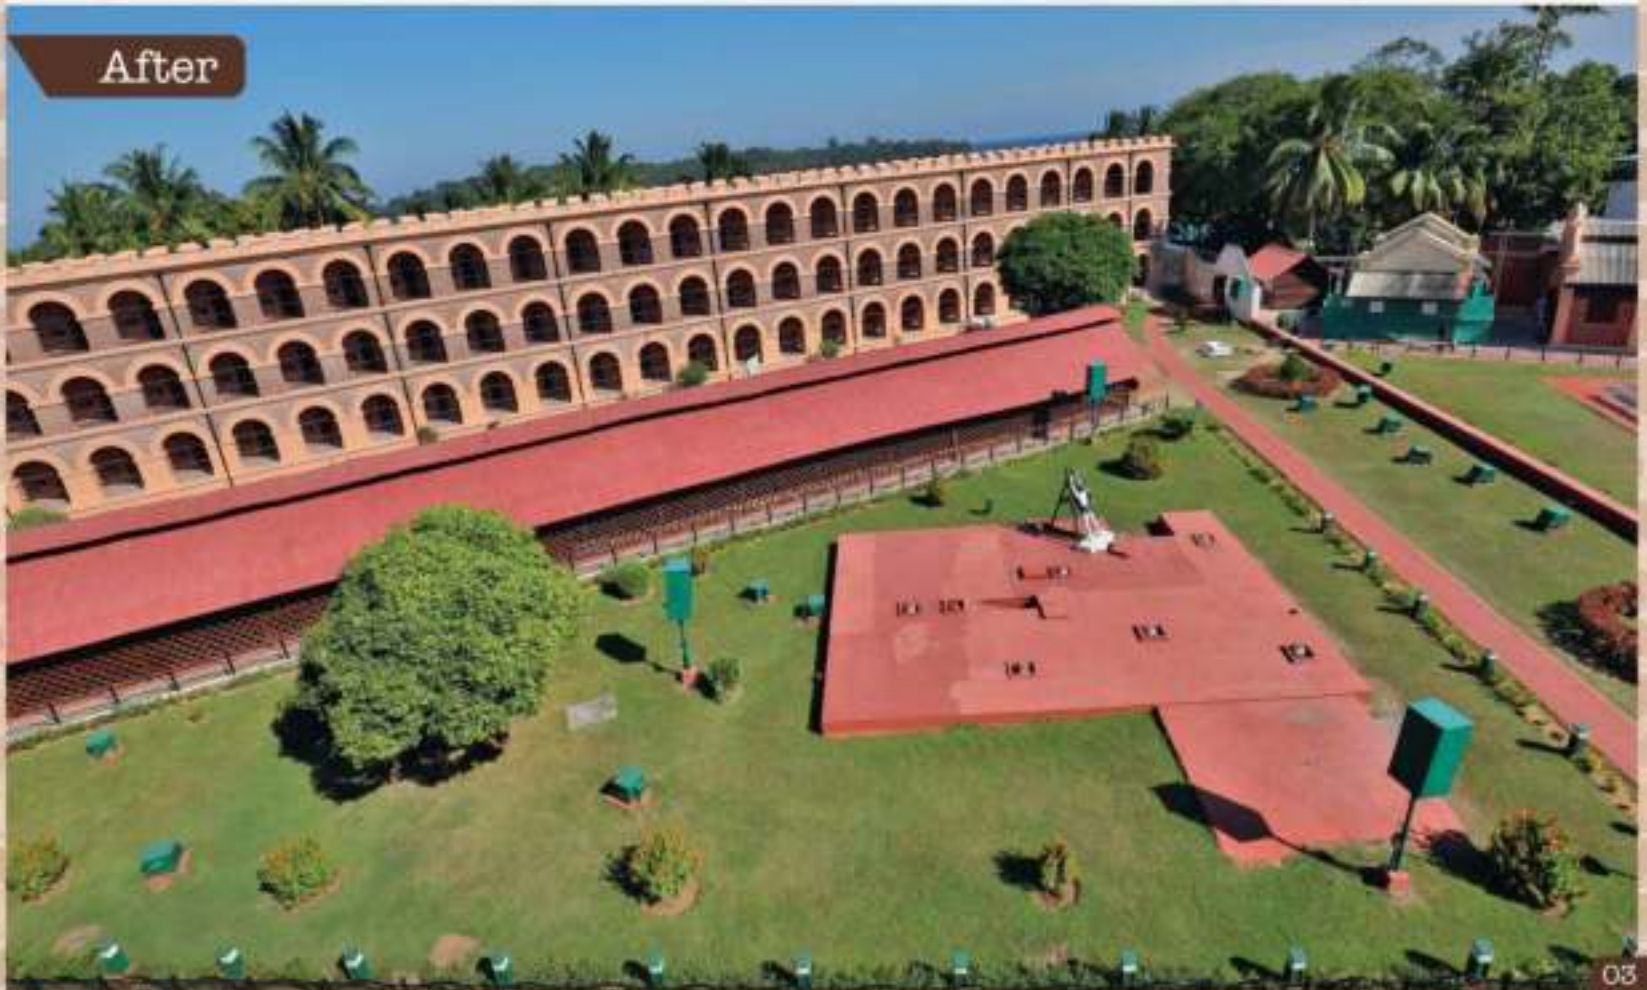
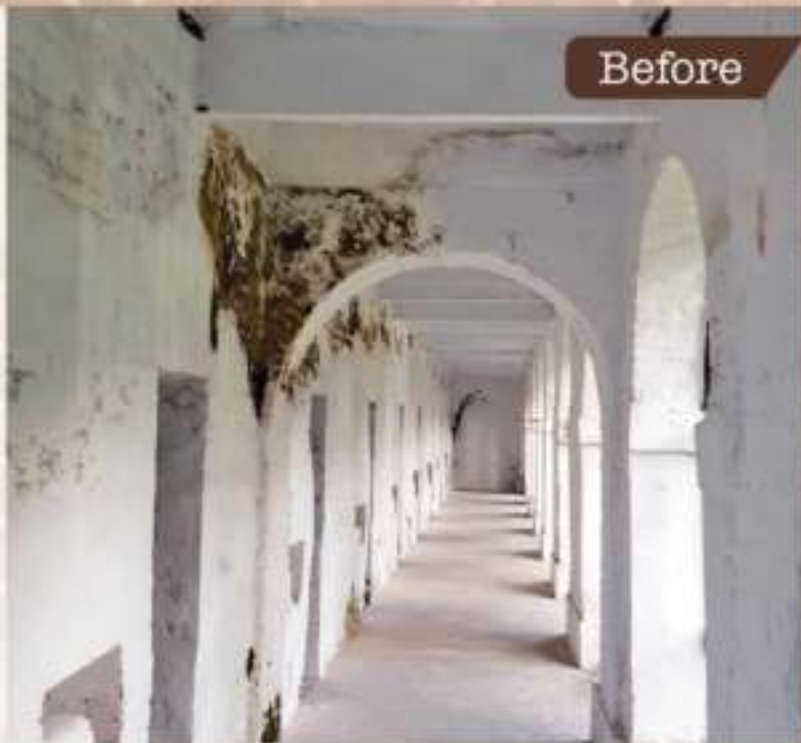
The corridors are one of the chief architectural elements of the Cellular Jail. These were incorporated to connect the seven wings and to keep constant vigilance on the inmates and monitor their activities. The corridor functioned as a barrier to tackle the local geographical conditions where very heavy rainfall is received during the monsoons.

The corridor was intervened in the meanwhile during the maintenance when it was rendered with cement and painted. After studying the archival images, it was understood that the bricks were originally exposed. Later, during the restoration, the bricks were exposed back to the original to retain the authenticity. The exposed brick surface had to be consolidated using ethyl silicate.

These bricks were also treated with water proofing treatment to retard the growth of the vegetation. Besides, the M.S. grills of the corridor were also restored as they were corroded in some places due to exposure to the sea breeze. The grills were painted later with anti-corrosive paint.

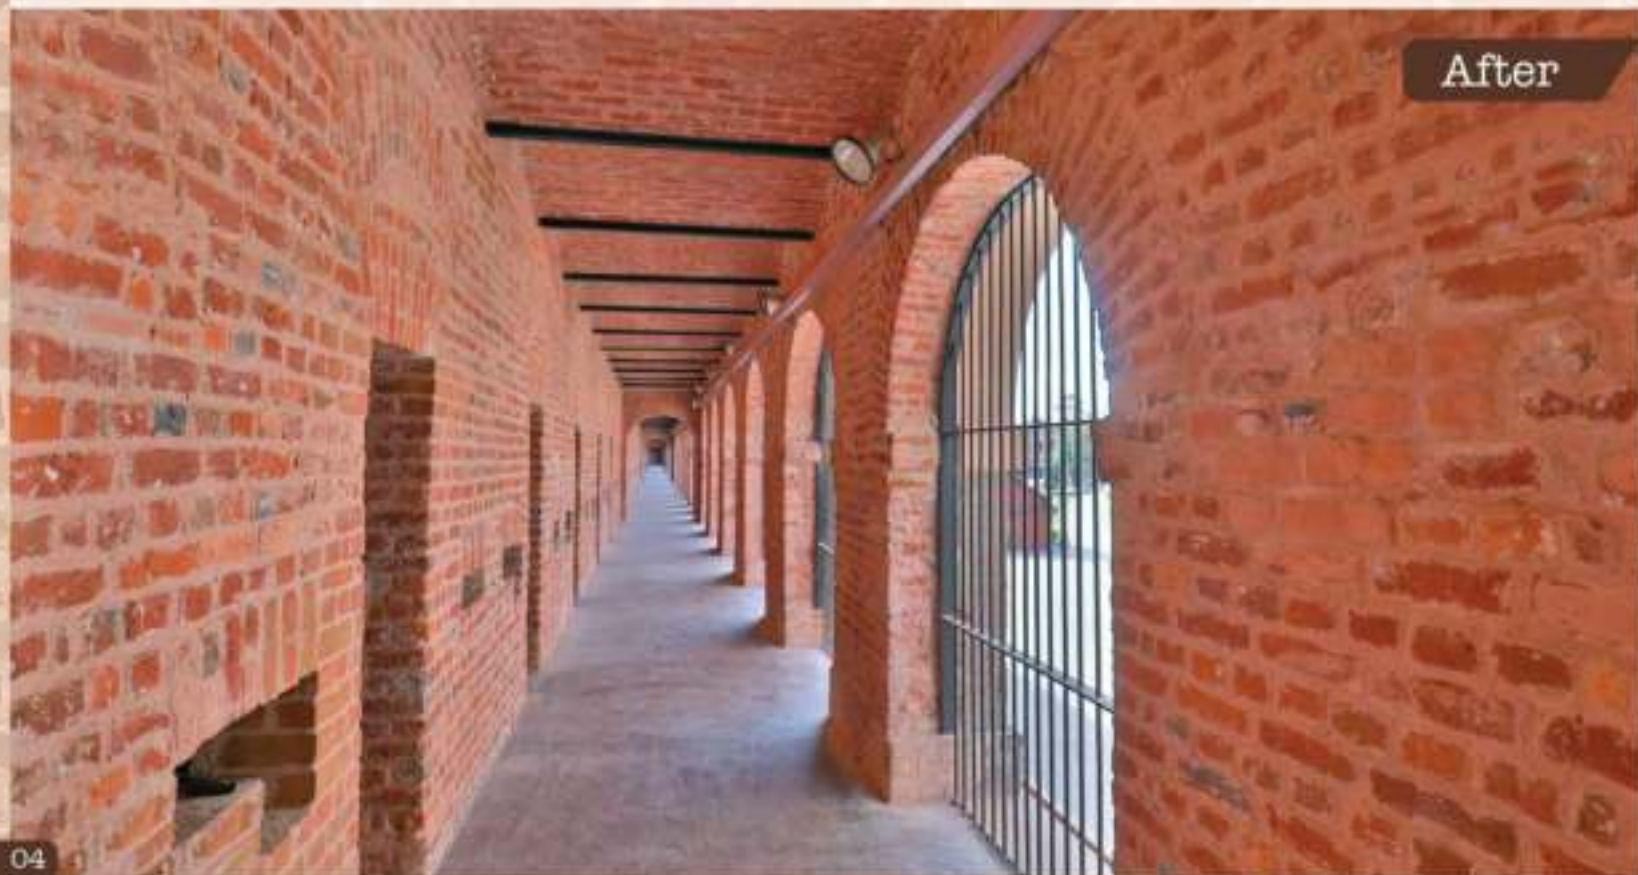
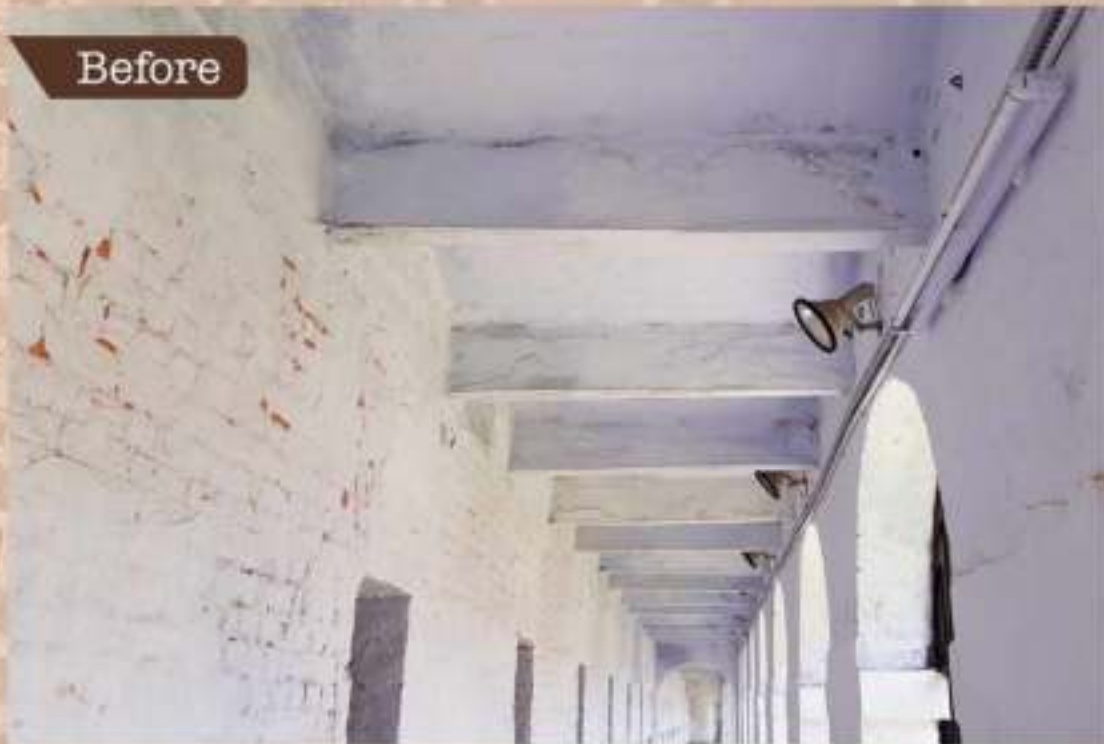
During the maintenance of the Cellular Jail, the fabric as well as the structure were exposed to brutal interventions such as paint layer. The brick wall was exposed and consolidated with ethyl silicate.

The ceiling of the corridor was interfered with by R.C.C. and beams. The ceiling of the corridor was structurally intervened such that the 'I' section had R.C.C. beams underneath, which were critically cracked.

The Jack Arch of the corridor was structurally strengthened and the Jack Arch was exposed. The restoration of the jack arch to its original location is an attempt to preserve its authenticity.

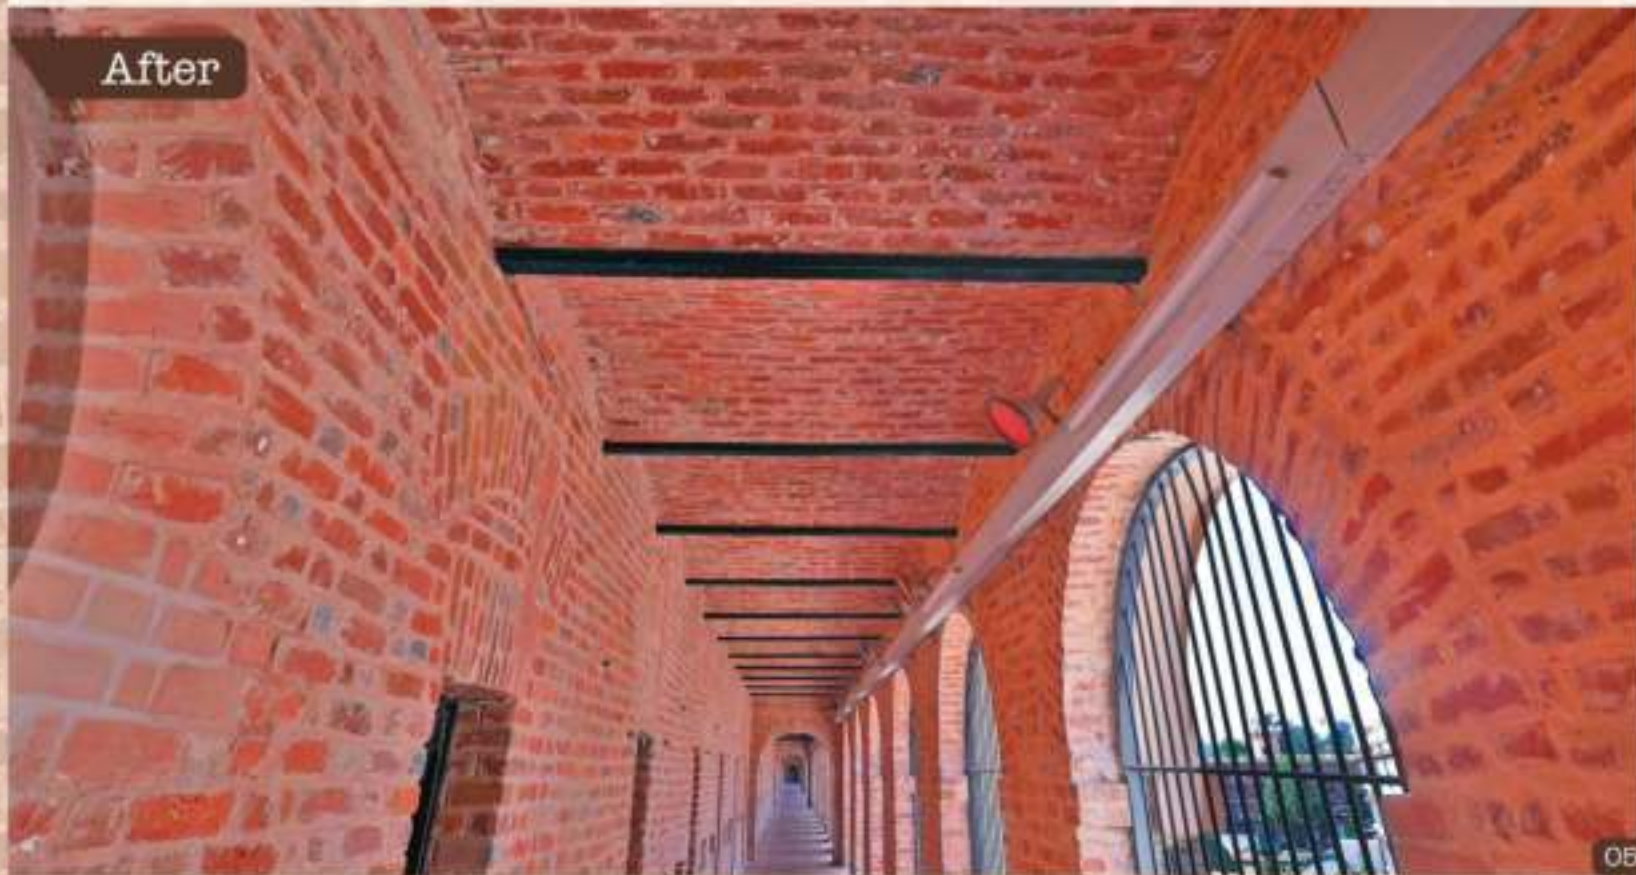
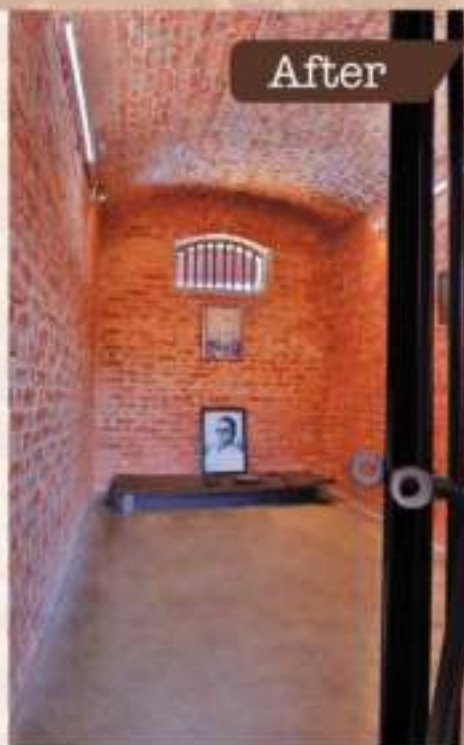
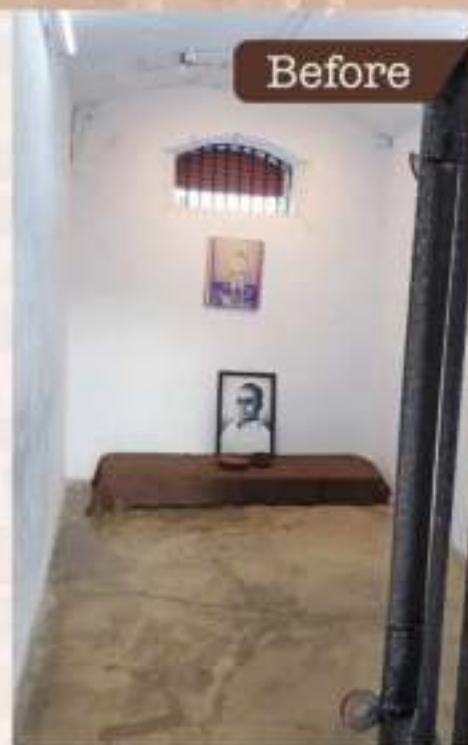
Each cell, which was a solitary confinement, had only one small opening on one of the walls. The M.S. cell grills secured the lockup and were restored by applying anti-corrosive paint after removing the rust. The cell walls and ceiling were plastered with cement during the maintenance over the original brick layer. After scarping off the paint layer, the bricks pointing were corrected with lime and consolidated with ethyl silicate.

The bricks were made locally on the island, and since the cells were meant to confine the inmates, their beautification was not taken into consideration, and hence they were left without any plaster. The Savarkar cell at the Cellular Jail is one of the most visited cell to pay homage to Freedom Fighter Veer Savarkar. The lighting system was also corrected while each cell underwent a holistic restoration and repair under a vigilant eye.

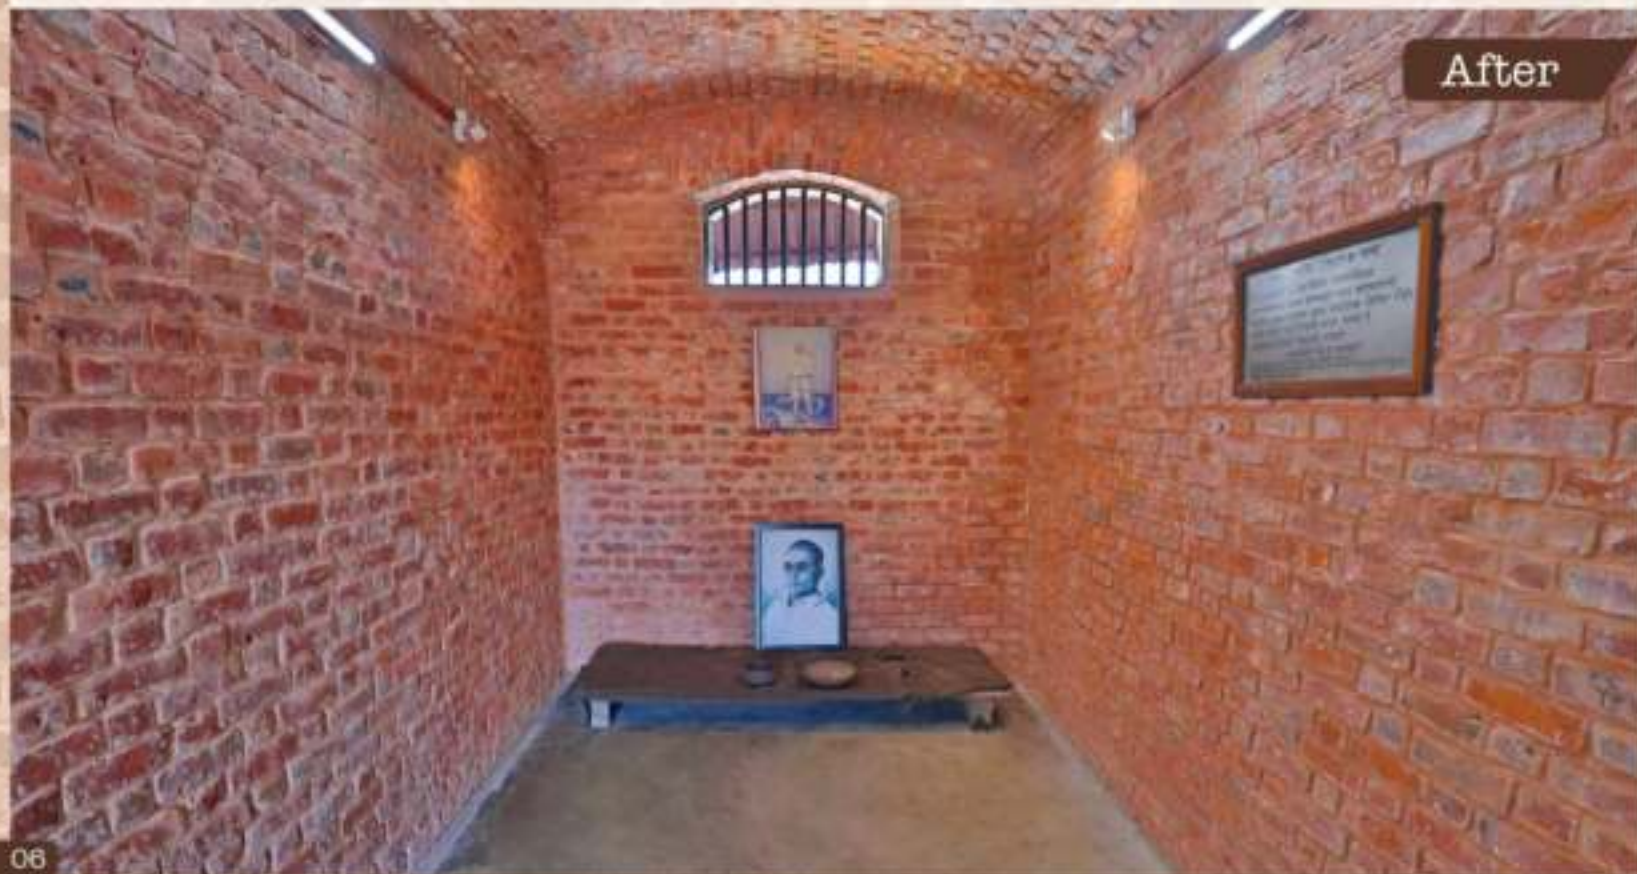
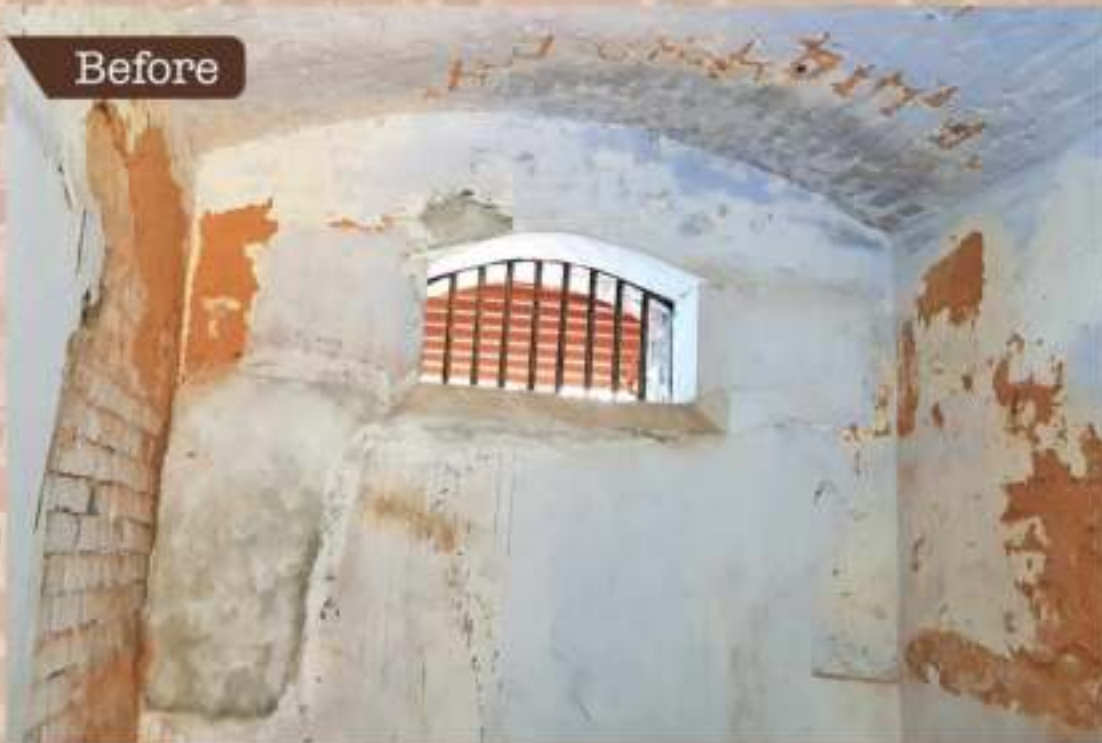
The internal walls of the cells were plastered during maintenance, which can be termed as intervention. It has been found out from the earlier references that the walls were not plastered.

Besides, the walls and the ceiling were also plastered and painted. These layers were scrapped off to expose the original brick finish. The bricks at some locations were retrofitted, which were severely deteriorated.

After exposing the bricks, the pointing was done with lime. After the pointing, the walls of the cells were applied with a layer of water repellent.

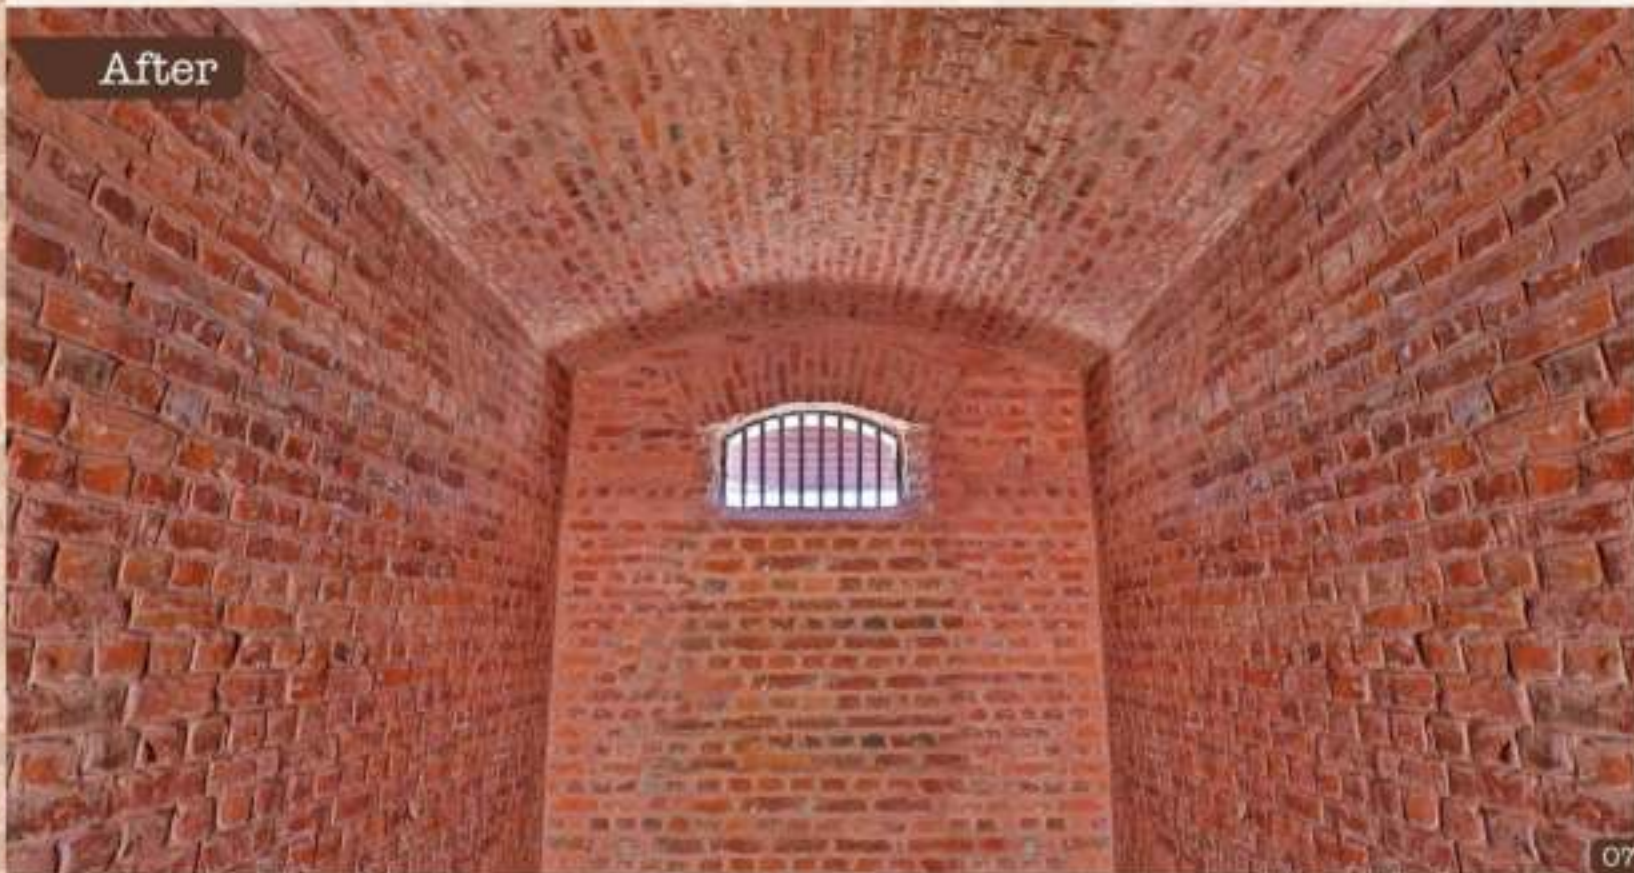
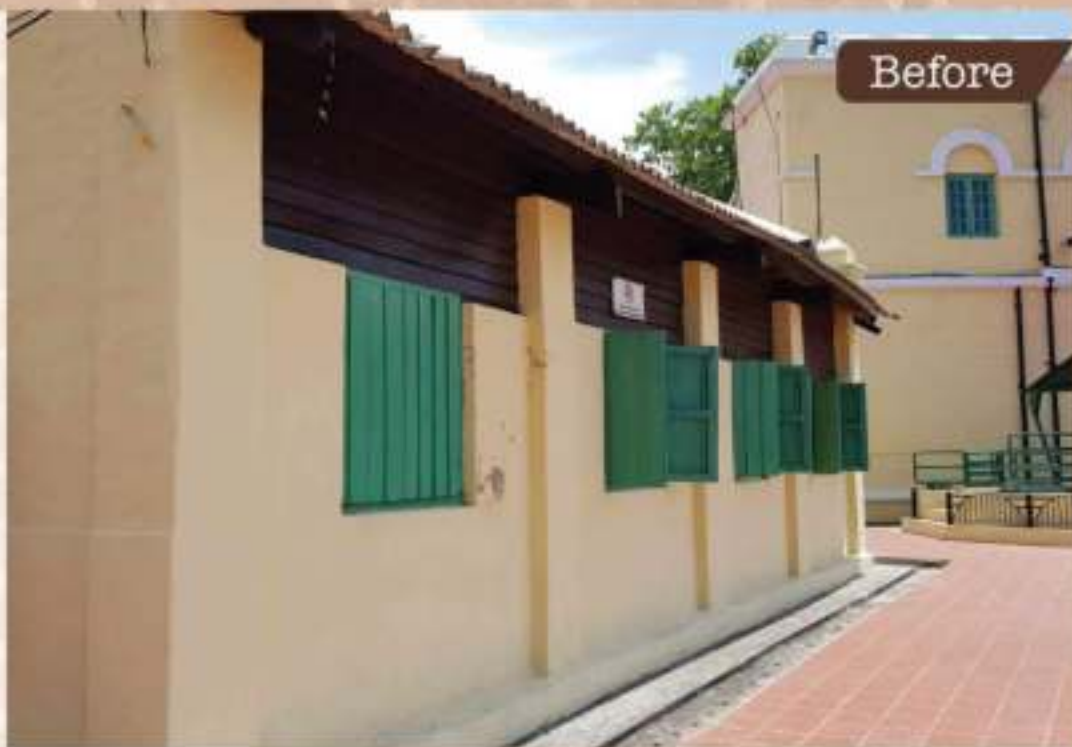
The *Rasoi Ghar*, or the kitchen block 1, was used to cook food for the residing officers and the inmates of the jail and is a part of the original plan. The sloping roof of the structure was replaced.

The façade was restored where the plaster and the paint, which was an intervention, had to be scraped off to maintain uniformity with the other wings.

The door and windows paint were also scraped off and repainted in the shade of brown. The pitch roof of the structure had to be replaced with AC Sheets changed timber members and the gutter around the structure was cleaned to channelise the flow of the rainwater.

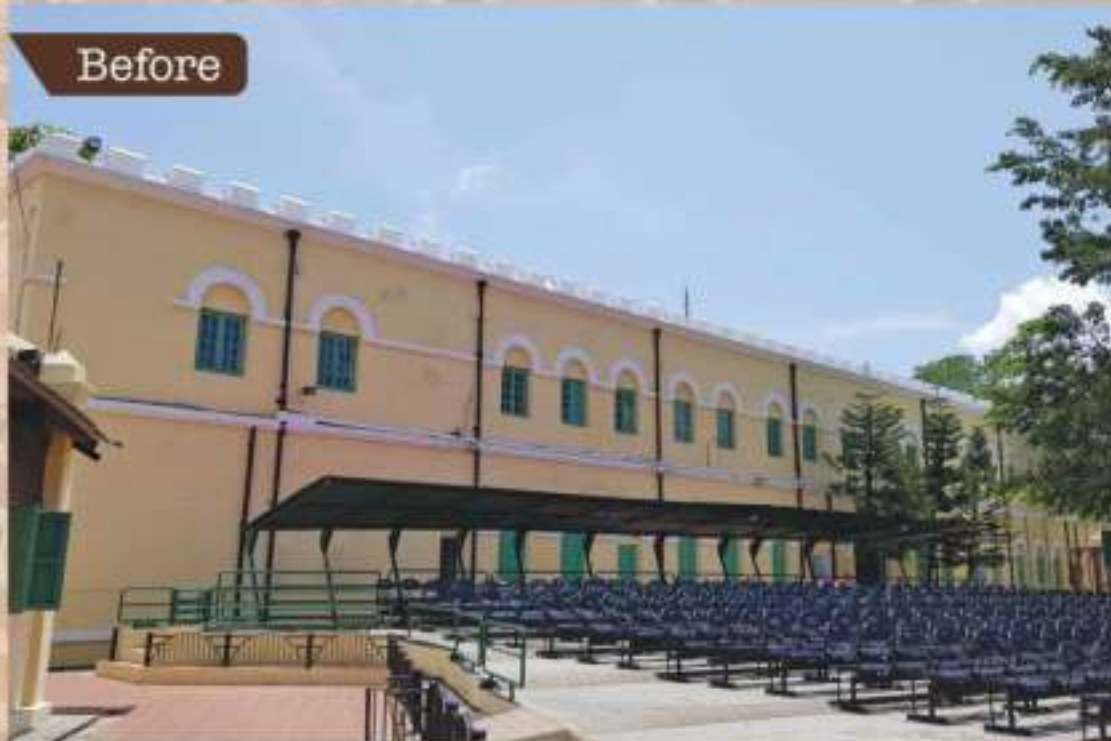
The rear side of the Admin block of the Cellular Jail, unlike the other wings, also underwent a façade restoration. One of the windows that was blocked was revived by reopening it.

These openings were repainted after scraping off the previous paint in the shade of brown. The plaster and the paint were scraped off to retain the original brick finish fabric. The cornices and other plain areas were replastered.

The paint over the brick façade was scraped off and exposed. The mass seating area in the vicinity is meant for the light and sound show.
