"Azadi Ka Tirth Sthal"

Andaman & Nicobar Islands

Our Story...

The extensive task of restoration and repairs of the cellular jail was undertaken by Andaman P.W.D. under the guidance of A.S.I. and Stambh Consultants. Proudly, "Savani Heritage Conservation Pvt. Ltd." received the opportunity and responsibility for the restoration of the national monument. We have strived to restore more than 150 heritage monuments and are obliged to work on a historic monument of national importance known as "Azadi Ka Tirth Sthal". It is the presence of the visitors that brings value to the heritage structure, ultimately leading to the efforts to maintain and care for the structure. We at Savani Heritage Conservation Pvt. Ltd. believe that restoring Cellular Jail is equivalent to paying homage to freedom fighters that were once imprisoned and have strived to gain independence for India. With this memorial, future generations of independent India will always remember their forefathers as heroes of freedom, and the saga of their sacrifice will be immortal for ages.

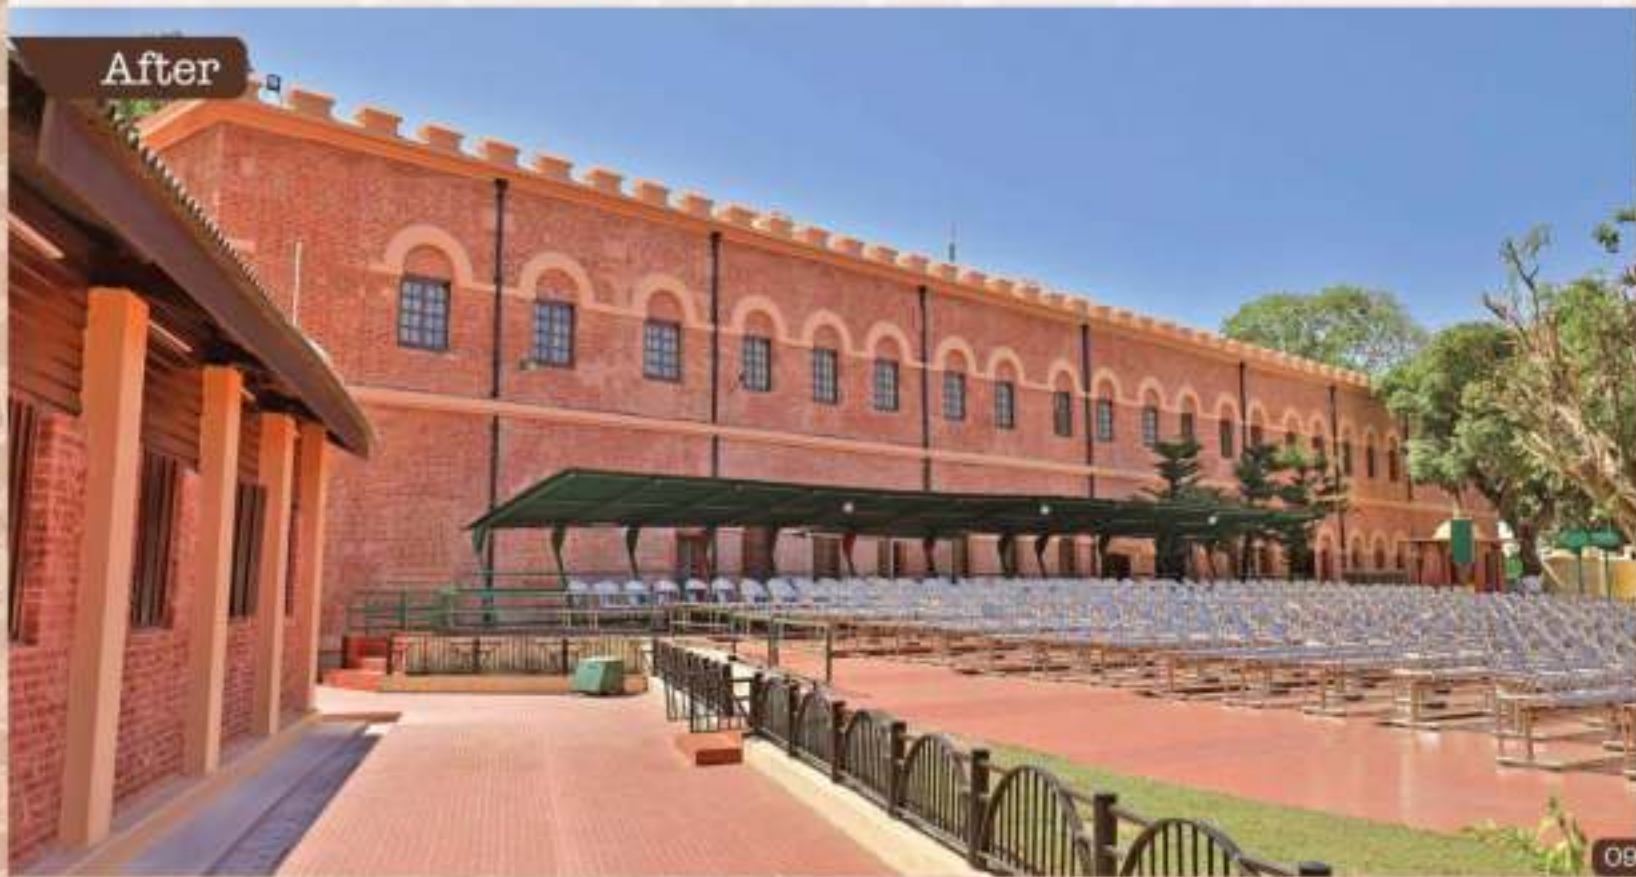
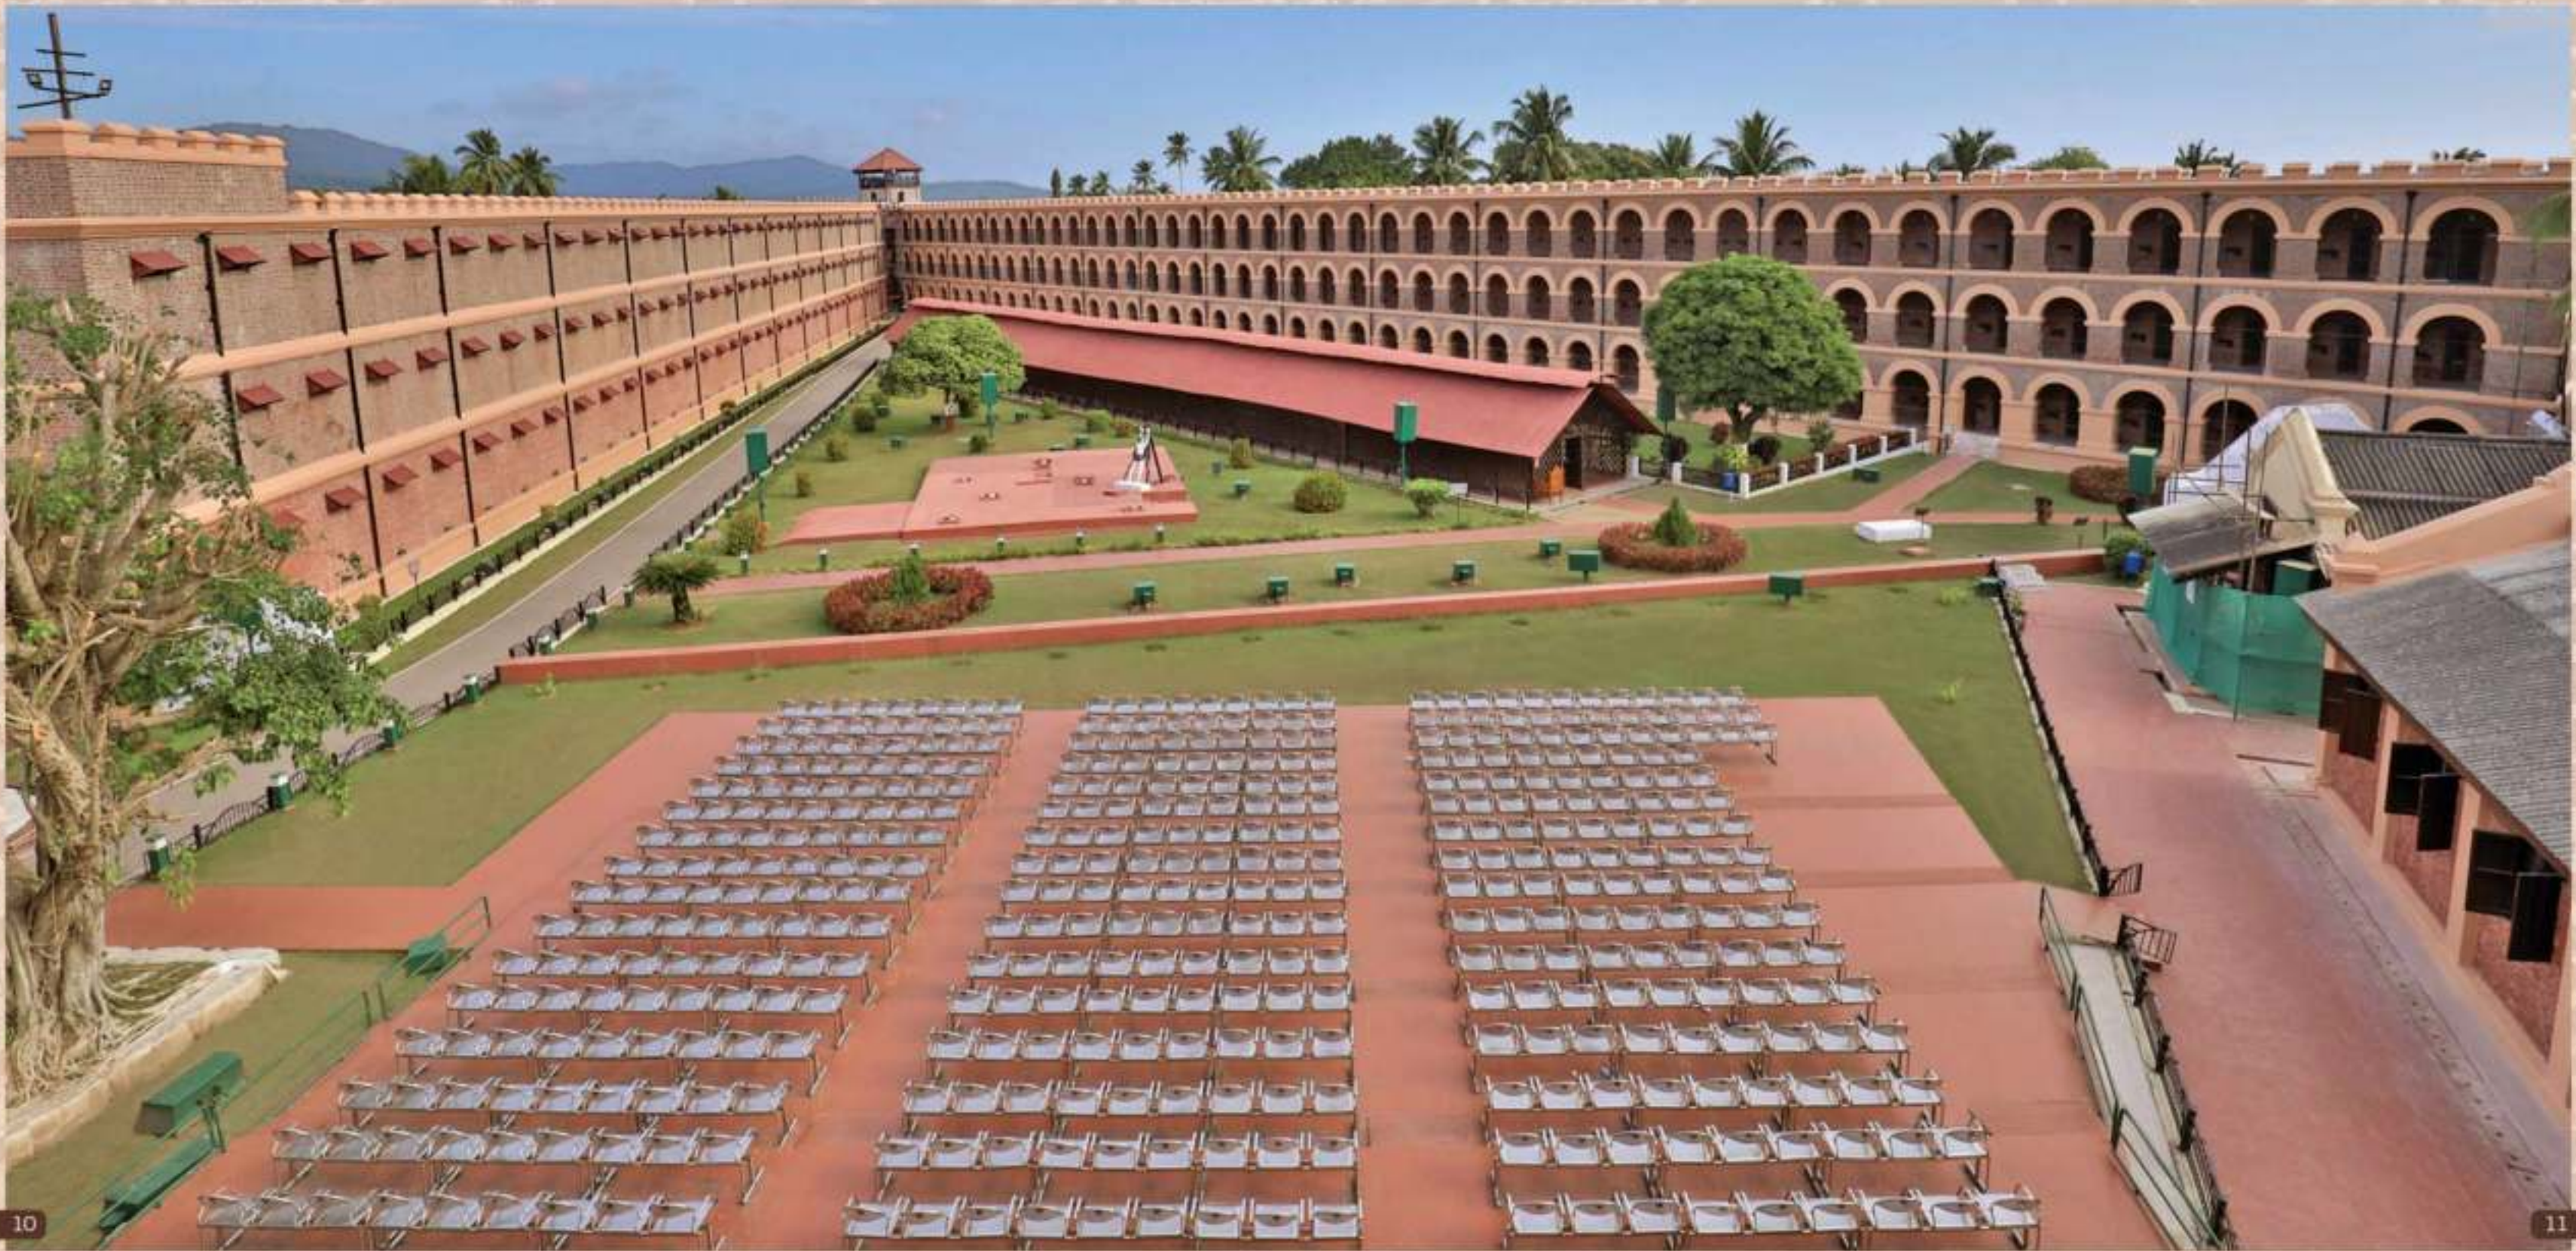
The *Rasol Ghar*, or the kitchen blocks 1 & 2 across the seating area, stood in an under-maintained condition.

During the restoration, the façade was restored where paint was scraped off and the bricks were consolidated using ethyl silicate. The roof was replaced with similar AC sheets, and timber members were replaced. The paint of the door and window was scraped off and repainted in the shade of brown. The brick surface was exposed after consolidating with ethyl silicate. Whereas the plain surfaces were plastered.

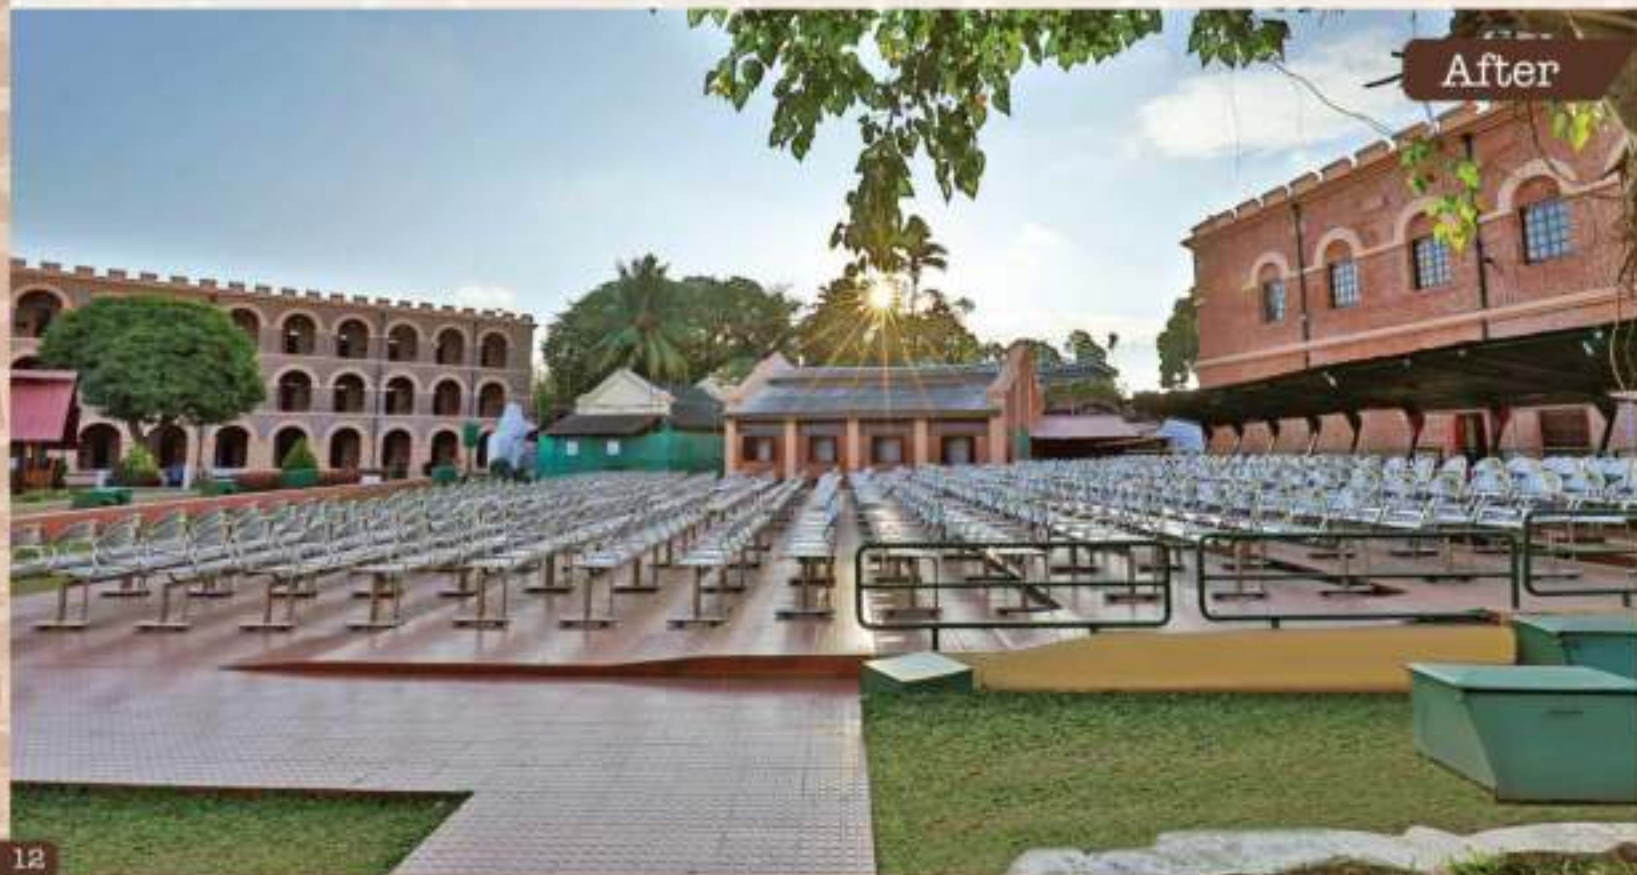
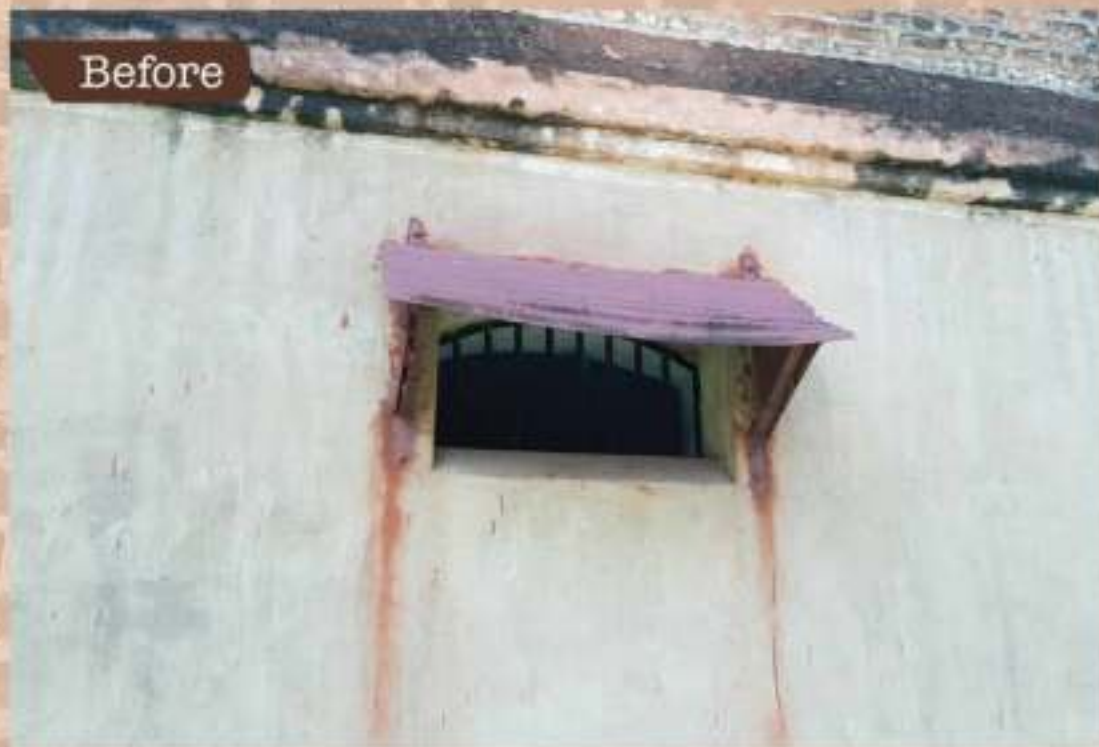
Each cell of the Cellular Jail had only a single small opening to allow ventilation and minimum light.

Originally, the *chajja* must not have been present. However, to protect the cells from rain water, it was decided to retain the *chajja*. Besides, the cells are fitted with light fixtures for the convenience of the visitors. The material of the *chajja* was changed, which corroded.

Besides, the brick fabric on the rear side was exposed as original, consolidated with ethyl silicate and later treated with water repellent coating.

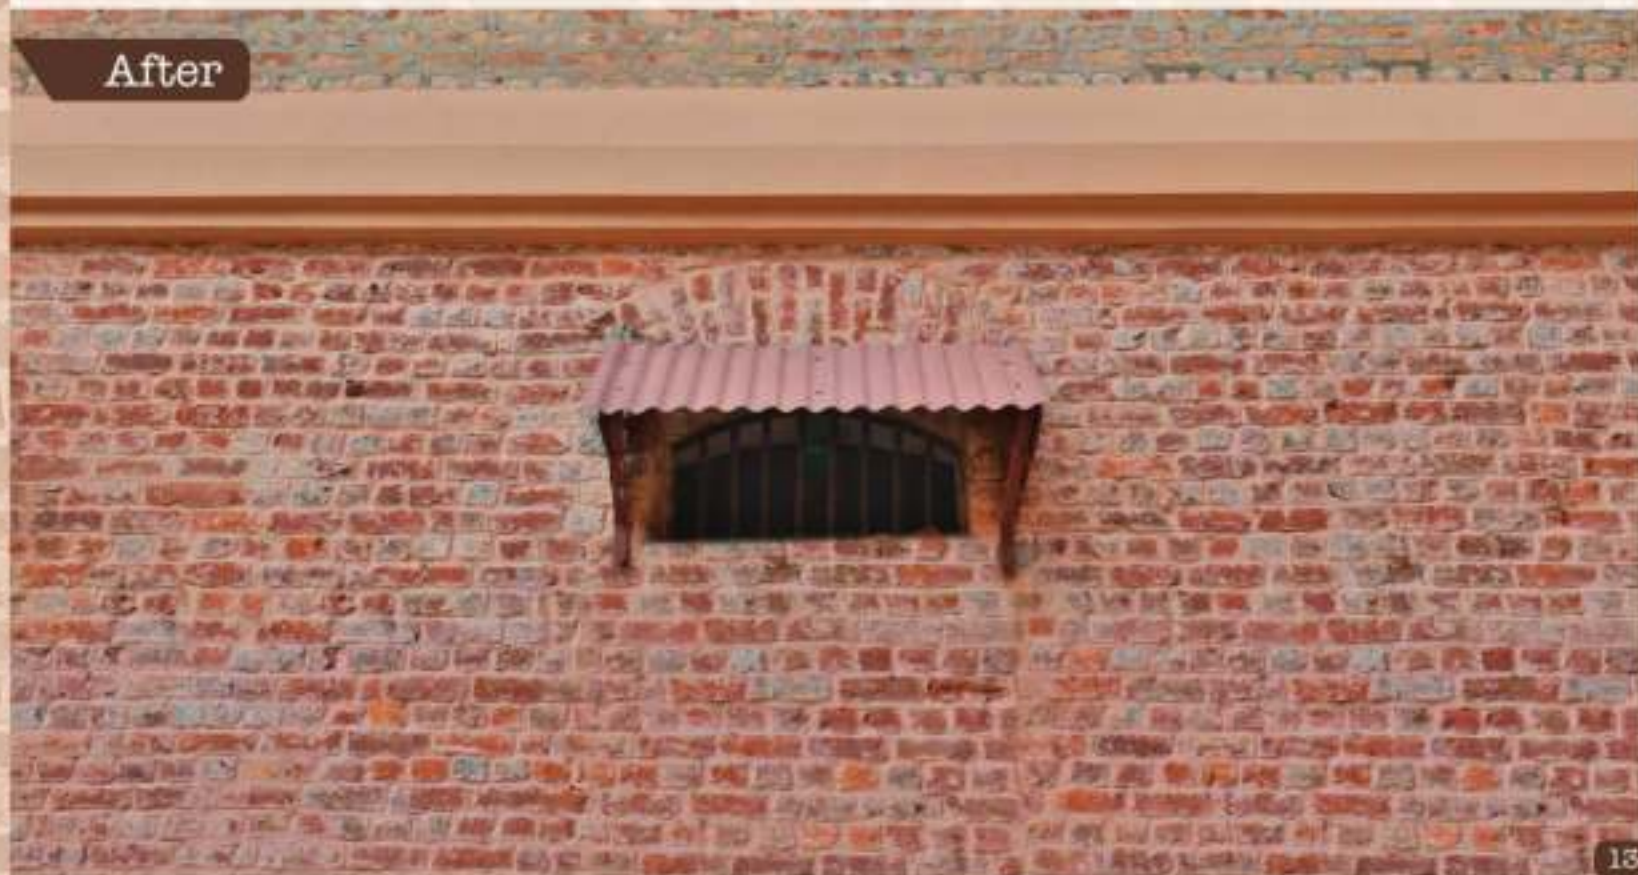
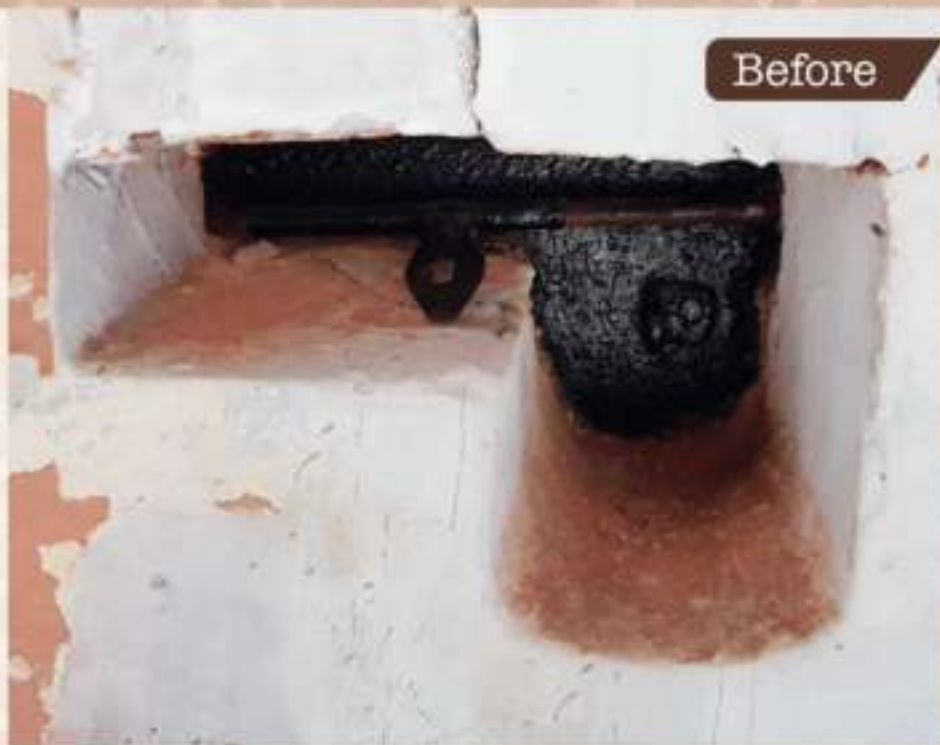
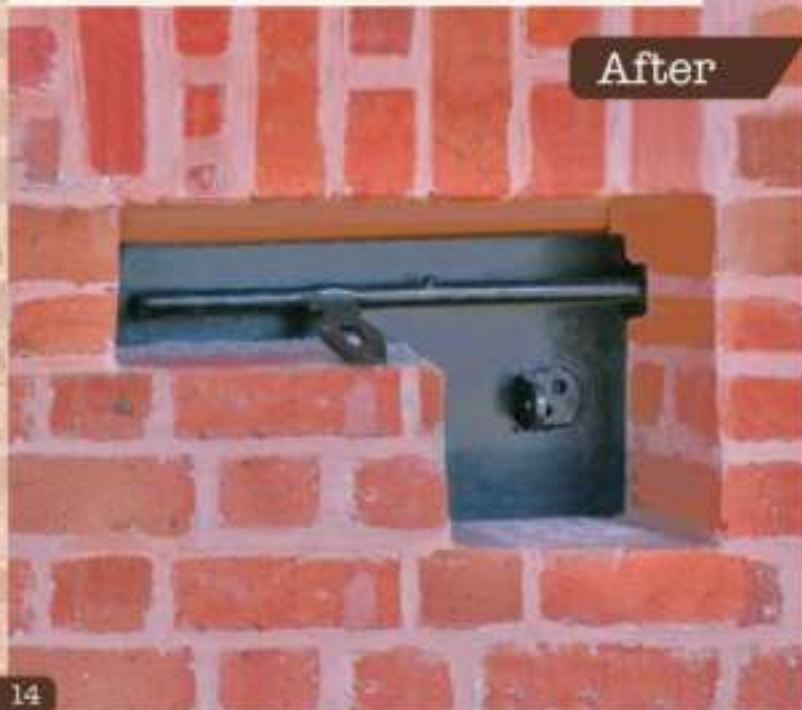
The locking system of the cell is a very interesting aspect of the prison architecture. The cell locking arrangement was done in a way that the AL drop is concealed inside the brick masonry, making it impossible for prisoners to escape. The rusting of the M.S. AL drop was caused by weathering in some locations. Furthermore, there was also a bulging of the bricks near the door.

The AL drops were treated with anti-corrosive layers and later painted with black paint. Also, the M.S. flap of the food receiving counter was repaired. The walls in some places had bulges in them, probably due to the dampness. The bulge was treated after the removal of the bricks from the place and refitting with new bricks. The plaster and paint over the AL Drop wall were scraped off to expose the joints between the bricks and to check for any AL Drop.

Thus, the unique feature of the cell lock up was restored and repaired without replacing the original locks.

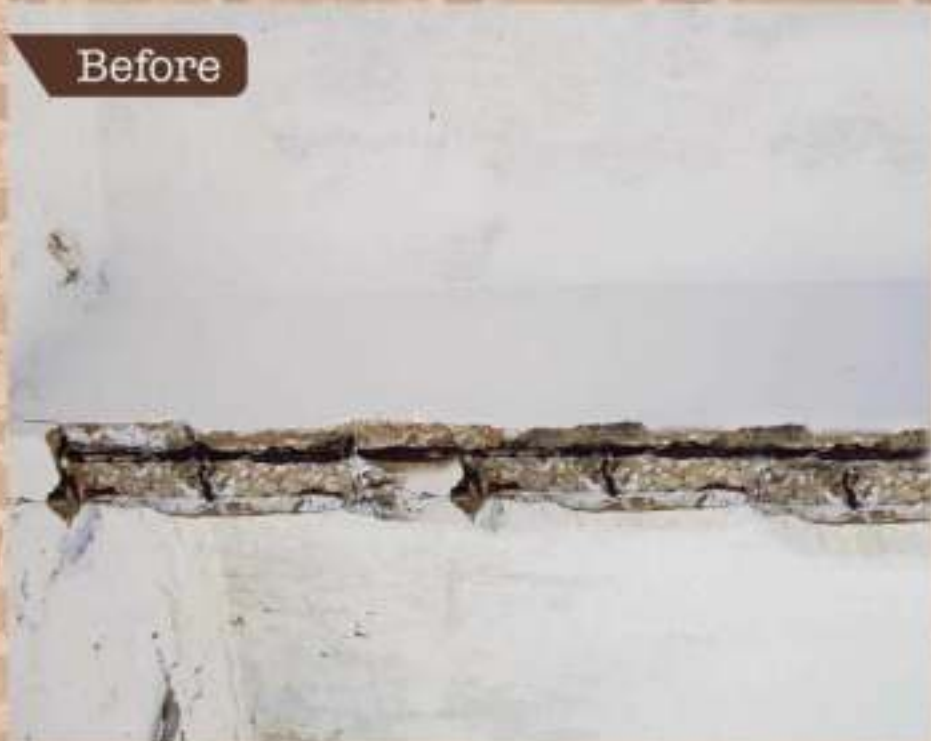
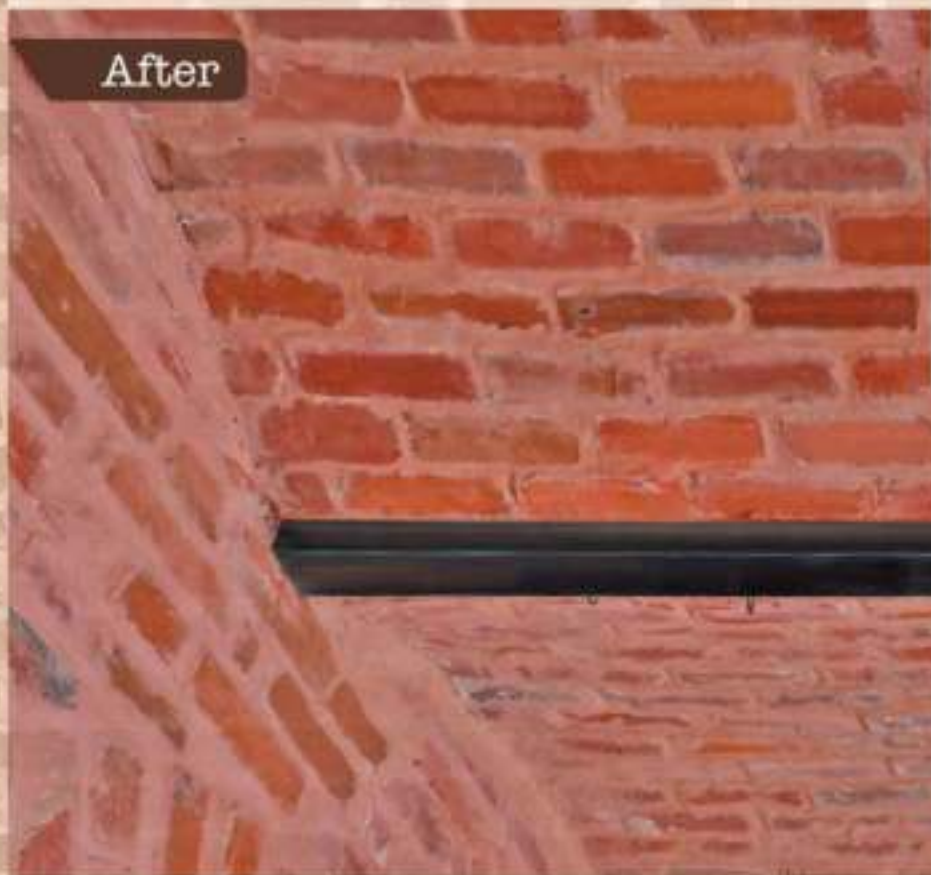
The ceiling of the corridor carries the load that is generated by the movement of the visitors. With the increase in the number of visitors, the load on the corridors increased and the additional load-carrying structural elements were introduced. During the maintenance by the jail authorities, the additional R.C.C. beams were introduced, which were an intervention.

Over the years, these beams began to corrode due to the prevailing humid and sea breeze conditions, which accelerated the rusting of the reinforcement. After an in-depth archival study and documentation, it was discovered that a jack arch exists above the intervened R.C.C. beams and slab. The 'I' sections of some of the jack arches were replaced because they were corroded. Before initiating the work, the slab was supported with temporary supports. The R.C.C. beam was removed and the original jack arch was restored. Further, the corridor jack arch 'I' sections were retrofitted by adding a plate 32mm x 65mm as wide as a flange in place of a concrete beam, an inclusion which was later removed. Finally, the ceiling, along with the walls, was exposed as original, with lime pointing done all over the walls and ceiling.

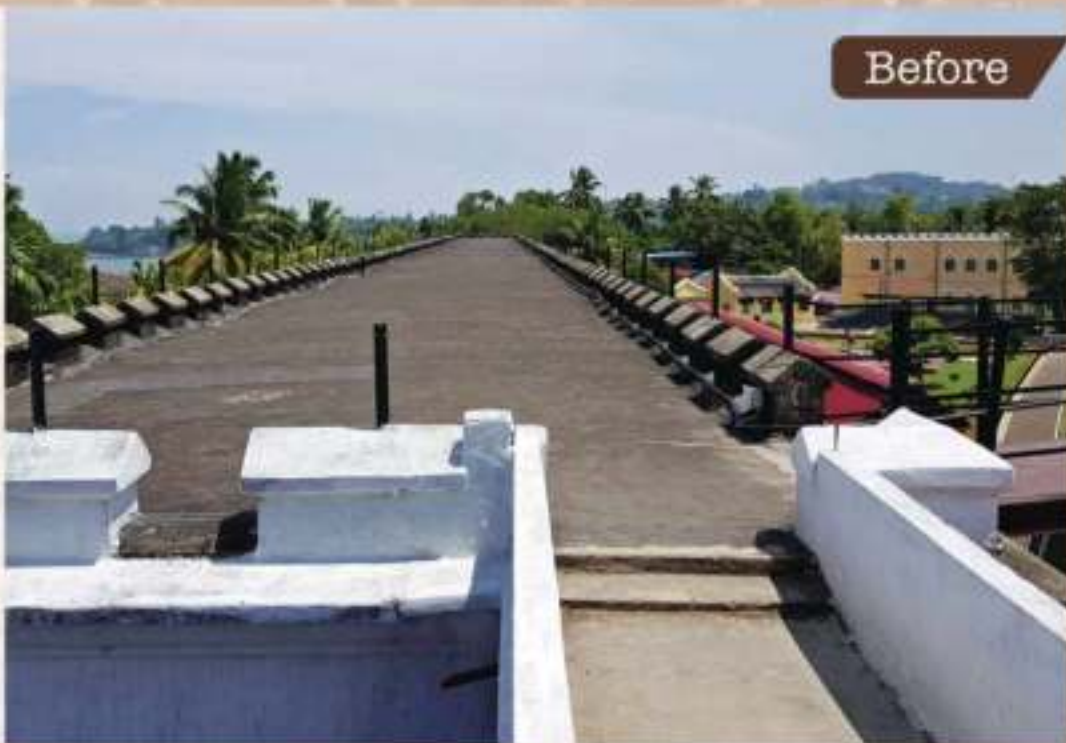
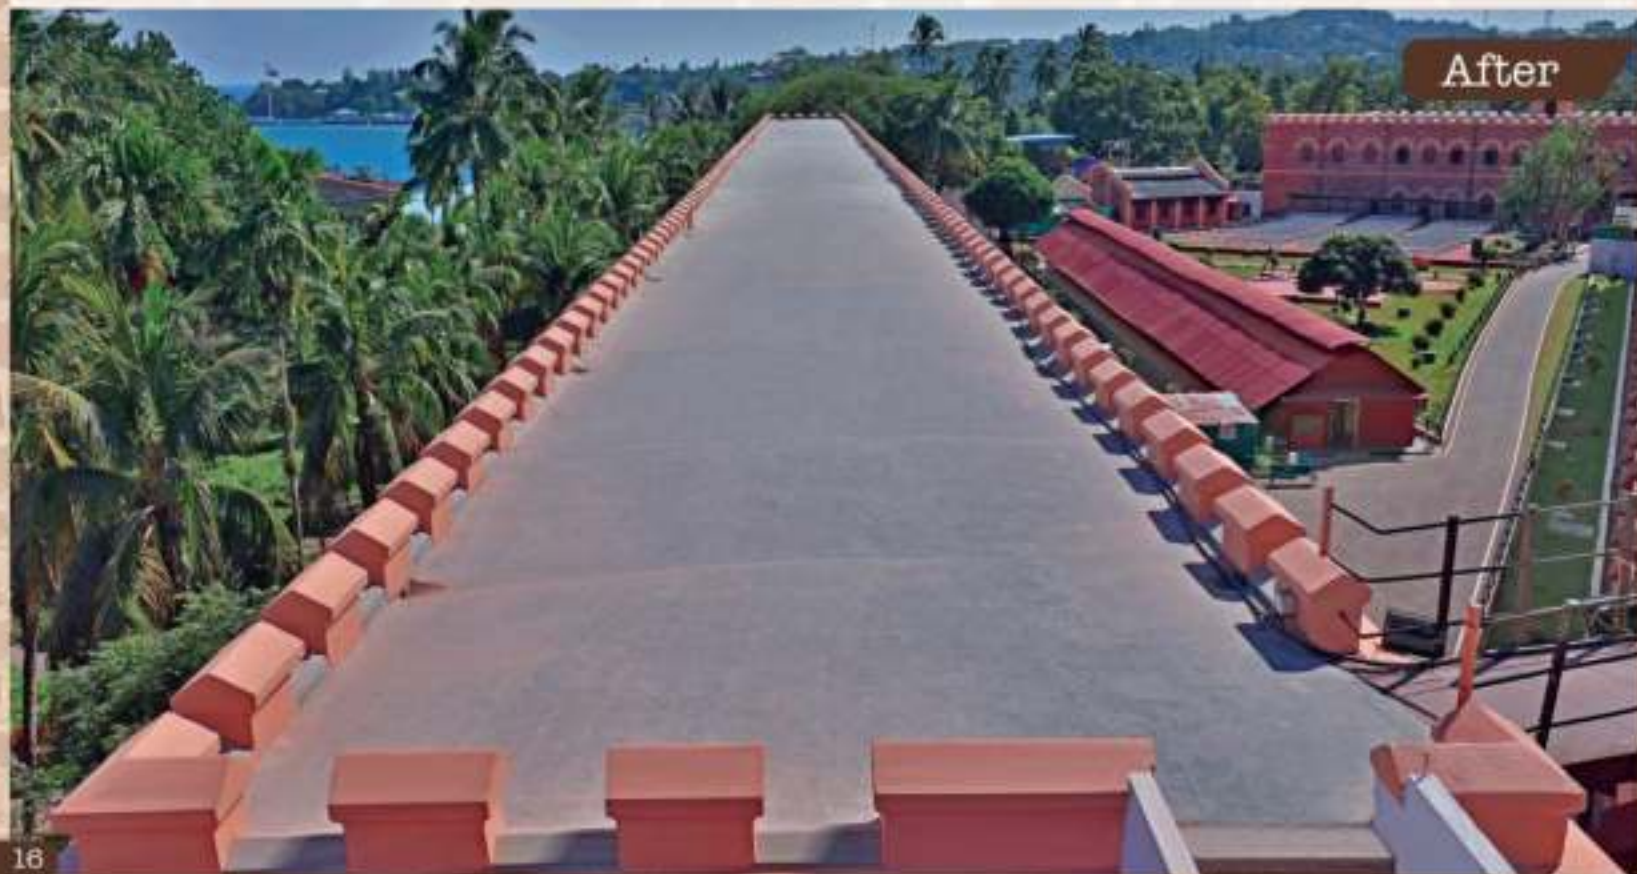
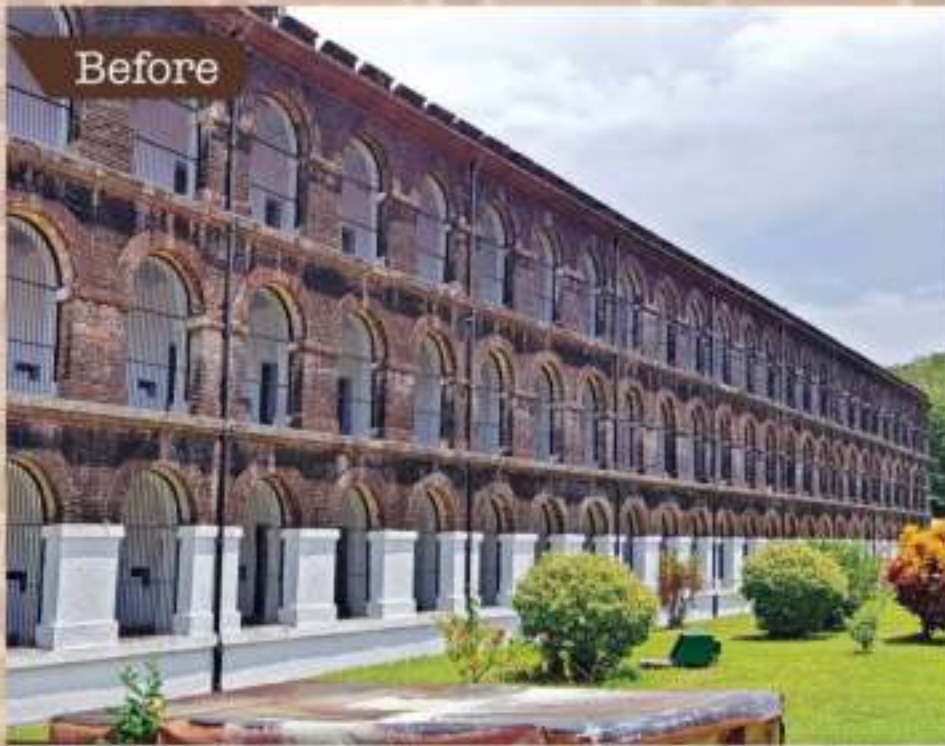
The terrace of each cellular wing has a flat terrace with merlon-like elements on the side. During the maintenance, the terrace was waterproofed, which was only a temporary solution. This caused dampness in the walls below, which further affected the walls.

Thus, the intervened layer was removed later at the time of restoration. The terrace waterproofing works were carried out afresh, and later a layer of new waterproofing was laid all over the terrace as guided by the consultant.

Thus, the terrace caused leakage and dampness in the cells and corridors and was waterproofed. Besides, the merlons were also repaired, repainted and waterproofed.

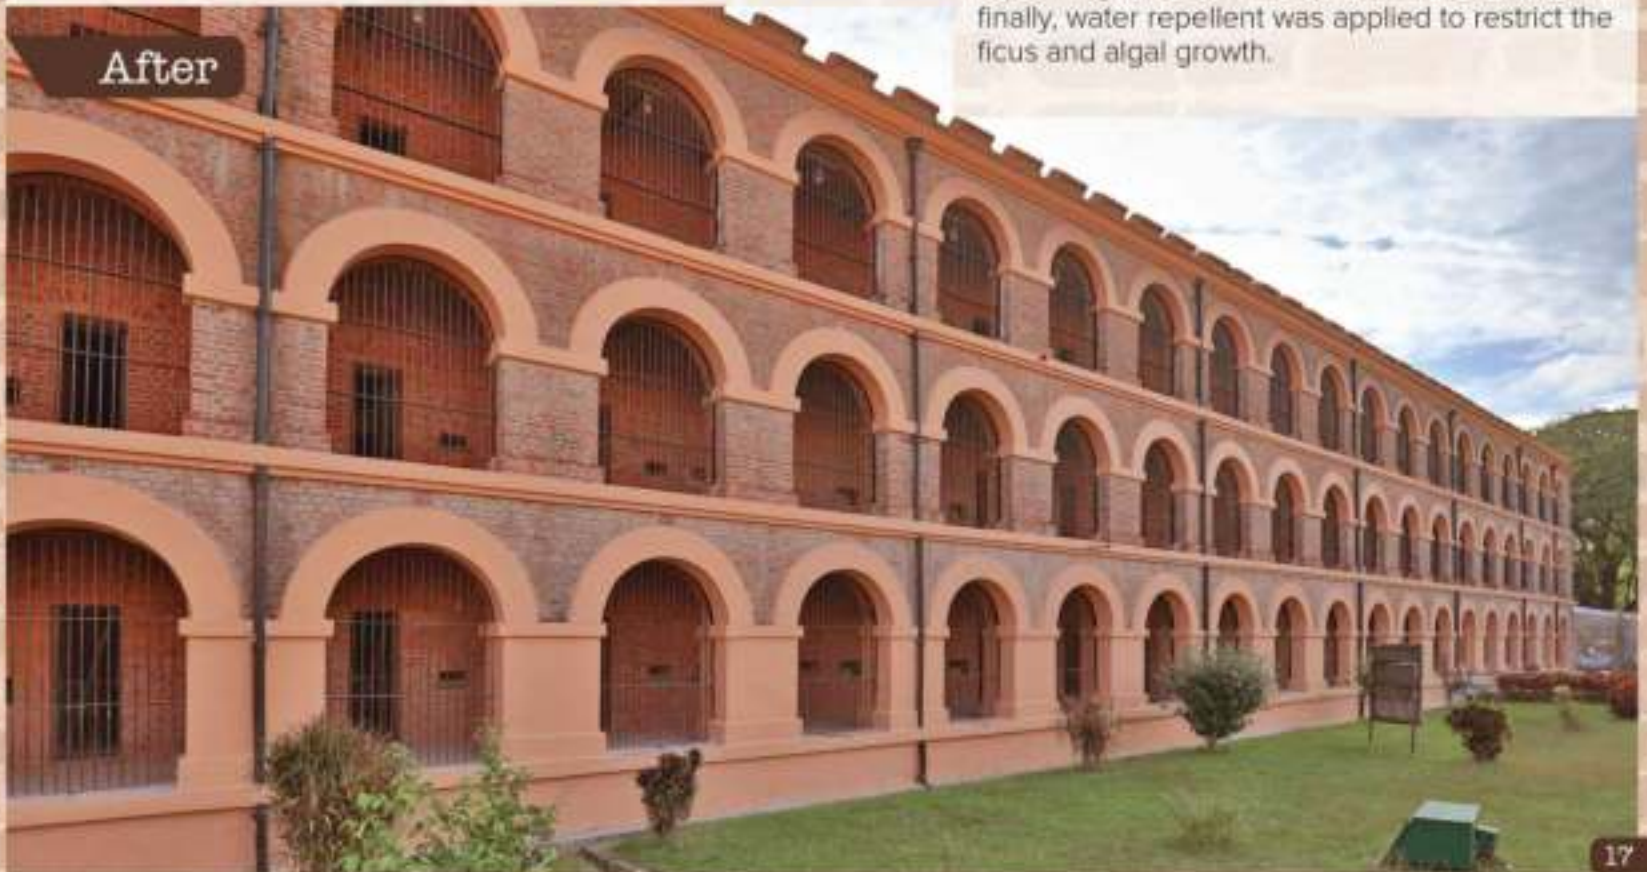
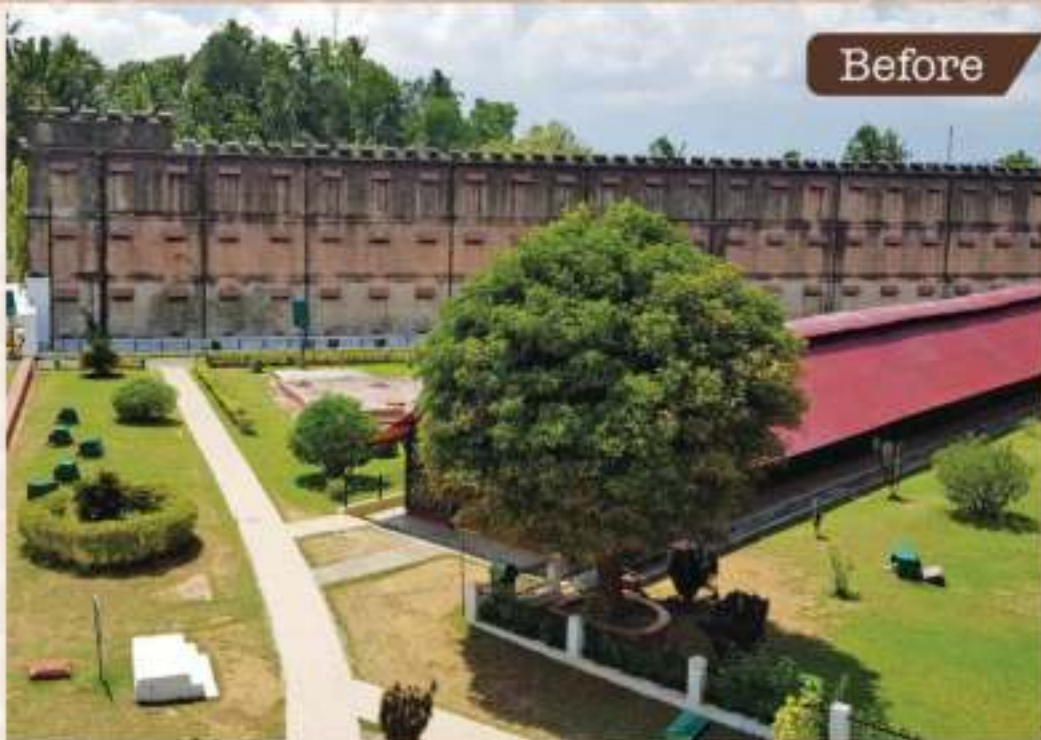
The cell wings are made up of one ground floor and two floors above. The Façade of the cells are arranged in a linear pattern, emerging from a central location. Two of the seven linear wings are part of the hospital in the vicinity. The Phase – I wings which were restored were the block on I, VI partially and VII completely. The semi-circular arches transfer the load as the structure is load-bearing. The arches form a distinctive façade feature of the structure. These arched openings also act as a semi-open barrier to allow the exchange of air and light. These arches have M.S. grills for safety purposes, which were rusted and were restored by applying an anti-corrosive coating and later black paint. Prior to restoration, the façade had black crusts all over, which was a result of algal growth.

At the time of restoration, the façade was cleaned thoroughly with the help of water jet mist and consolidated with ethyl silicate. Later, repointing was done in between the bricks, and finally, water repellent was applied to restrict the ficus and algal growth.

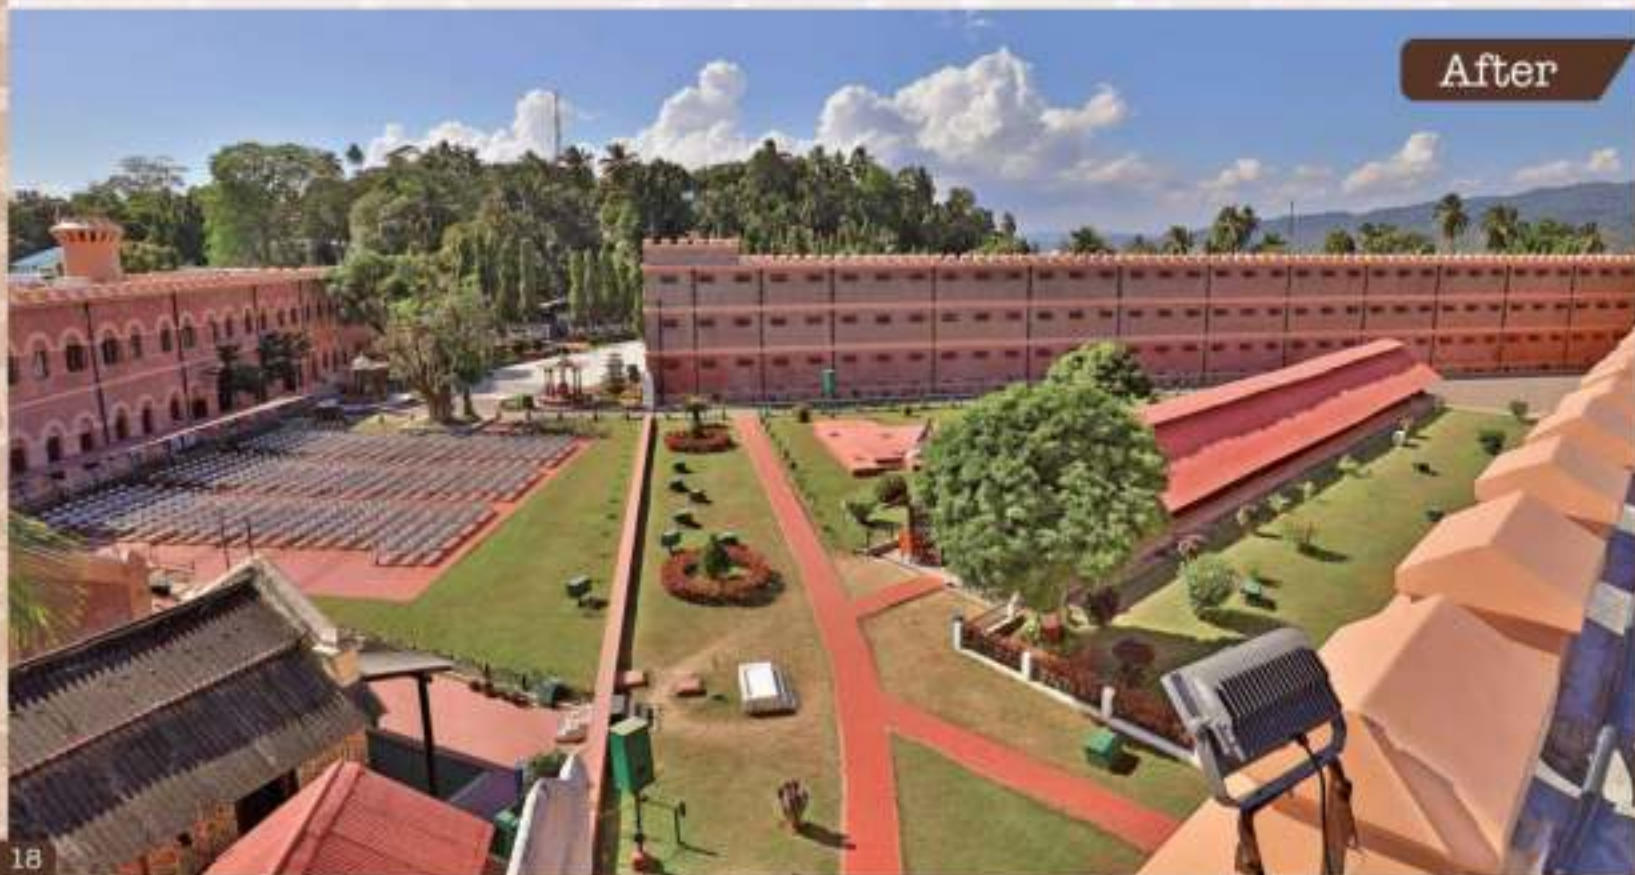
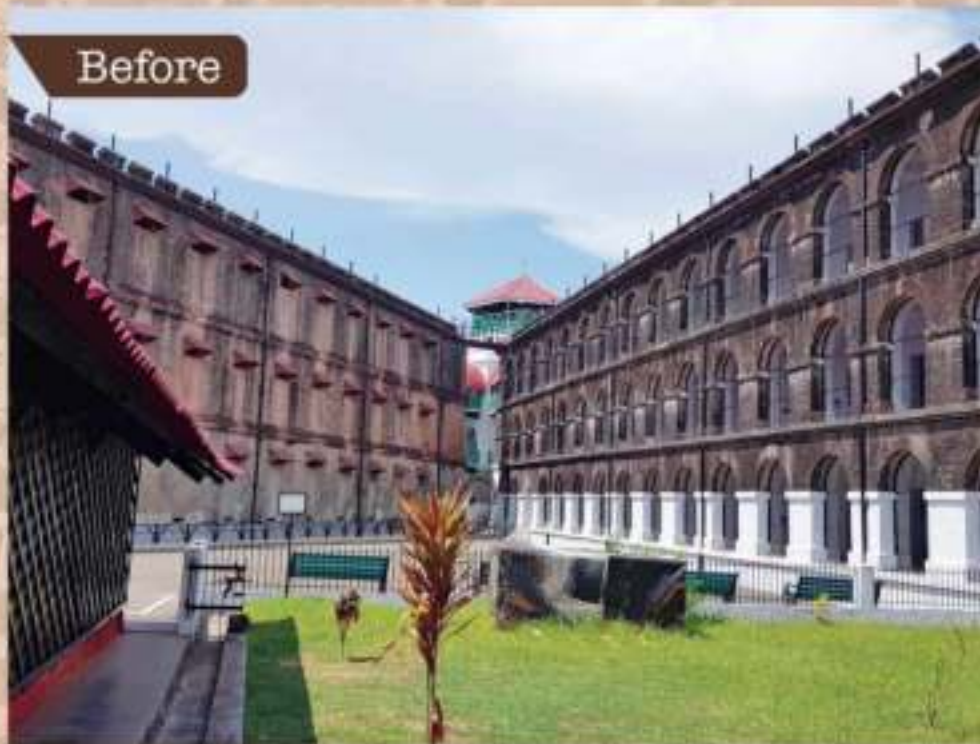
With time, the weather took a toll on the structure, as, geographically, the islands receive heavy rainfall and the corridors act as a barrier. Semi-circular arches and jack arches support the entire stretch of the corridors.

The wings of the Cellular Jail have a typical liner style, stretching in length for over 40 m. Constant exposure to the heavy rains had caused algal and ficus growth, which further, after drying, caused black crusts all over the facade of the cell wings. The cornice was re-plastered as observed from the archival image.

The façade was treated to make it water-proof, and the *chajjas* were also replaced. The roof of the workshop area was repaired, which stretches over a length in a linear way.

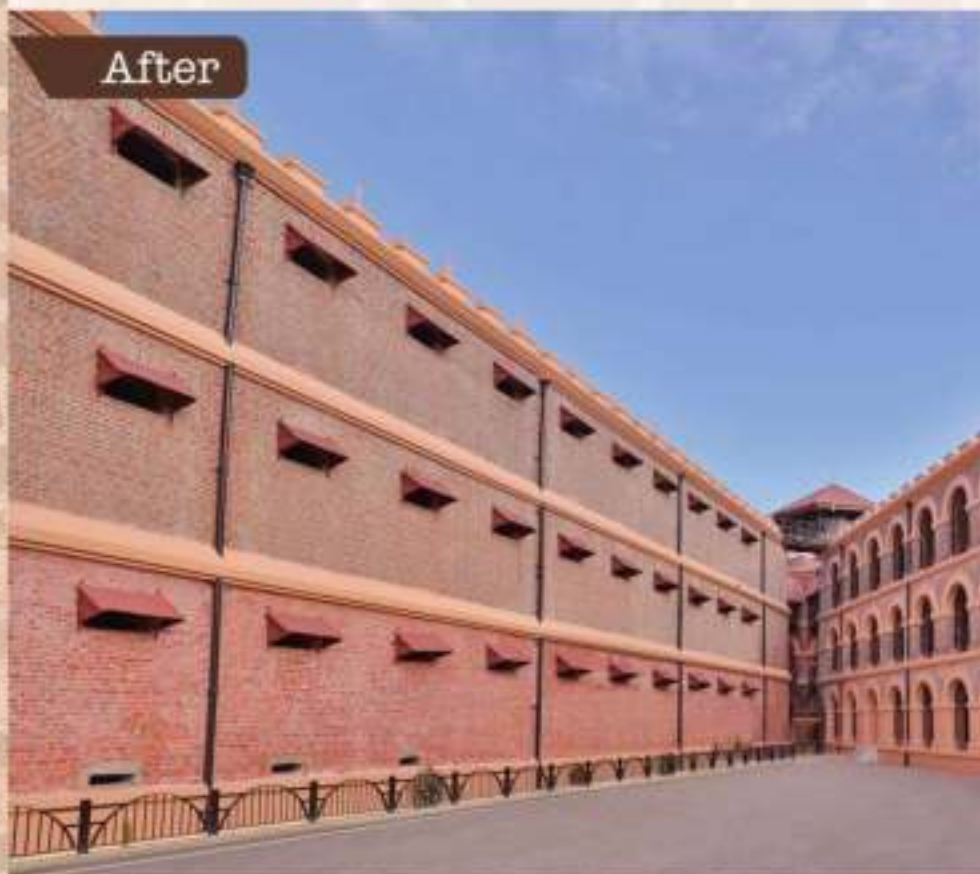
The Panopticon architecture of the prison where the wings radiate outward from the central watch tower. The image shows a junction between two wings, one behind the other. The central tower is visible in the background. No two wings face each other, and each of the seven wings radiates out from a core. Prior to the façade restoration, the façade was in very deteriorated condition with a thick layer of black crust present all over the façade. The heavy rains all over the island caused the bricks to soak up the water and cause dampness in the passage as well as inside the cells.

As the restoration began, the black crusts all over the façade were gently cleaned with water jet mist and a brush. The consolidation of the exposed brick facade was necessary and was done using ethyl silicate. Originally, the façade must have been exposed bricks as the purpose of the building was to only keep the inmates. Thus, after exposing the original brick layers, the cornices were plastered. This plaster and the brick pointing were done using lime mortar to replicate the original layer and to retain the authenticity.

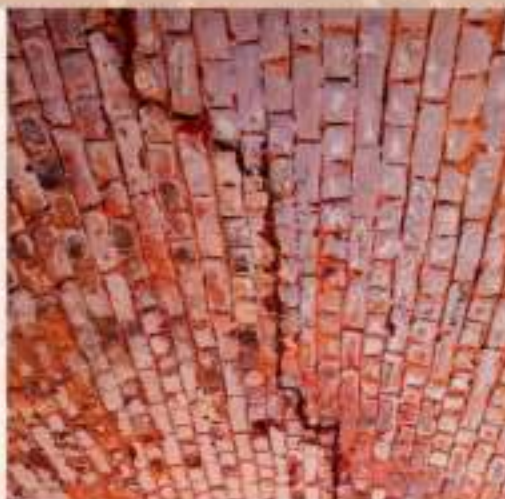
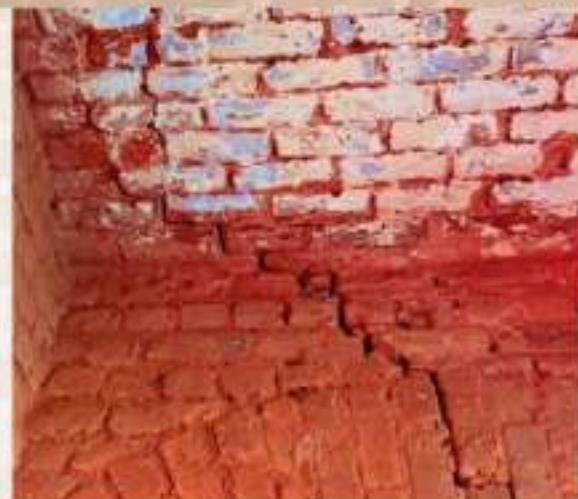
The cracks caused in the vaulted brick roof were a severe concern for the cell.

Such cracks were stitched with the help of S.S. pin stitching and strengthened with helifix.

The bricks were retrofitted and consolidated using ethyl silicate.

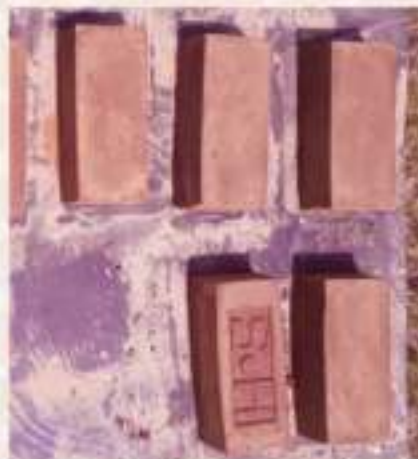
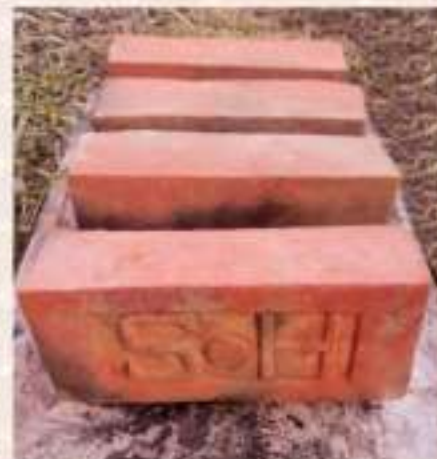
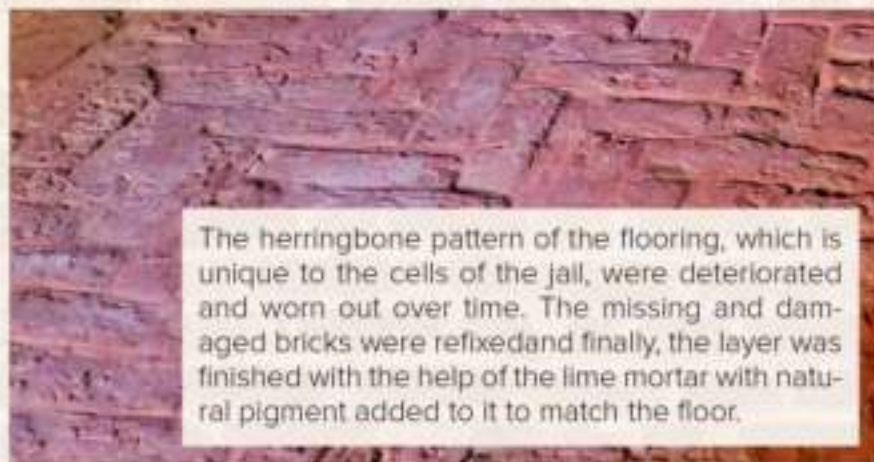
An attempt was made to manufacture the brick from the local soil and later baked. The size opted was 190 mm x 90 mm x 90 mm, similar to the old brick sample. This experiment enabled us to understand how the bricks were traditionally made out of which the entire Cellular Jail was constructed.
