"Azadi Ka Tirth Sthal"

Andaman & Nicobar Islands

Our Story...

The extensive task of restoration and repairs of the cellular jail was undertaken by Andaman P.W.D. under the guidance of A.S.I. and Stambh Consultants. Proudly, "Savani Heritage Conservation Pvt. Ltd." received the opportunity and responsibility for the restoration of the national monument. We have strived to restore more than 150 heritage monuments and are obliged to work on a historic monument of national importance known as "Azadi Ka Tirth Sthal". It is the presence of the visitors that brings value to the heritage structure, ultimately leading to the efforts to maintain and care for the structure. We at Savani Heritage Conservation Pvt. Ltd. believe that restoring Cellular Jail is equivalent to paying homage to freedom fighters that were once imprisoned and have strived to gain independence for India. With this memorial, future generations of independent India will always remember their forefathers as heroes of freedom, and the saga of their sacrifice will be immortal for ages.

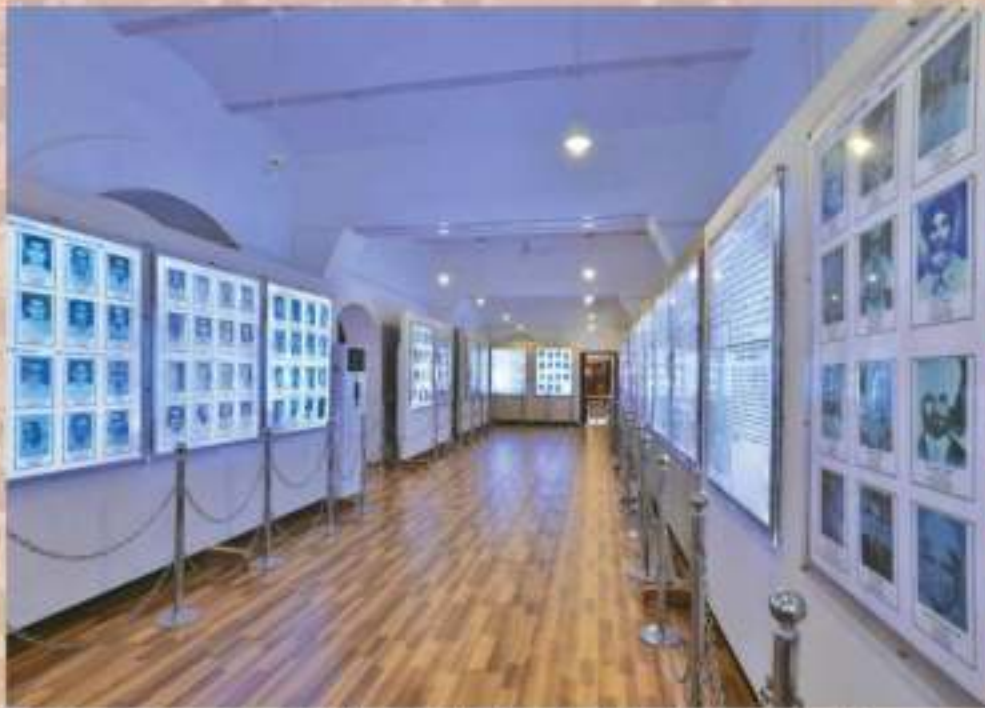
The herringbone pattern of the flooring, which is unique to the cells of the jail, were deteriorated and worn out over time. The missing and damaged bricks were refixed and finally, the layer was finished with the help of the lime mortar with natural pigment added to it to match the floor.
