Aligarh

Muslim University

I.e. The Taj, Mumbai, Royal Structures in Bhuj, Sardar Gate in Junagadh, ancient Fort in Surat... was more than enough to entrust the responsibility of AMU. Savani Heritage Conservation Pvt. Ltd., took up the task head on and executed the project in a span of _18 months. The restoration work was initiated by the AMU trust with a view to retain the legacy and pass it on as a heritage. This task of restoration would not have been possible but for one person Vice chancellor of the AMU who made remarkable efforts in generating funds and took the initiative to ensure that no stone is left unturned in getting the AMU campus up and ready for generations to come. The restored AMU Version 2.0 today is a mark of never dyeing spirit of education and a source of Knowledge and Wisdom.

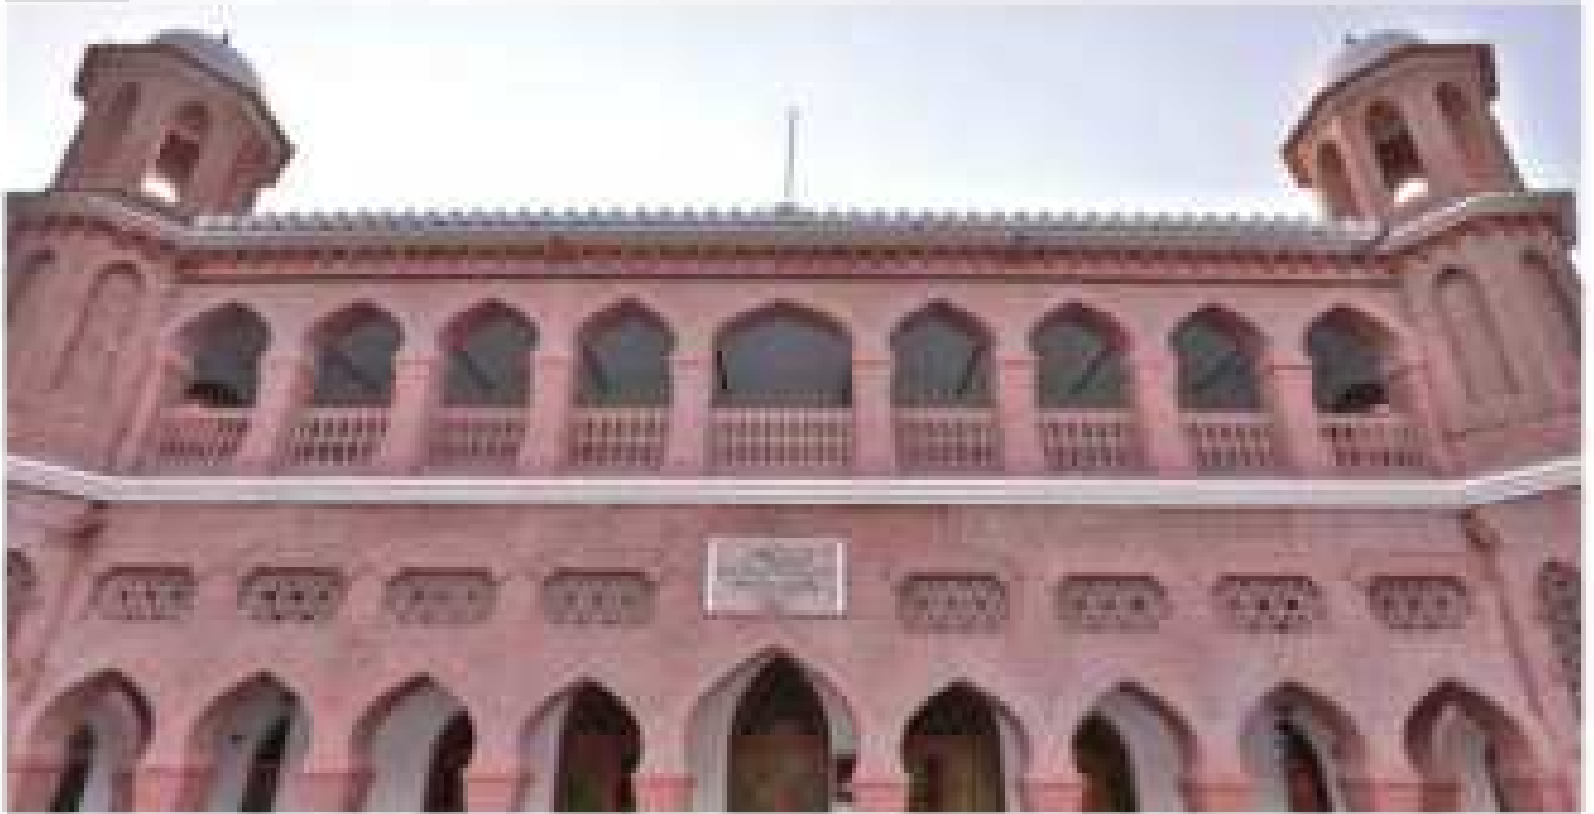
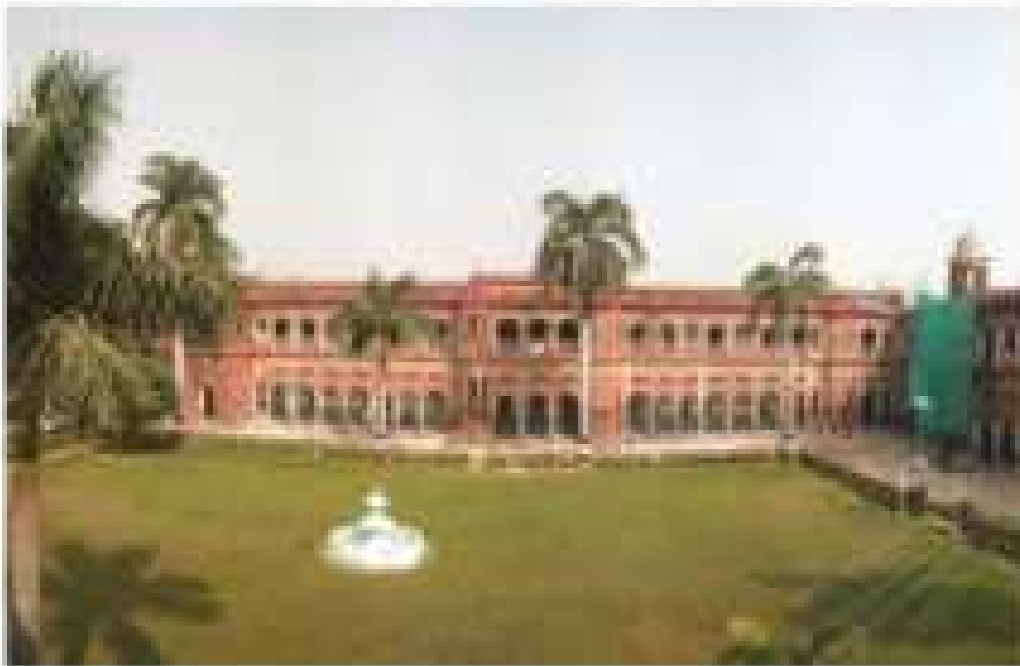
The restoration work of Library was one of the most complex and intense task at hand as the building is huge and it needed a specific finish to keep the decorum intact. Keeping to this view, the restoration work was initiated. The 'C' shaped building displayed a close relation with the prevailing local weather conditions, overlooking lawn on the foreground the facade was restored and repaired with necessary structural and aesthetic intervention. The key architectural elements used were brick and lime that highlights the now improved face of the library building.

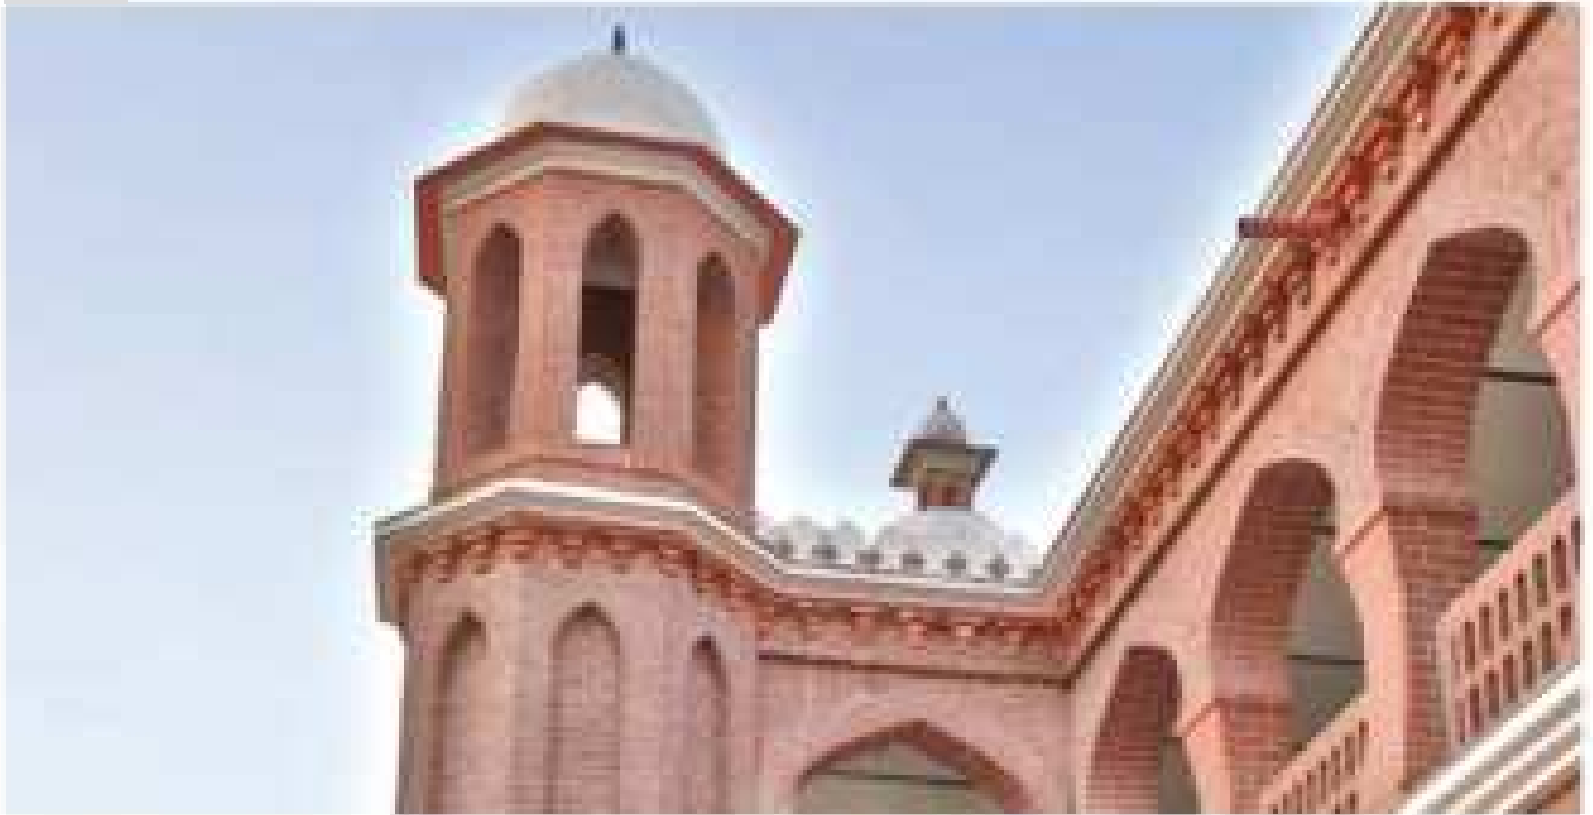
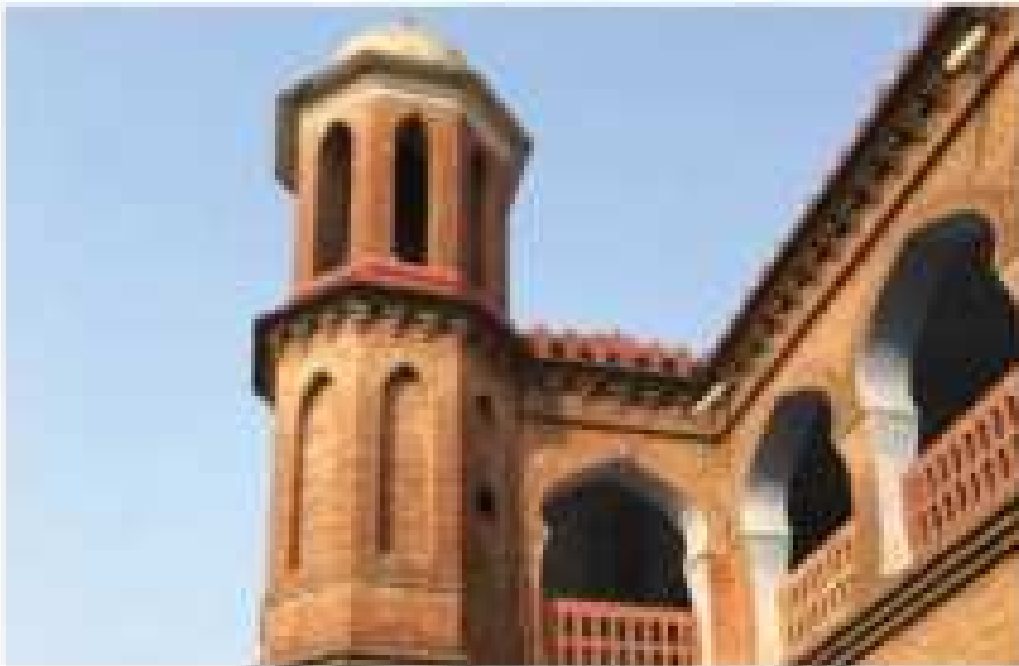
The minarets as you see in the picture are distinctly visible and stands tall along with its architectural details, these were repainted in contrast to create a character and make them glow out as opposed to the being a hidden element prior to the restoration.

The dome of the minaret was restored with a layer of lime and the old dome finial was refabricated and redone meticulously. Extreme care was taken to blend the water outlet/snout with the facade to retain its character without affecting its workability or changing its original position.

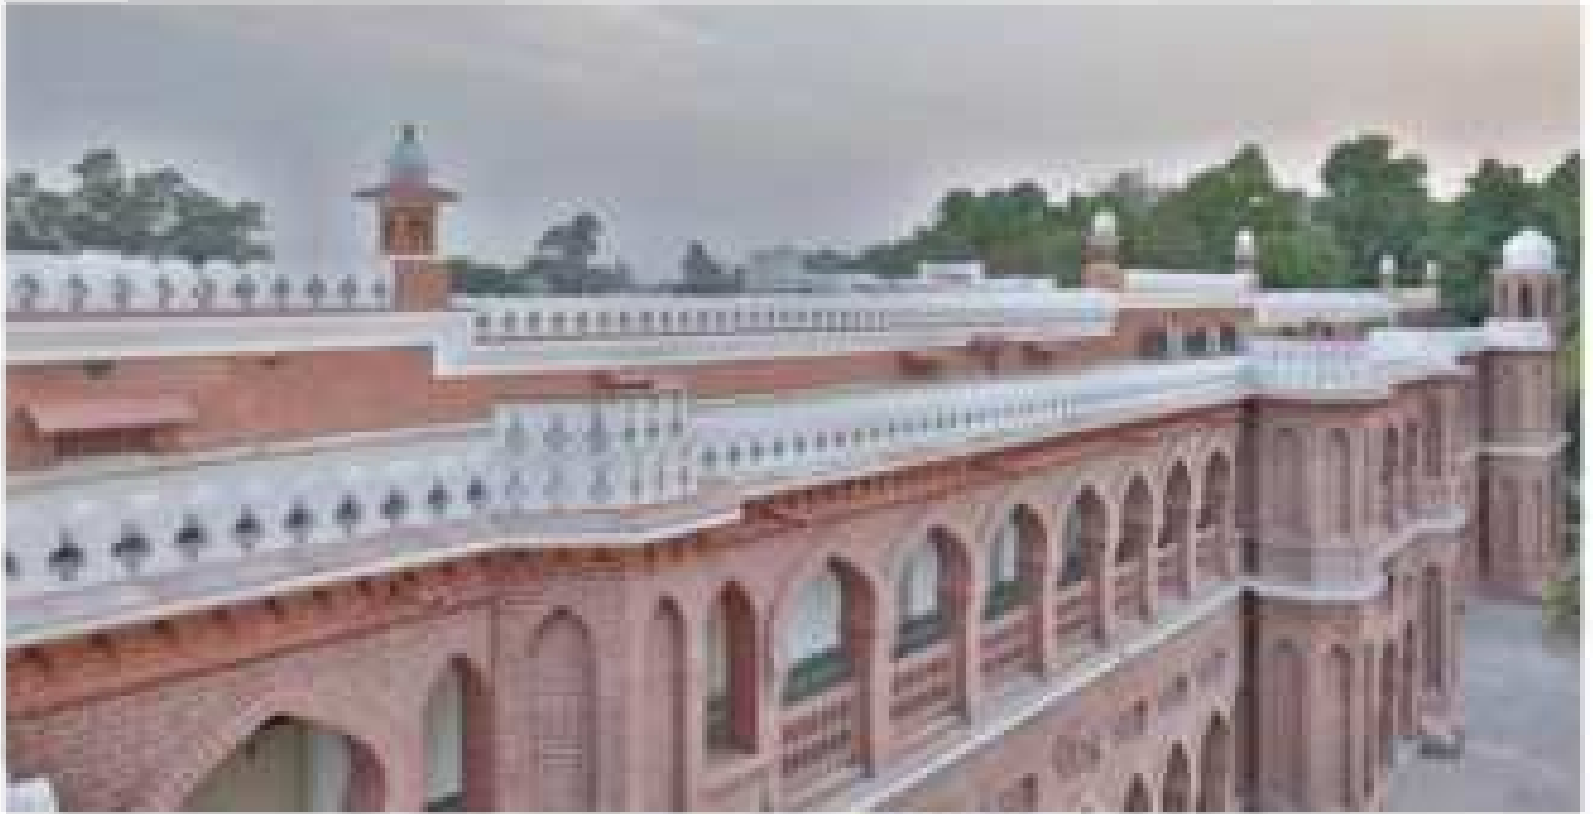
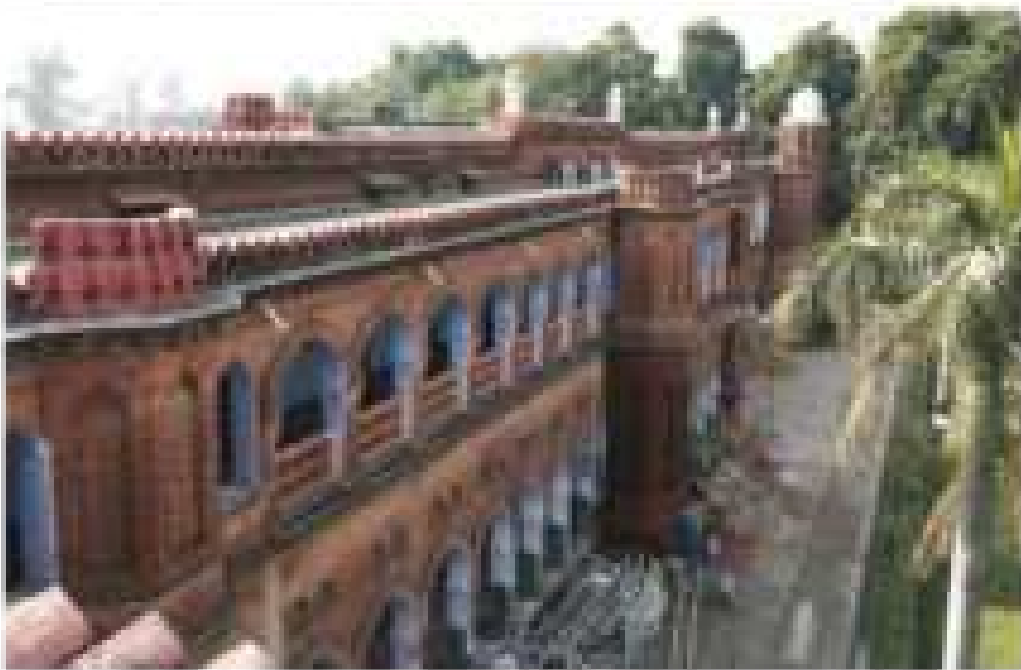
The series of merlons is a characteristic element which holds the building visually in a frame. Use of parapet of merlons over the minarets makes the minarets appear tall and sleek. The smaller domes over the turrets were a later addition with a view to balance it out with the domes of the minarets. The turrets marks the difference of layers and the top floor of the building is lined up in sequence of merlons at various intermediate levels. The entire facade was treated with waterproofing techniques to avoid further damages to the building in the future.

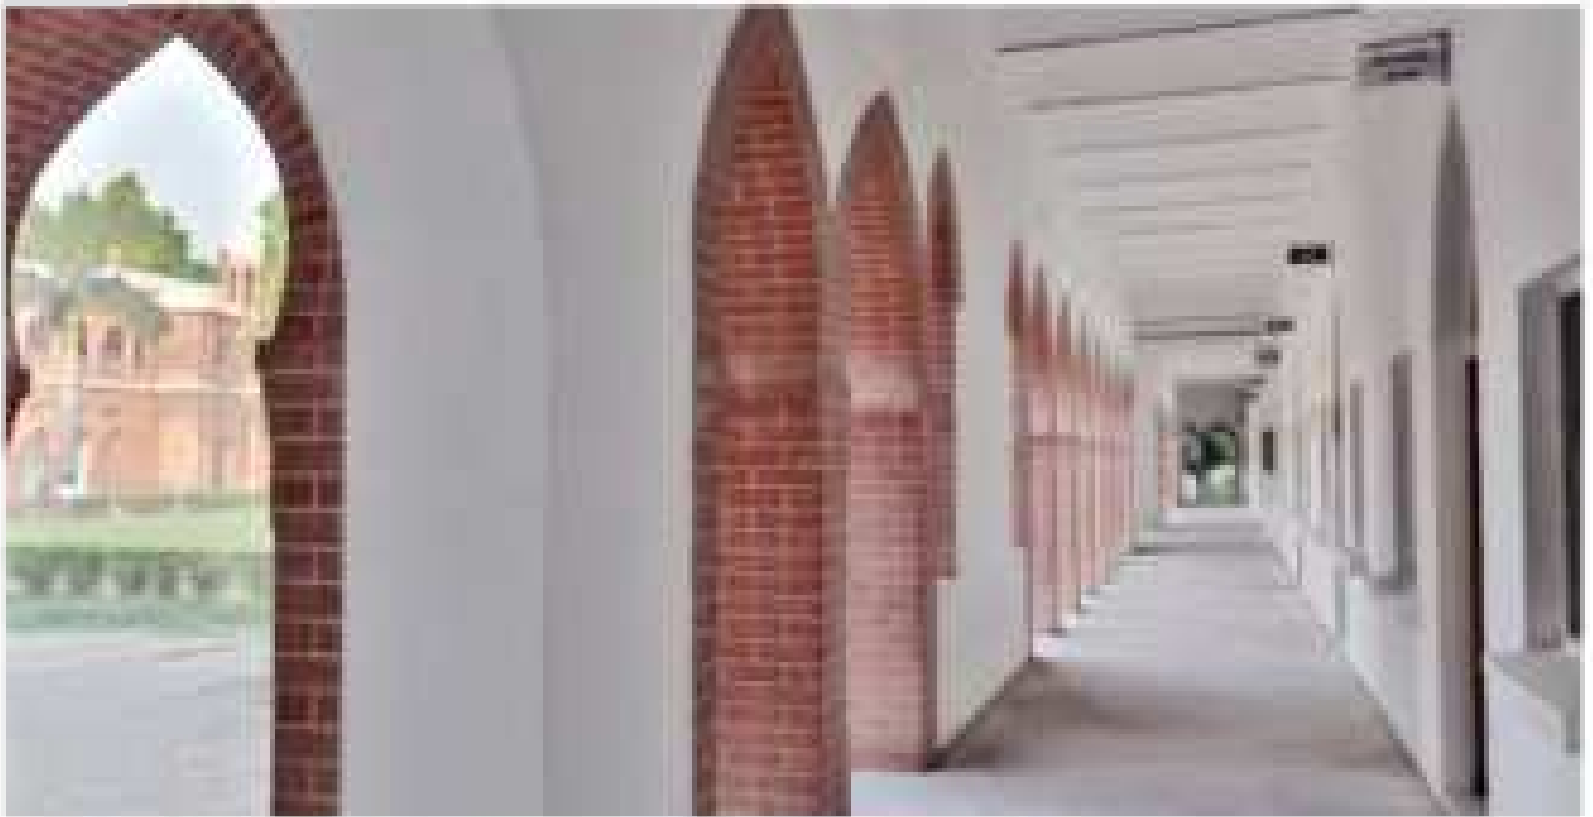
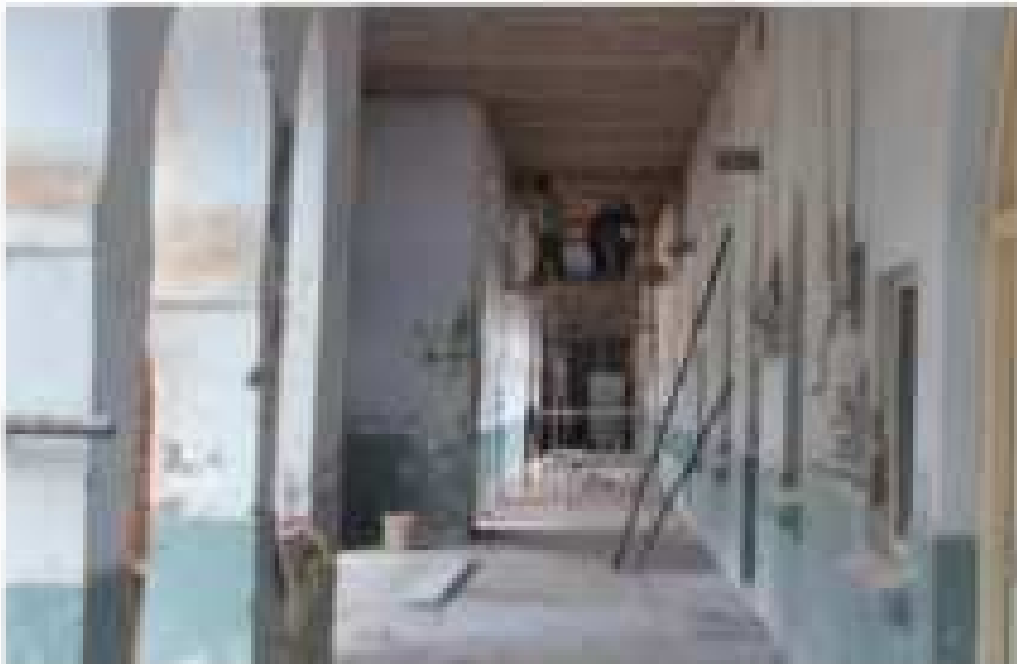
The building displays use of jack arch slab. The edges of the slab needed thrust and were reinforced with iron 'I' sections using flat M.S steel plate to ensure additional structural strengthening. The walls were given extensive lime finish over the original layer.

The lime plaster being a sustainable material was used to allow breathability. A two brick thick layer of brick from the inner side of the corridor was exposed to break the whitish monotony of the lime wall to ensure proper finishing to the layout.

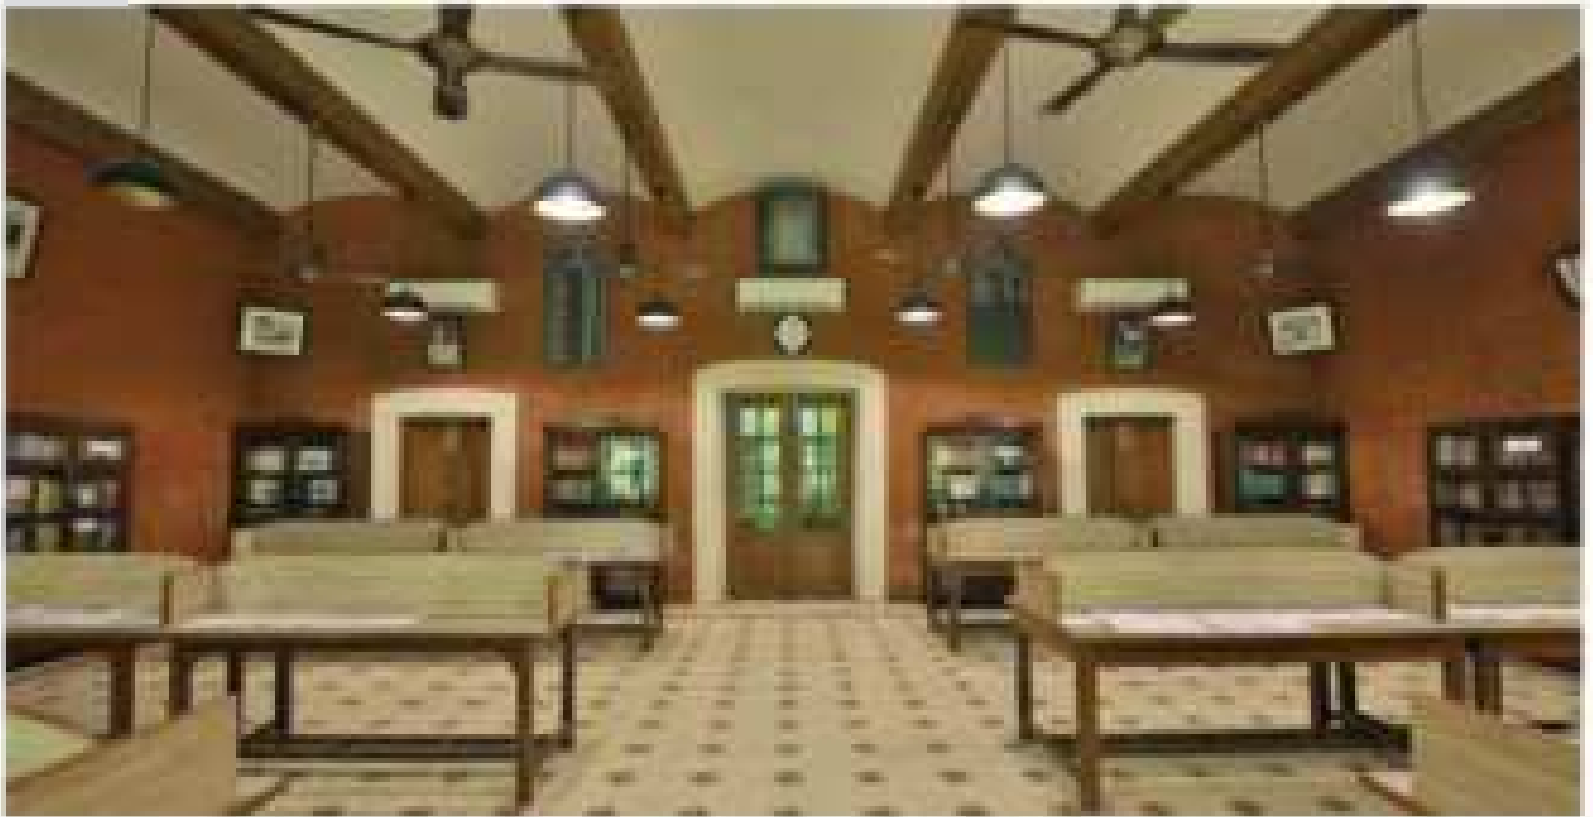
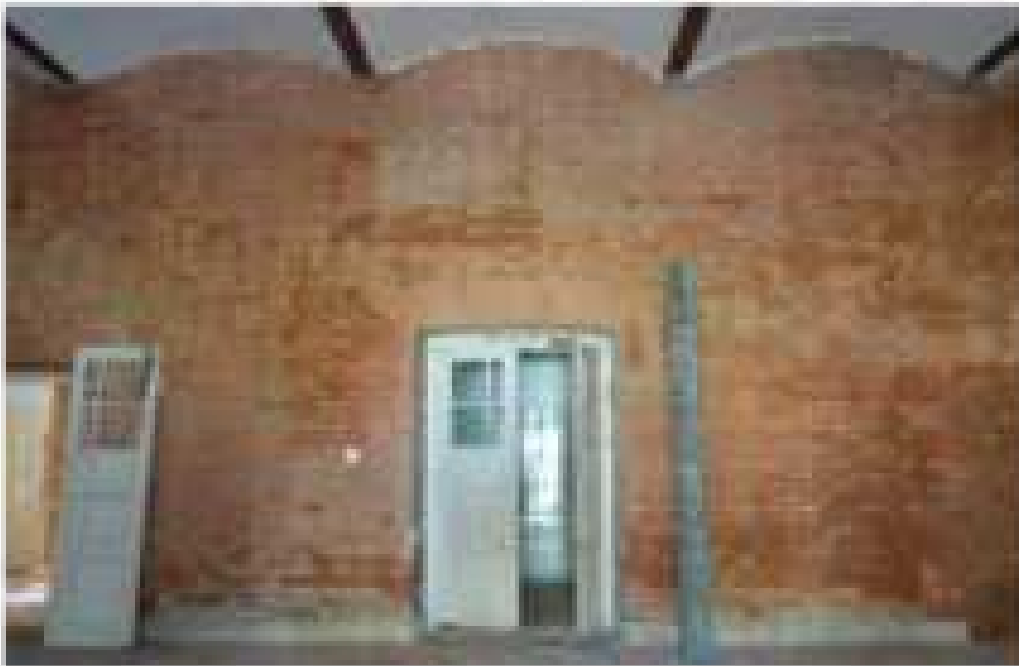
The library was brought back to its older charm by adding up lamps, reading desks and furniture. Out of total three doors, one was blocked and hence the same was released from its brick stacking facilitating a new three way access to the library. The doors and window frames were replaced completely as they looked worn out and were redone using Burma Teak. Also, the flooring was redone with new tiles to compliment the overall décor and to ensure longevity.

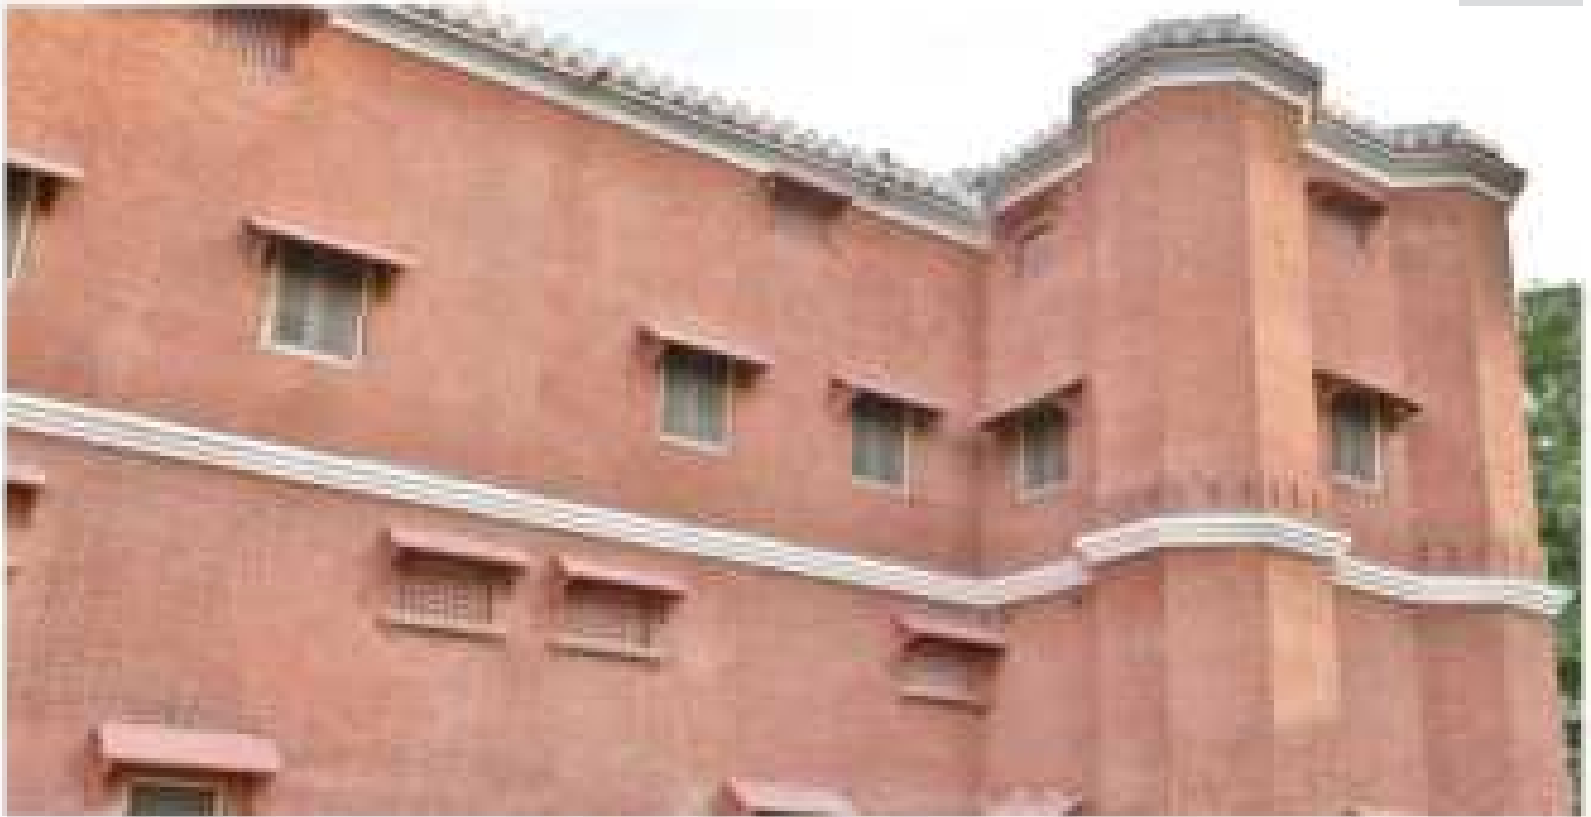
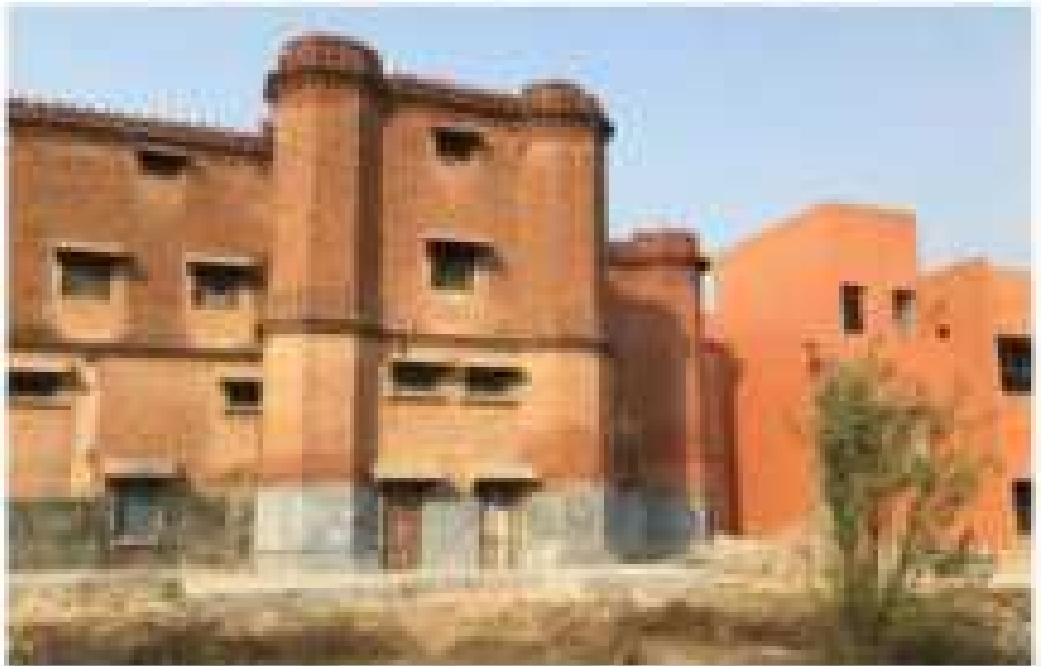
The exterior wall on the rear was waterproofed and cleared of biological growth and the wall was cleared of the black crusts. The cement layer put up at the rear door entrance as dado was meant to break the seepage of water. This cementitious layer was removed and the entire rear facade was waterproofed.

The windows were topped with chajja and covered with mosquito net. The lime washed cornices were restored and were given extended lime plastering.

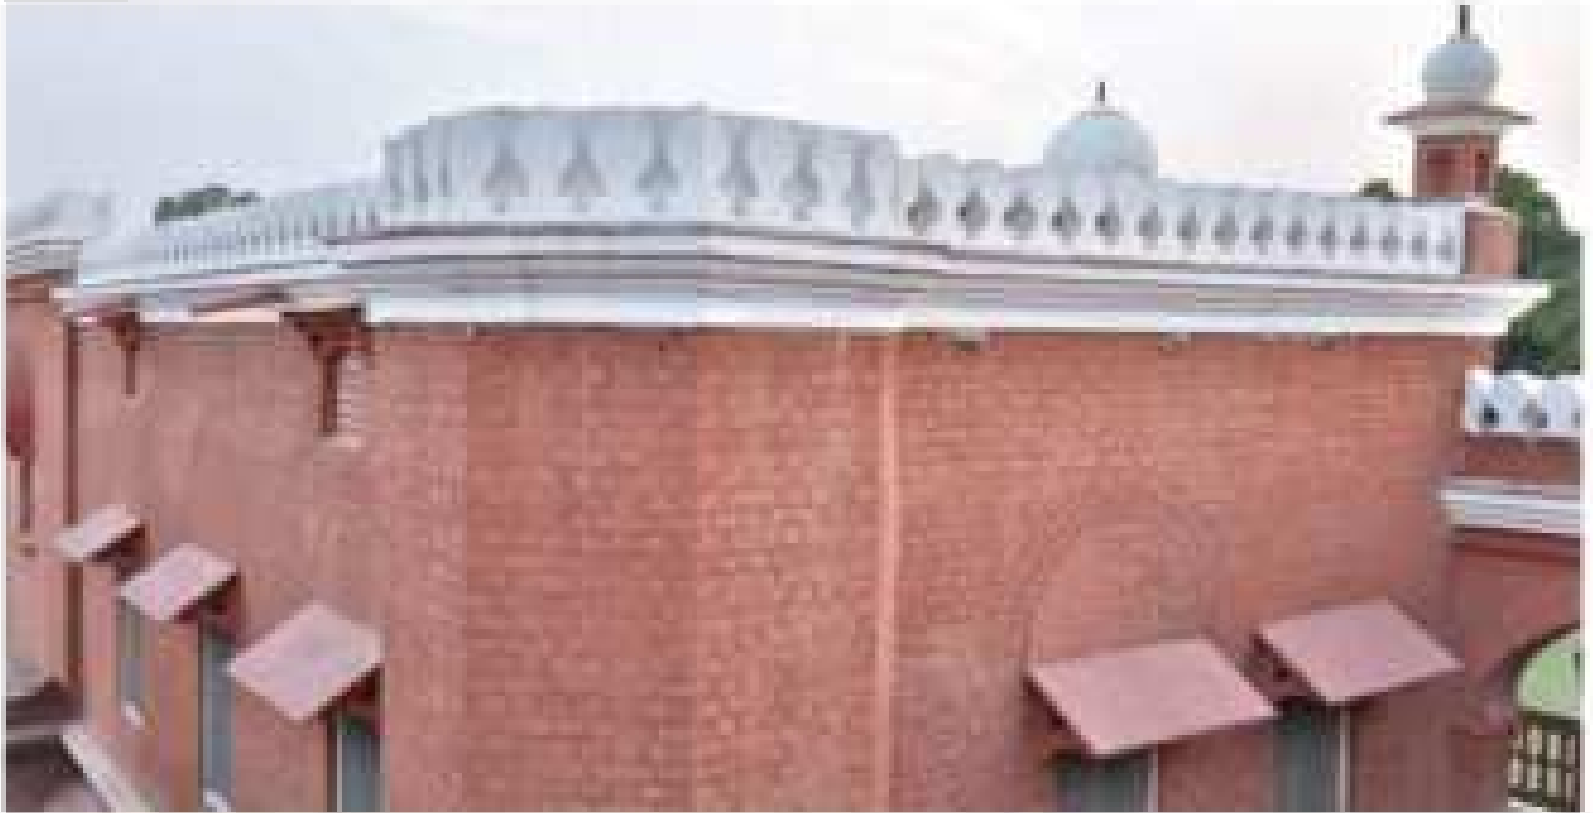
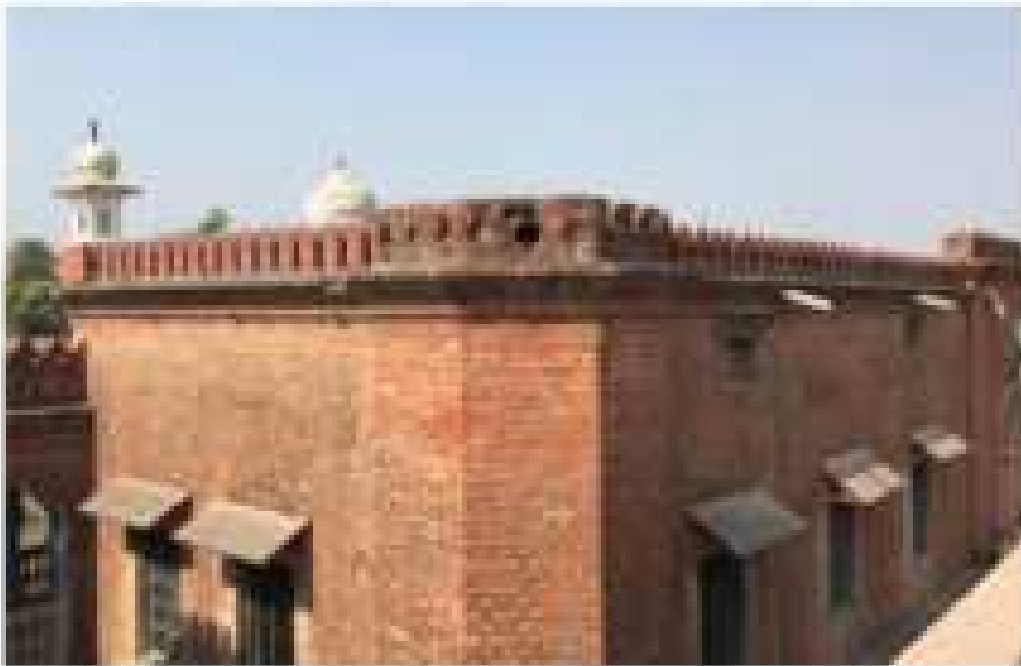
The blackened crust of the wall due to water seepage was repaired and waterproofed with pointed mix of surki and lime in the shade of red. The non-uniform design patterns of the merlons along the terrace lining were made uniform and the damaged merlons were mended back to maintain its original state.

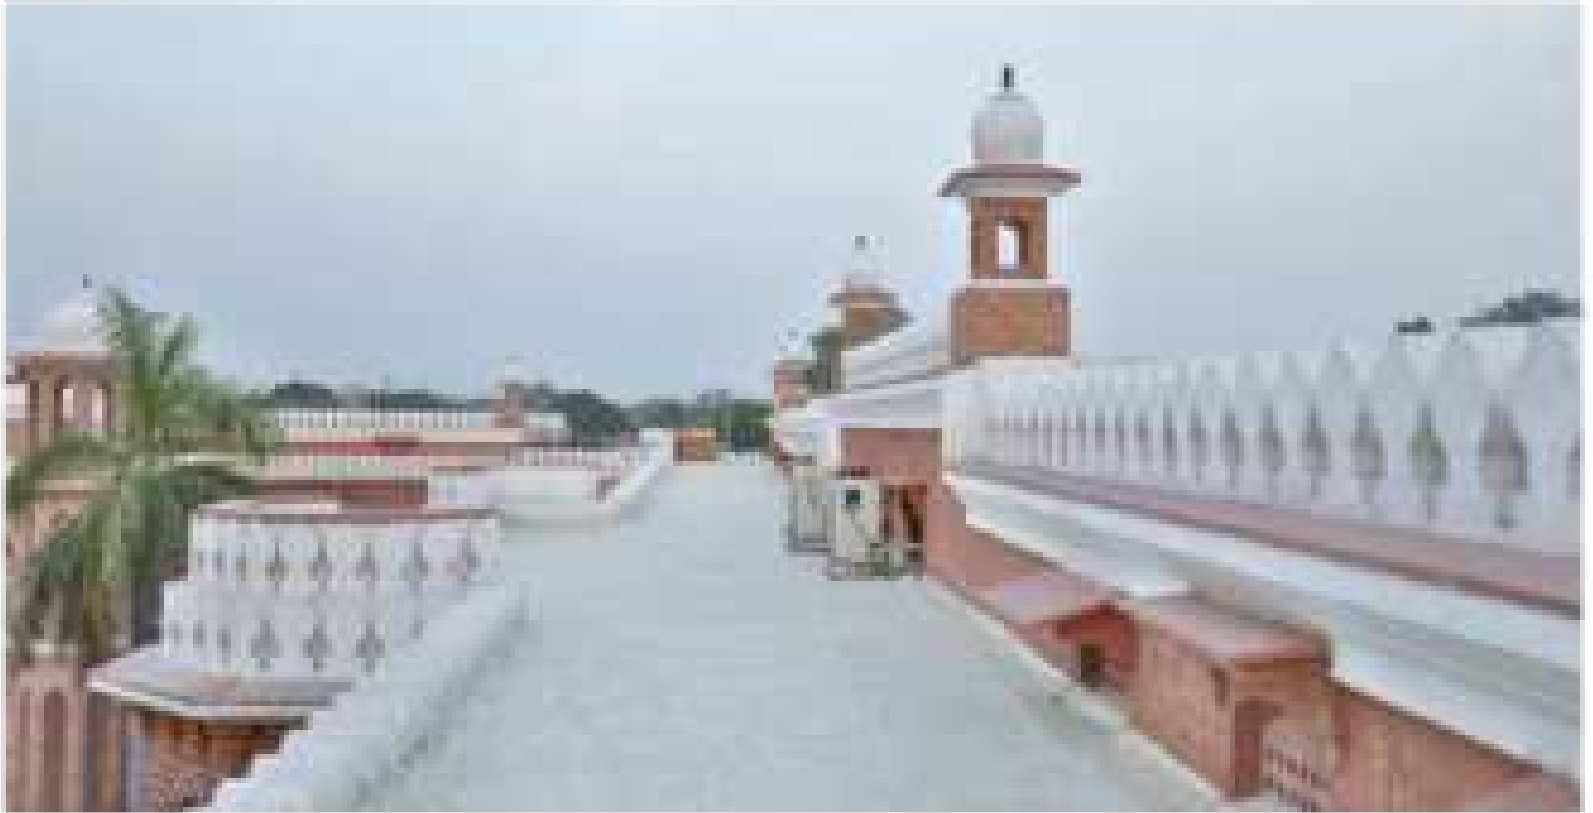
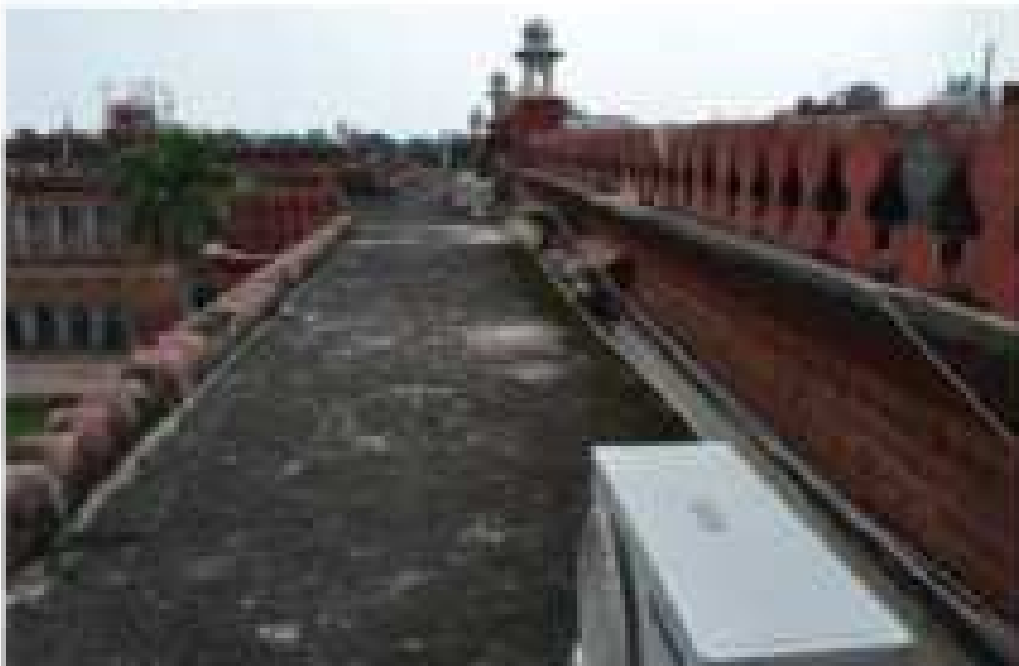
The terrace was treated diligently with lime water proofing to make the slab watertight. The glazing was layered with white tiles to accord harmony with the building. Moreover, the merlons were covered with a layers of moss in its niches and the broken ones were repaired. The overall historic feature, characteristic value and other salient features of the building were kept intact with thoughtful application of restoration practices and philosophy.
