SAVANI HERITAGE

Restoring a Rare Architectural Genius

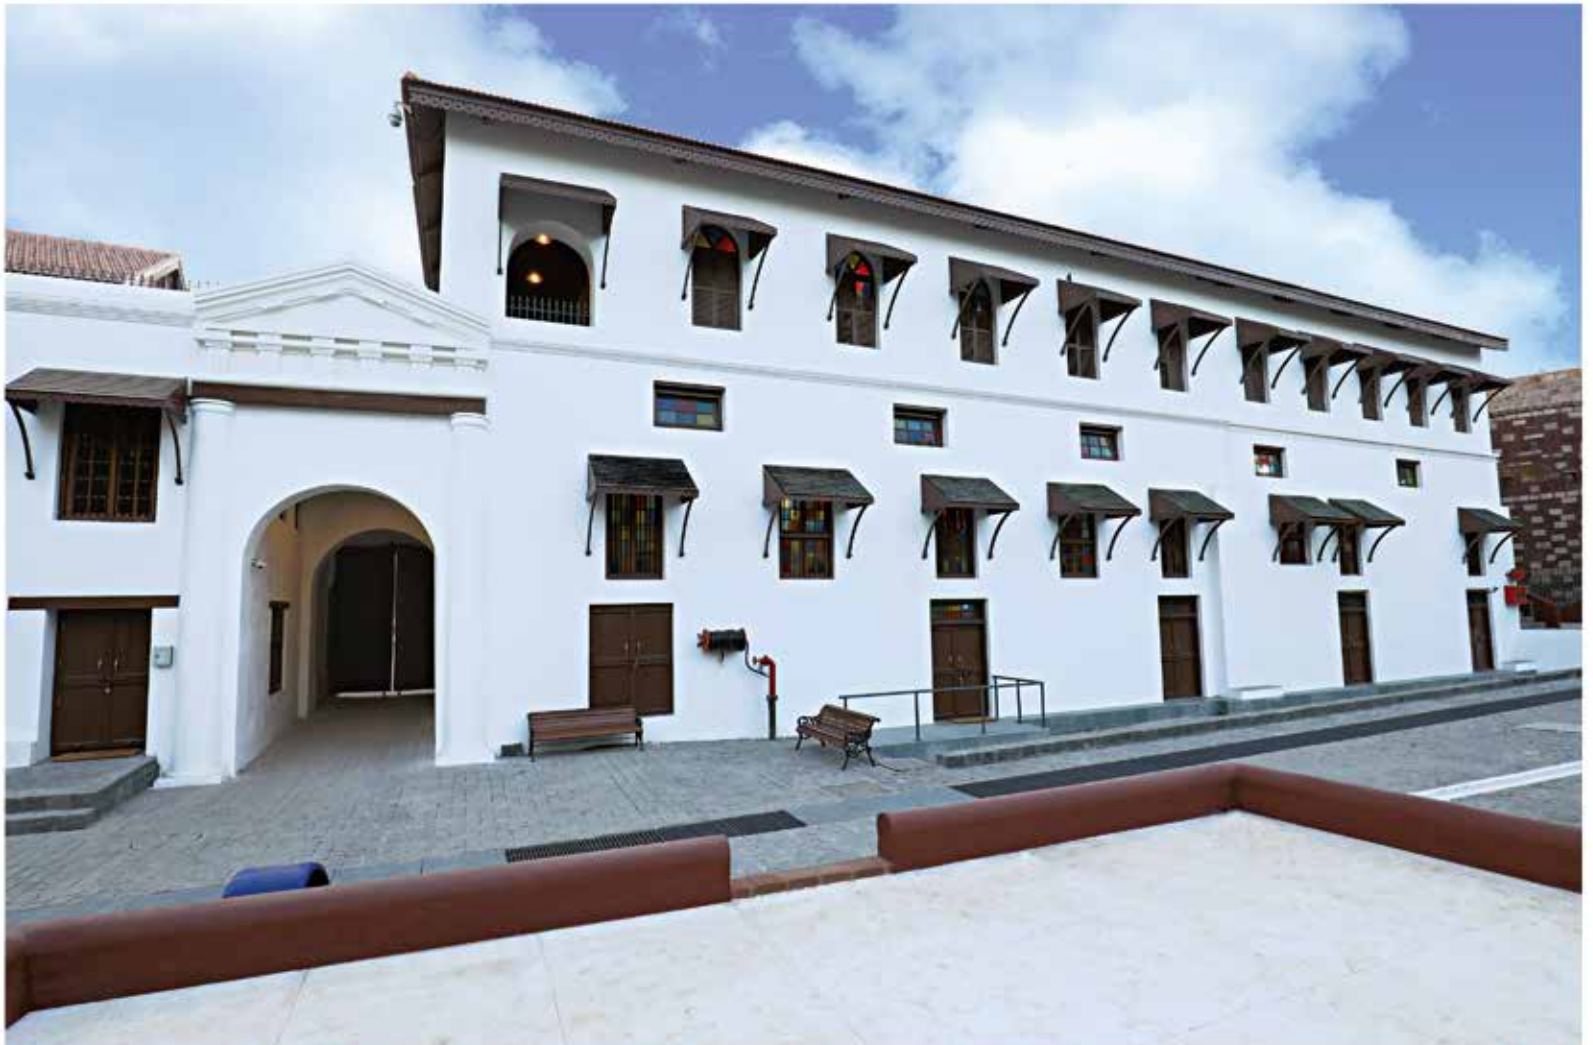
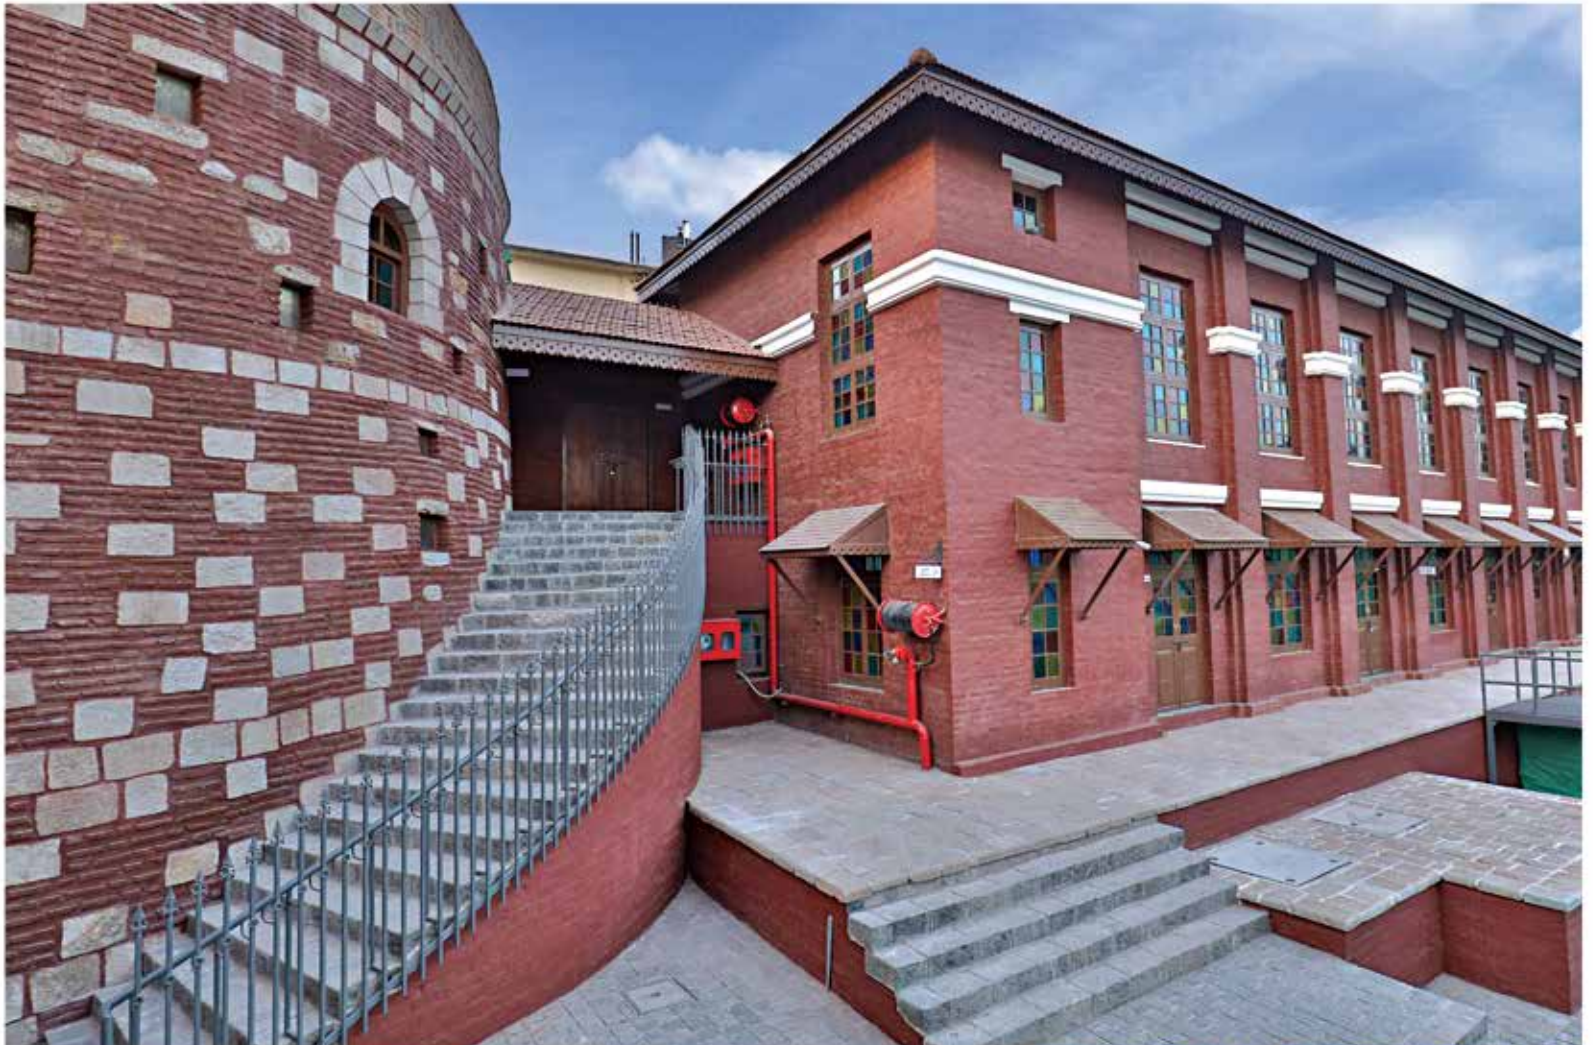
The interiors and exteriors add to the charm of any structure, surat fort needed a fair but of refurbishing as the exteriors looked barren and ailing. It needed scientific and at the same time artistic treatment to restore the history. A lot of lime, jaggery syrup was used to bind the structure again. Insensitively done plaster was removed. Removal of topmost layer of floor revealed a new floor level. The windows were refitted with wooden shutters, stained glass & overhangs. The brickwork was restored with proper finishing using arais plaster.

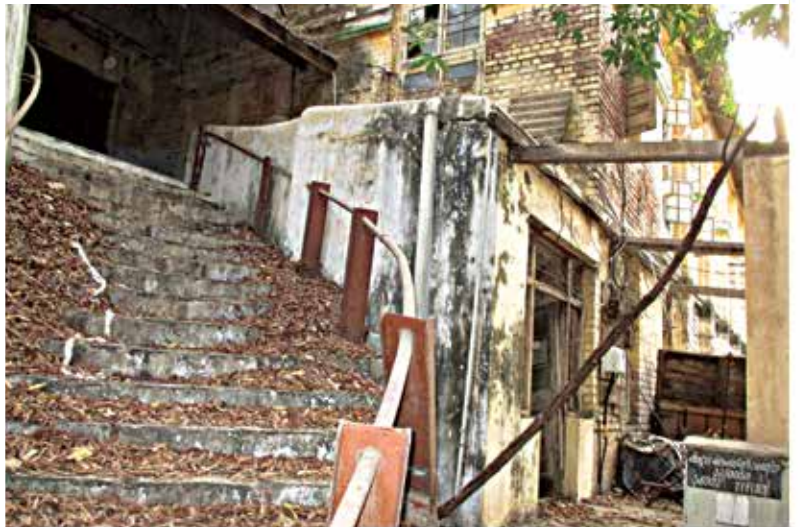
It was highly evident that the work volume was huge and being a medieval monument it also required a deep understanding of structure and material used then. After a lot of research, the work began to bring alive the beauty of exterior. It needed a lot of painting, polishing and pointing. The external paint and plaster was scrapped off to show case the brickwork that has now been restored. It required high degree of pointing and finally it was coated with weather proofing layer. The windows were refitted with wooden shutters, stained glass and overhangs.

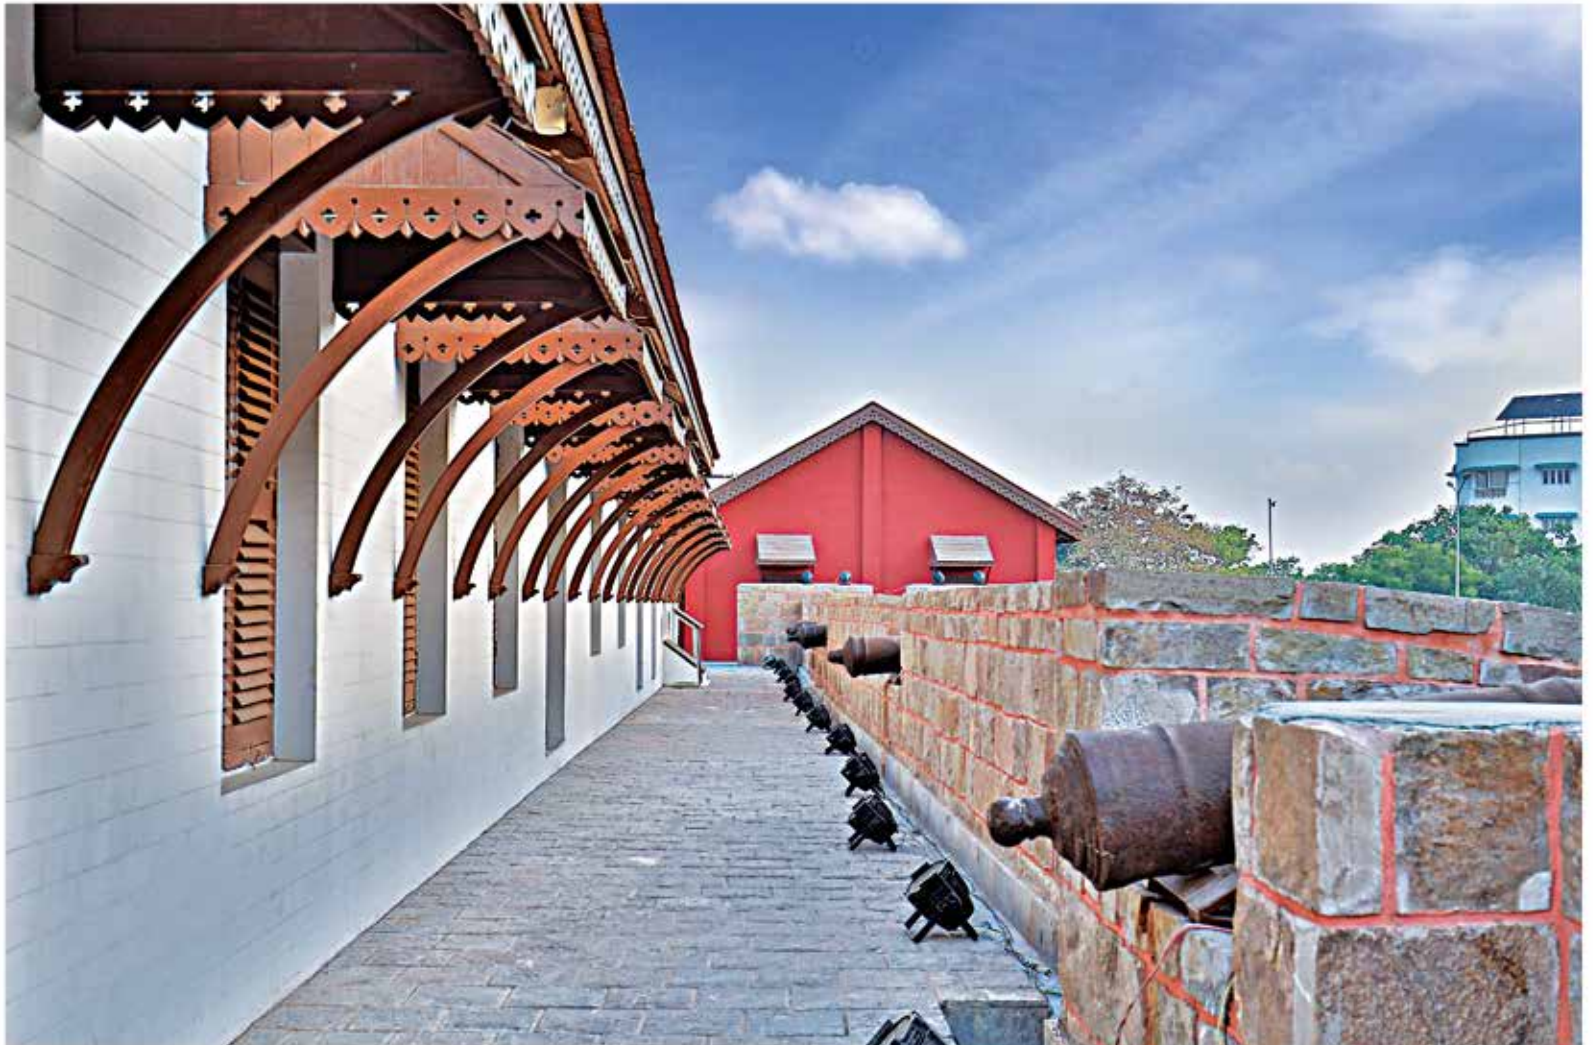
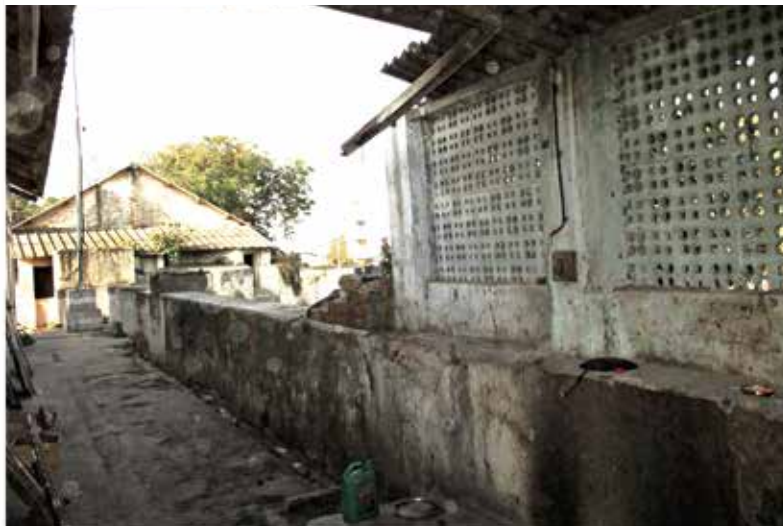
The eastern ramparts had been covered and encroached to become bathrooms for the offices housed here in the late 1990s. This took away fair share of its beauty as originally they were meant for some other purpose. It was originally meant for gun pockets, these bathrooms & offices were removed to reveal gun pockets. It has now been restored fully to the original stone construction. Each gun pocket has been substantiated with canons that were procured from all over the city. Surat fort now has the intrinsic feature that grabs the eyeballs and that is the use of canons at the terrace, immaculately fitted between the walls that make it a treat to watch.

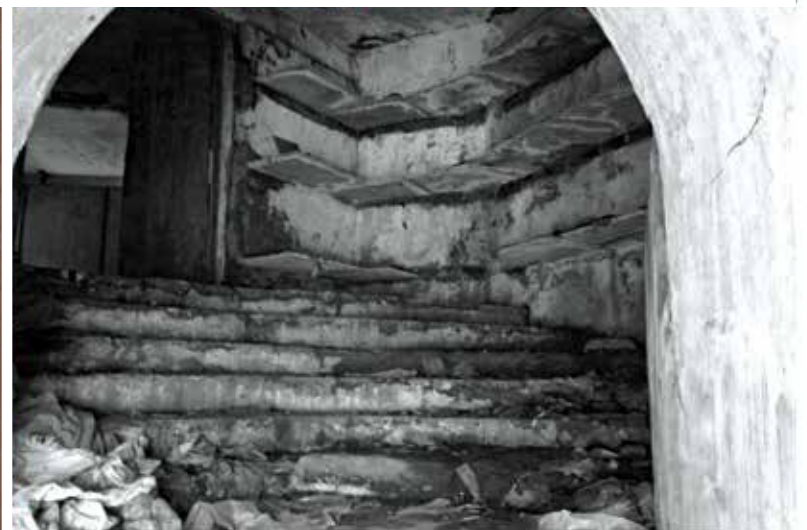
It was hard work at the archway was almost invisible after paying great attention to details and removing several layers of plaster, the real brick work was revealed which was the charming factor. The bricks required treatment and maintenance of pointing and weather proof coating which was given to restore its shape and it was also ensured that it remains visible to catch the beauty.

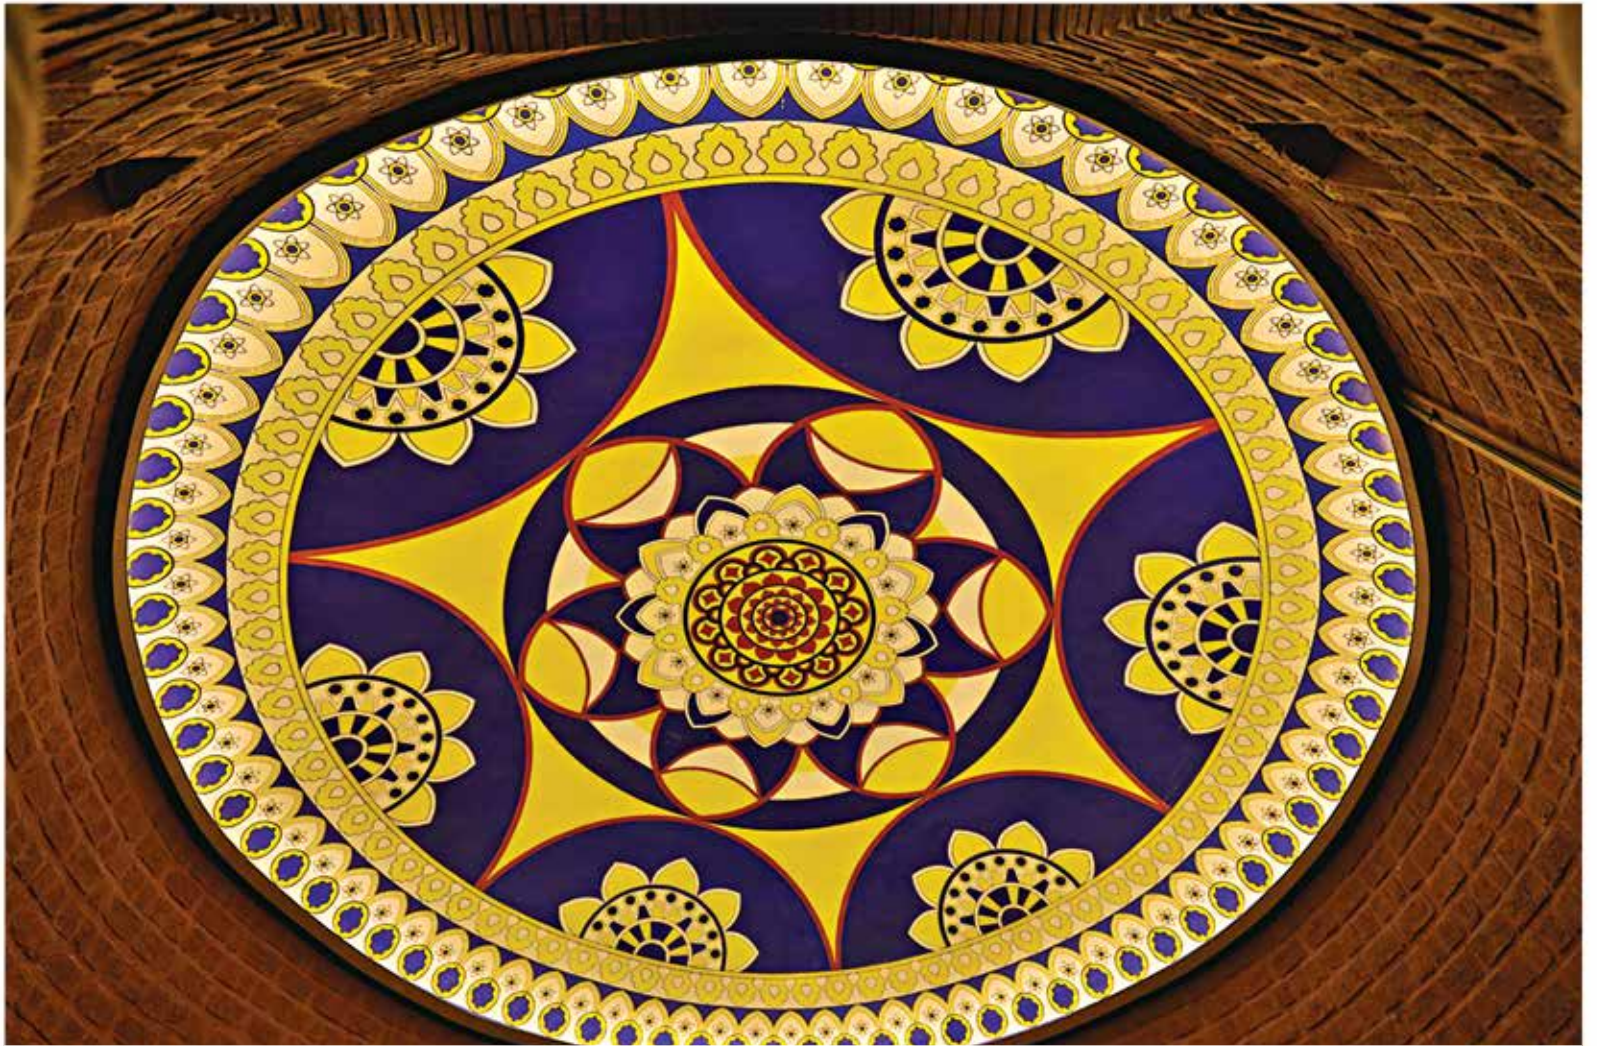
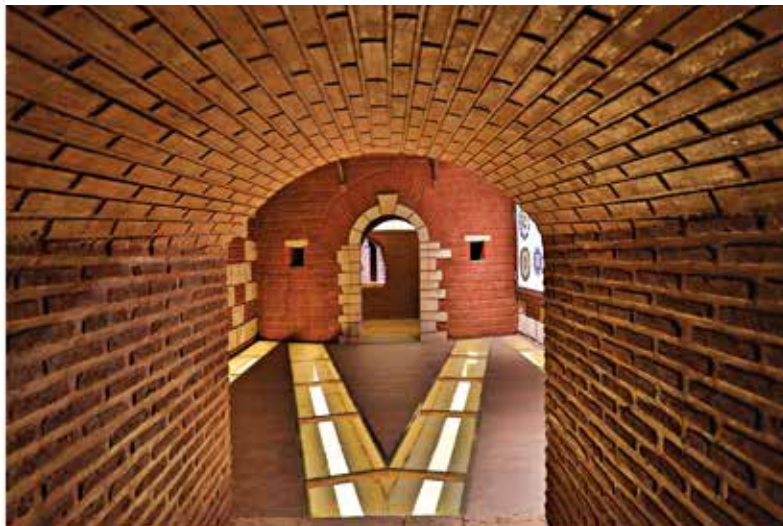
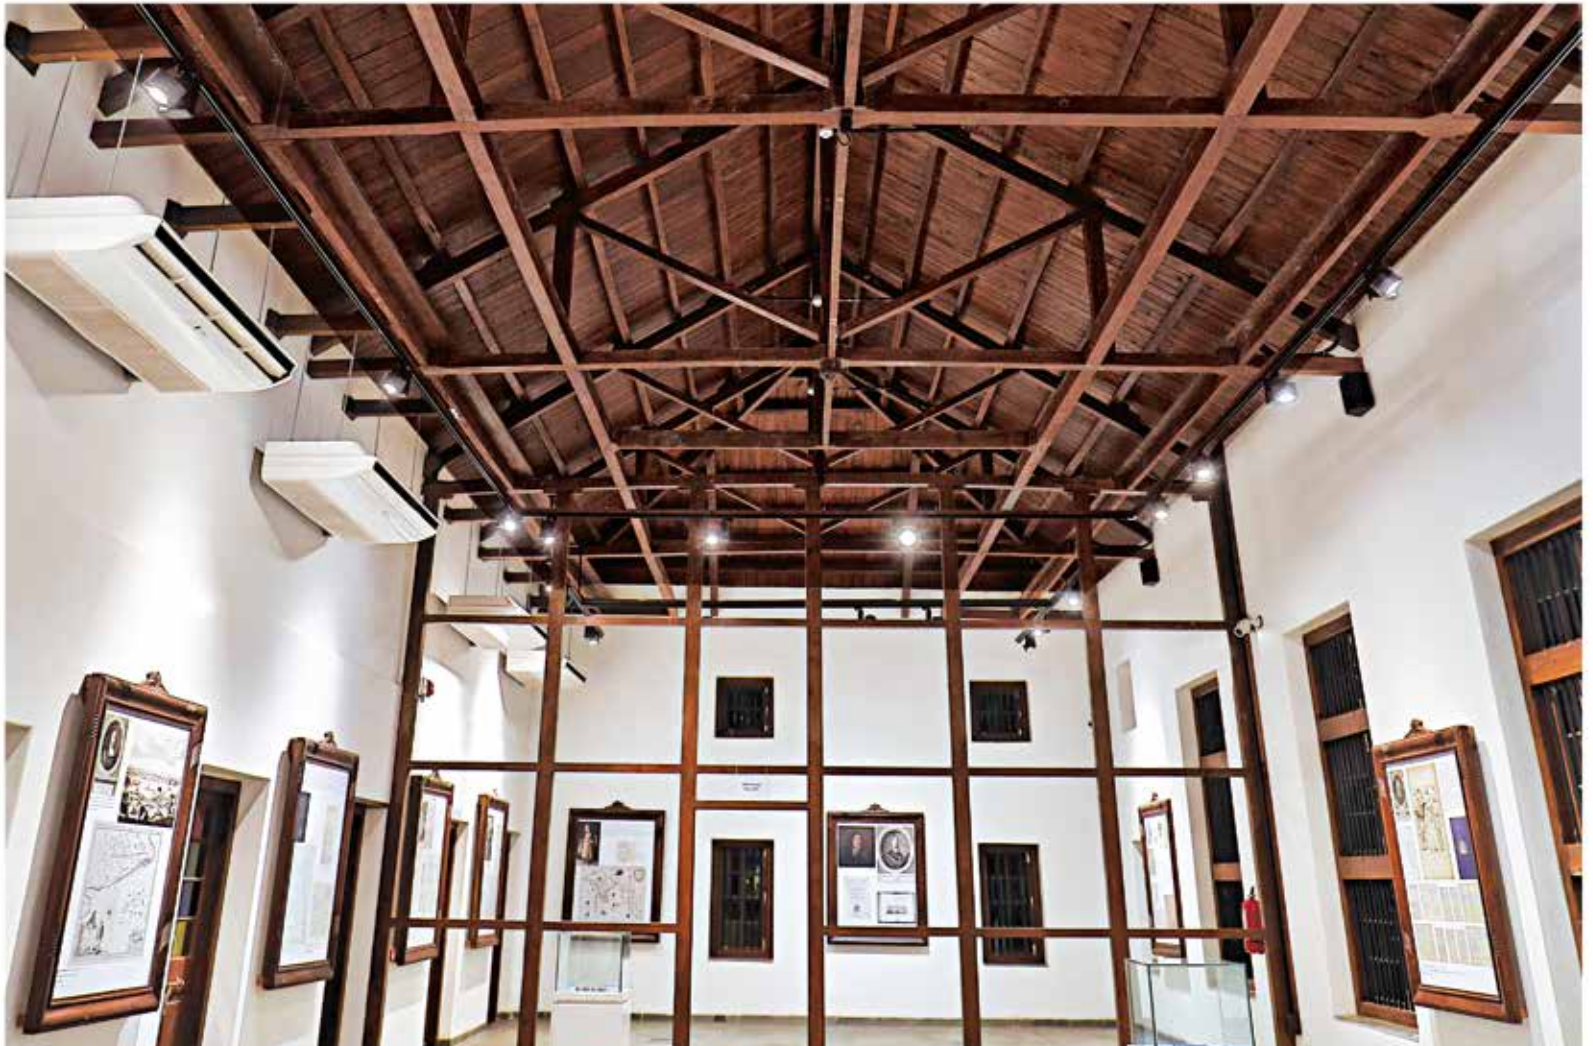
The pathway along side has great interiors needed plaster and pointing, original brick work was restored astutely and beautified with deigns of ancient decor. The Fresco Painting was neatly done to ensure its ancient look and at the same time reveal its freshness to a visitor.

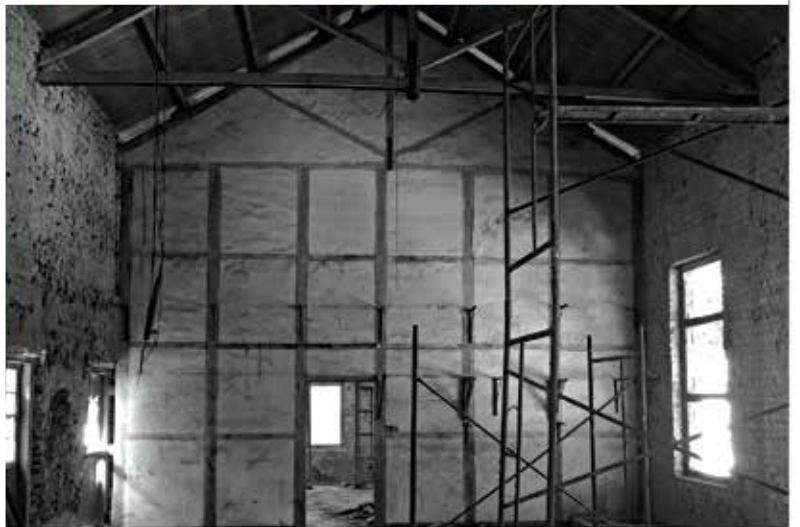
Plaster panels in the partition walls have been removed and replaced with wooden frames to create a porous space – more effective for an exhibition gallery. However, the partitions from the late 1900s have been retained to suggest the most recent intervention – that of the police department – as well as to break the volume into interesting spaces. The window shutter have been replaced and fitted with stained glass. The walls have been finished with arash plaster.

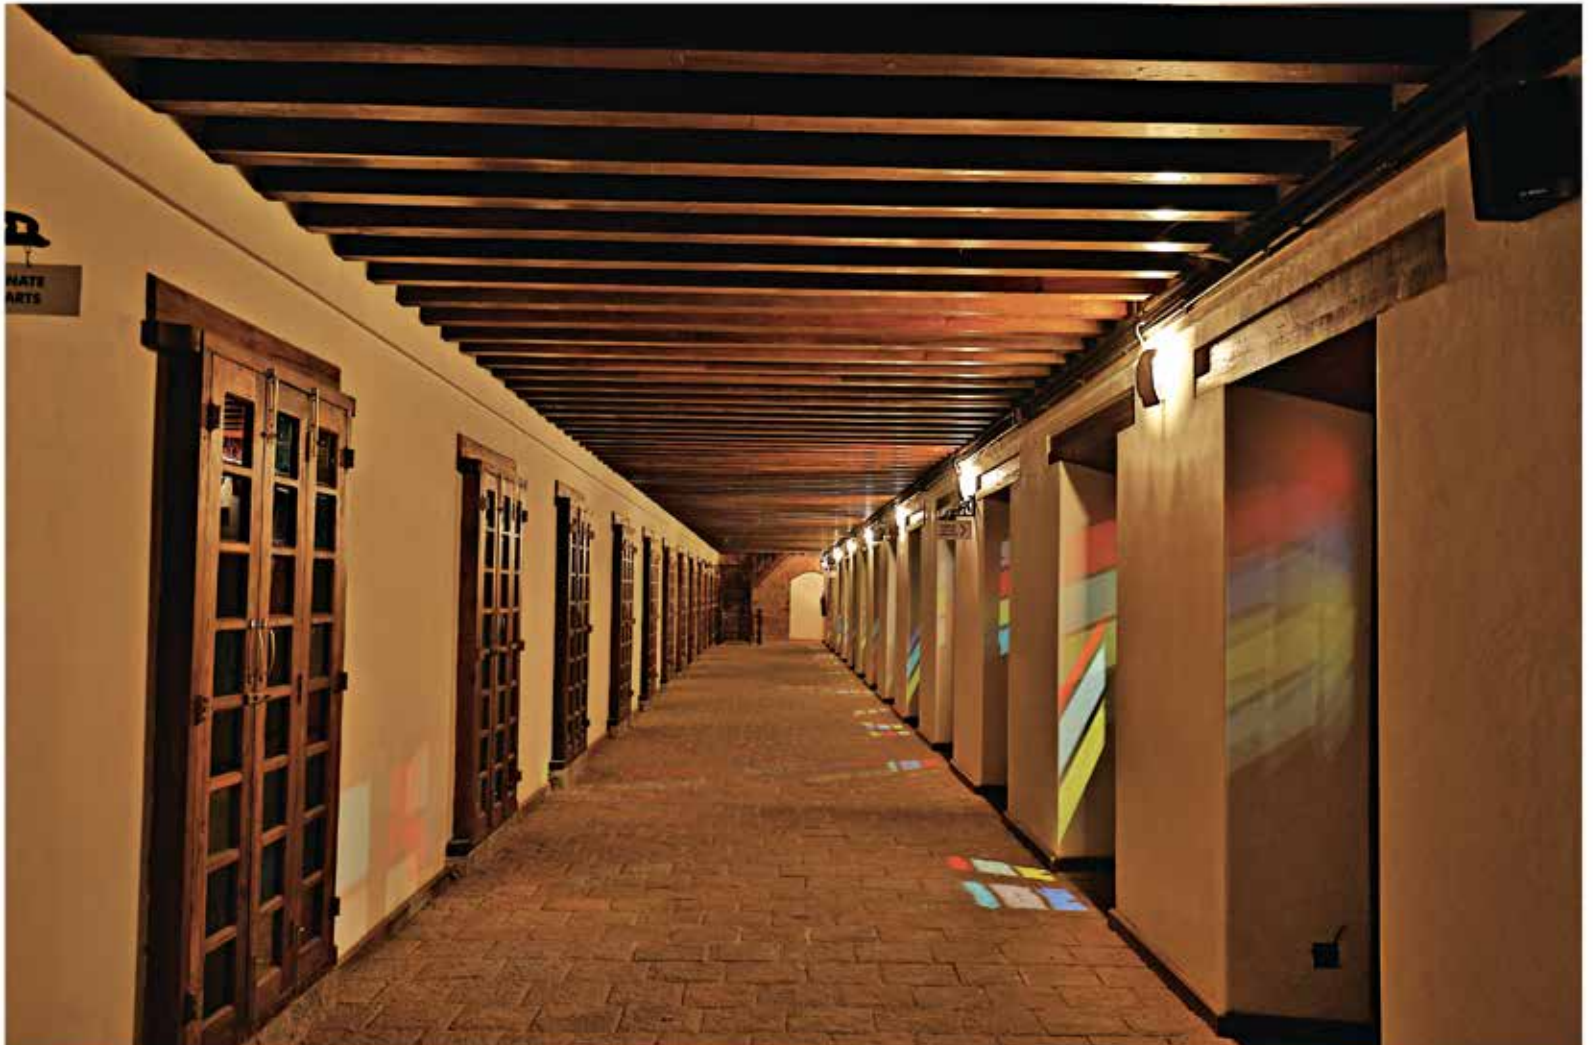
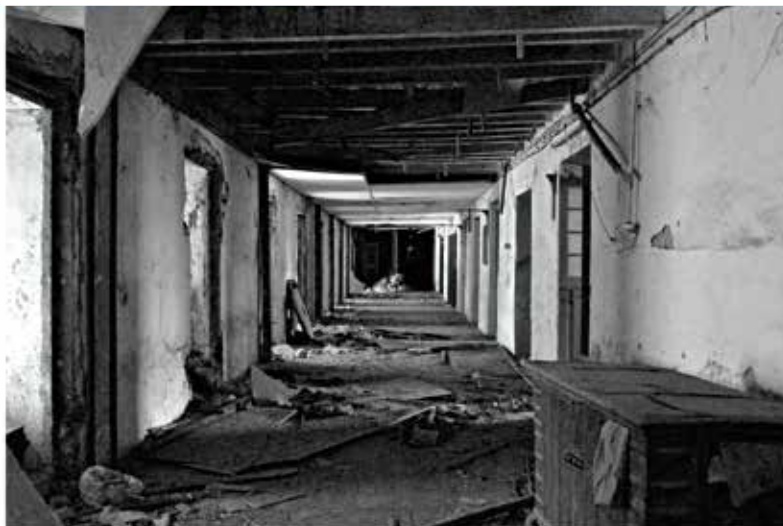
The images here show the south rampart of the castle. The ceiling has been restored by cleaning. The wooden décor was treated distinctly to shine. The gathered debris were removed which revealed the original floor level upon which wooden planks have been laid. The original window shutters were retained and refitted with stained glass to complete the aesthetic look.

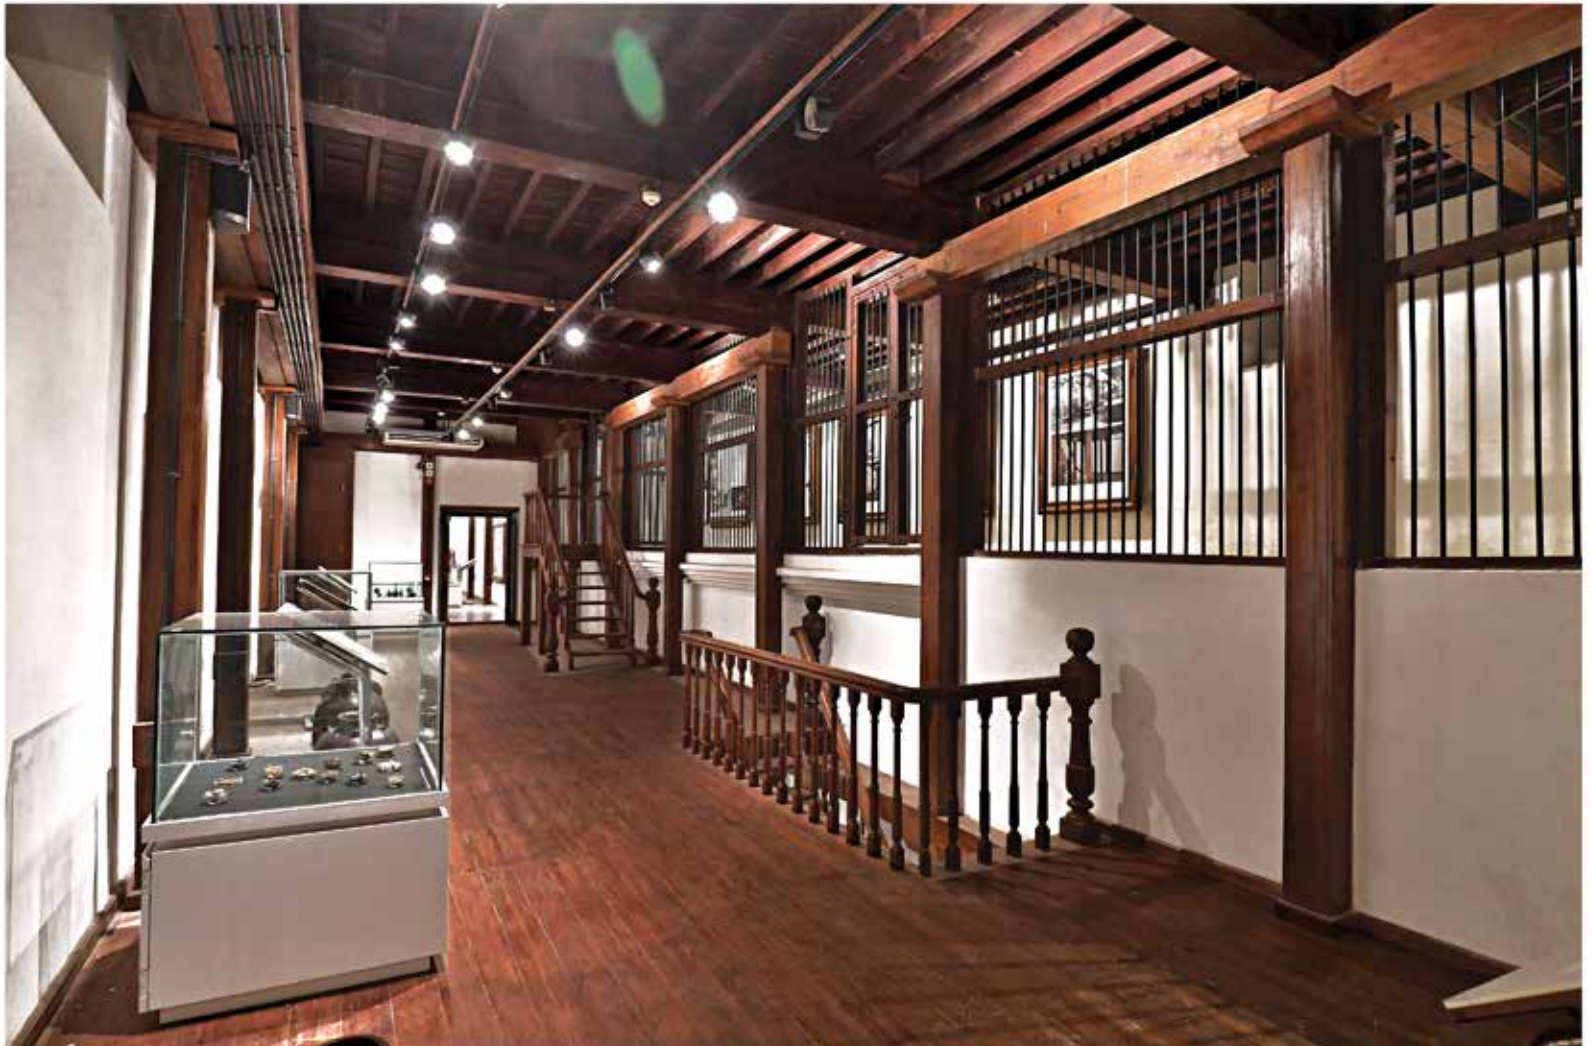
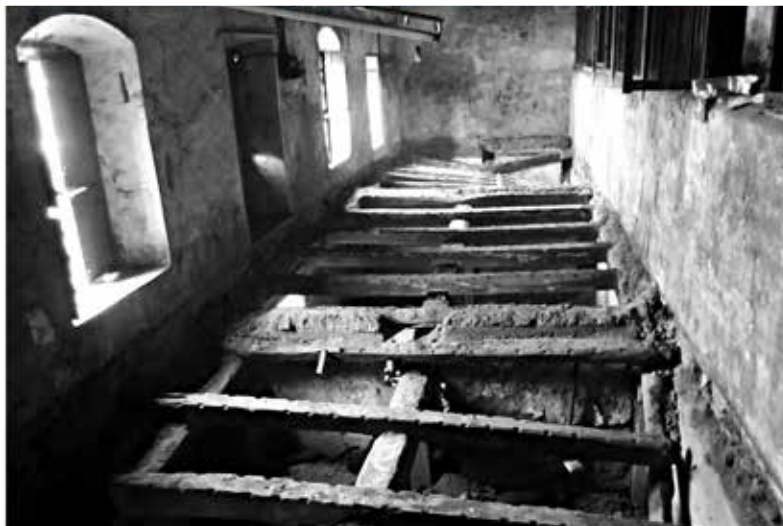
Removal of the topmost layer of flooring opened up two construction layers. The rampart on the right and the linear room on the left. These have been restored and reconnected with a staircase. The flooring has been restored to replicate the original using wooden planks. Additional supports have been placed along the linear room- as seen in the form of columns to strengthen the structure especially the main beam. Window shutters were retained and refitted with stained glass to complete the overall finishing

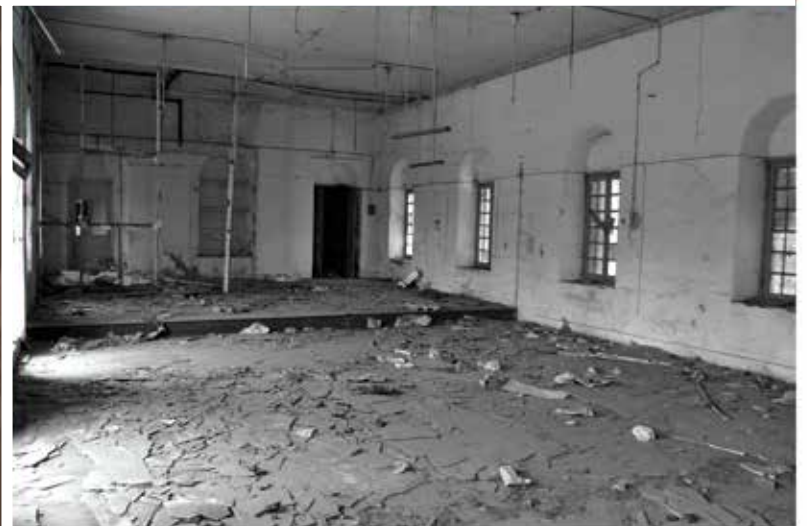
Removal of false ceiling revealed a dutch roofing system. The membrane of the system has been restored to expose the original construction system. Historic evidence indicated that the floor drop might have had a court hidden until then. This contributed immensely to the theme of restoration. Hence, this room being has been presented as a dutch court room with exposed brick walls, wooden floors and stained glass windows.

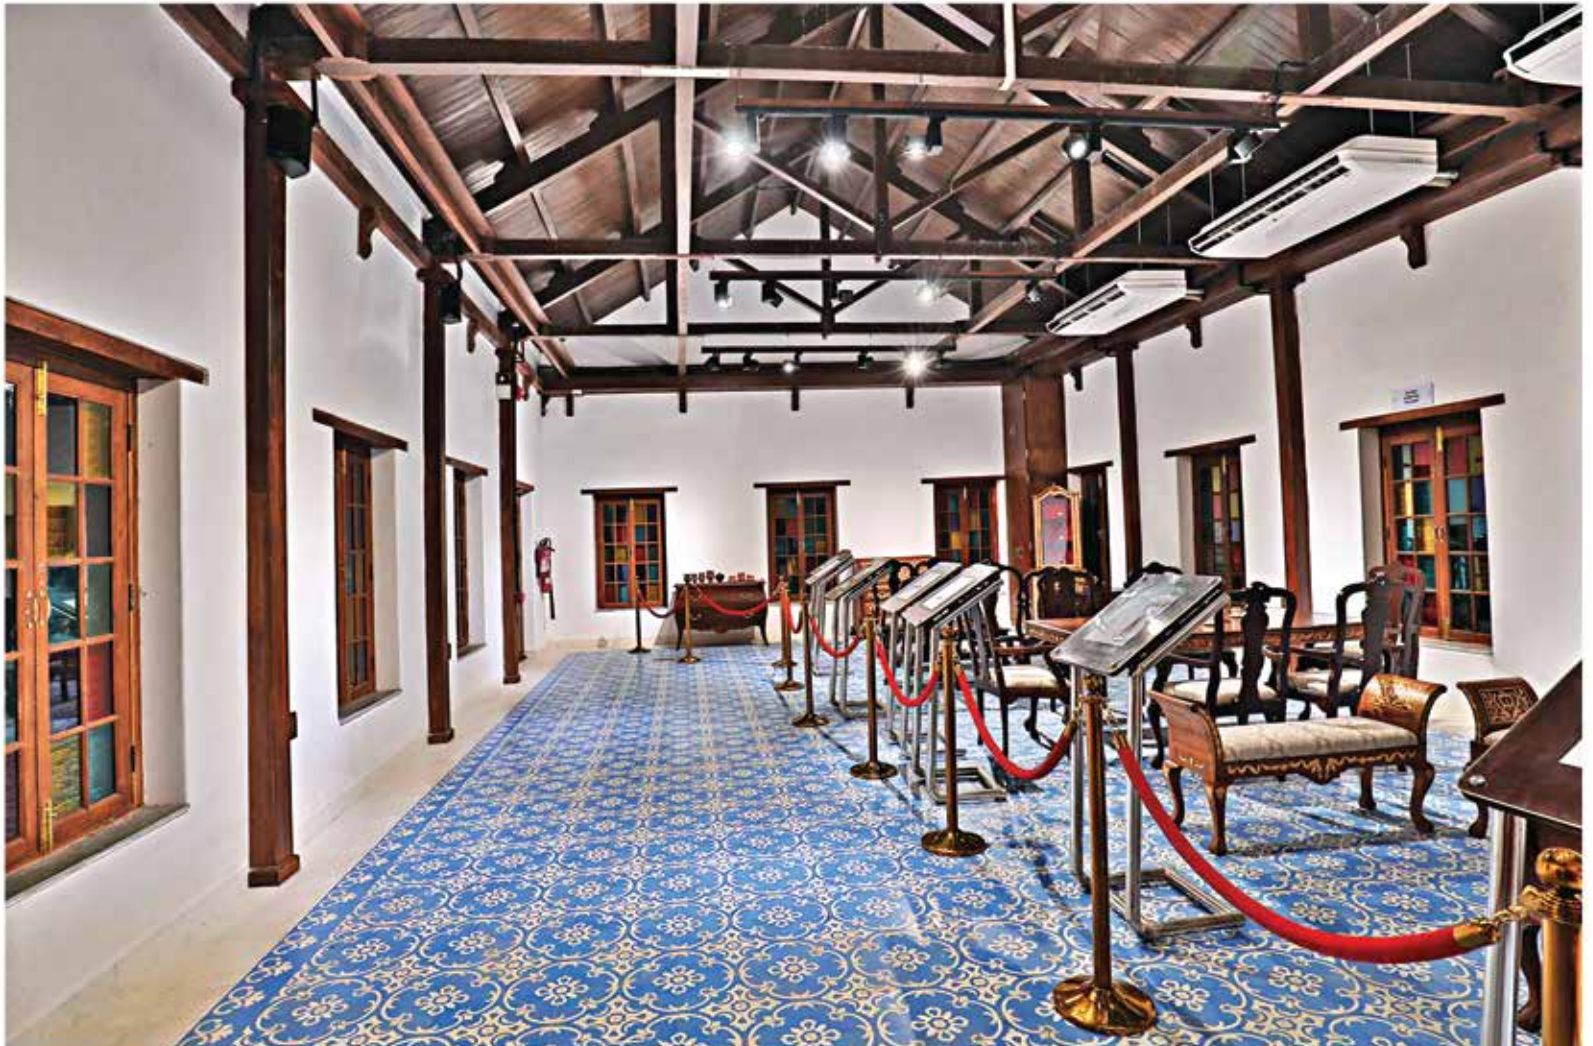
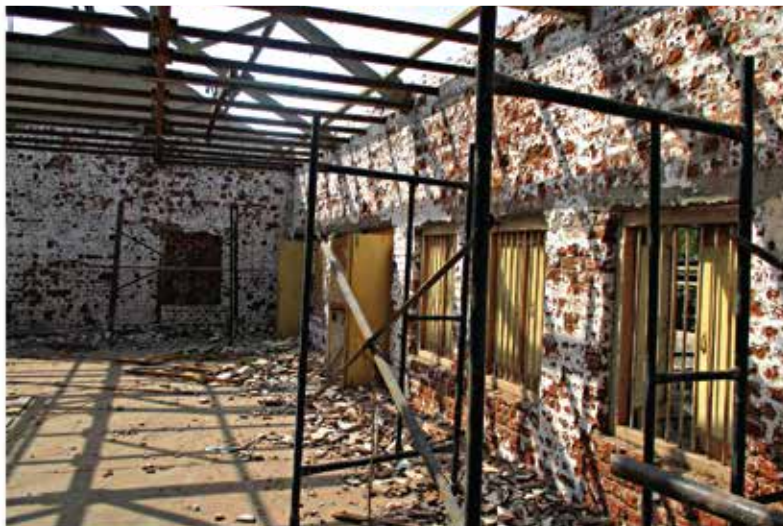
Removal of the false ceiling revealed an intricate as well as strong British roofing system in perfect structural condition. The chambers of the system have been salvaged neatly, treated for longevity, broken ones replaced to restore the original construction system. Same has been executed for window shutters. The floor has been finished with stone tiles resembling Victorian British design, specially acquired for the project.
