The Bombay High Court

A Conservation Story

A report of restoration and repair works

2012-2019

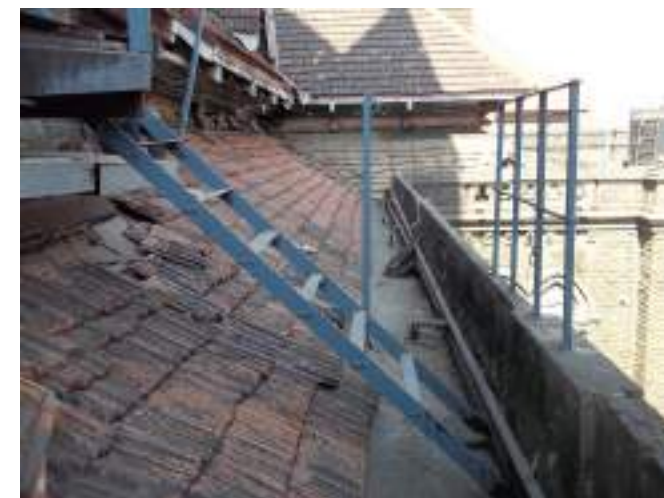
The roof has had severe seepage through the timber structural elements, into the load bearing stone walls, damaging the building in several places causing cracks, dampness, leakage, water puddles, and structural distress.

The lean to roof above the public corridors.

were some make-do efforts undertaken to repair these parts of the roof in the past, but due to poor execution it aggravated the damage to the terrace and the floor below.

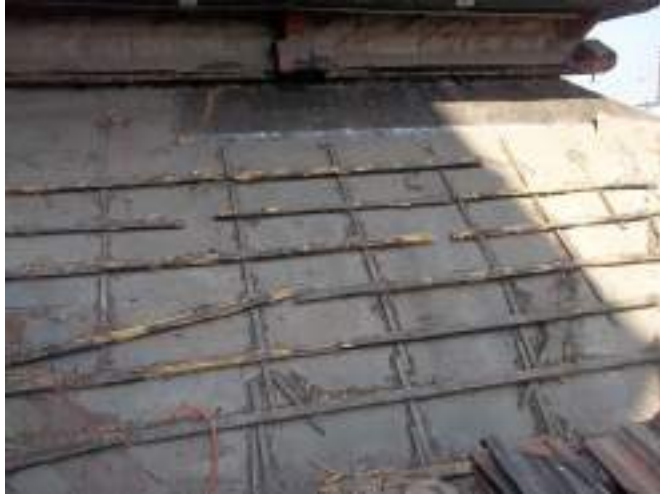
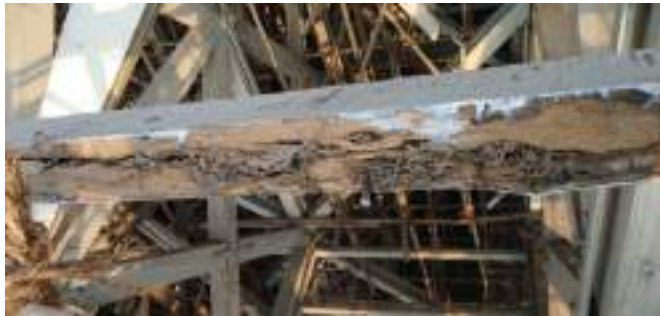
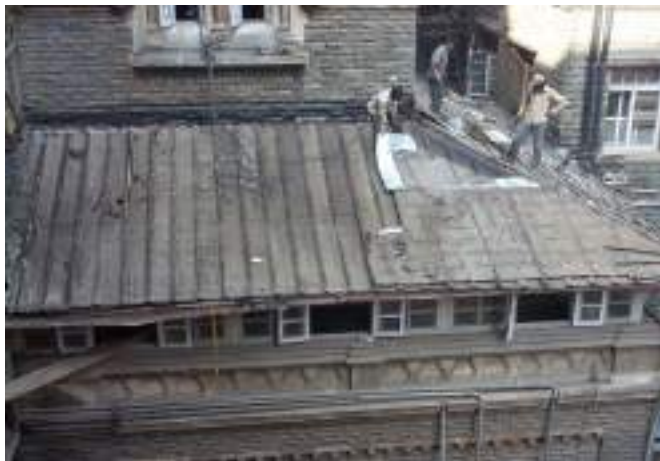
The above three images show damaged roof members at multiple locations in the building.

The process of roof restoration was began by removing and dismantling the existing mangalore tiles, waterproofing layers, the teak wood boarding, rafters and purlins. Once these were removed inspected and sorted, the damaged rafters, purlins and boardings were replaced with new members using well-seasoned Burma teak wood to match with the original. Wherever feasible, the salvaged members were reused. Once replaced, the layer of boarding and battens were fixed, it was covered with waterproofing layers of dungaree cloth, bitumen and specially profiled G.I. sheets. A final layer of horizontal battens were fixed above the G.I sheeting before fixing the mangalore tiles. Since most of the older mangalore tiles were in good condition, these were cleaned and fixed back. Wherever damaged, these too were replaced with new tiles of similar make and quality.

In the severely damaged gutter areas, the timber members were dismantled, replaced and further laid with water proofing layers of brick bat coba, G.I sheet and fibre reinforced bitumen tar felt sheets, finished with lead sheets. Storm water drains were cleaned up along with adding new water spouts, that spewed the water away from the facade.

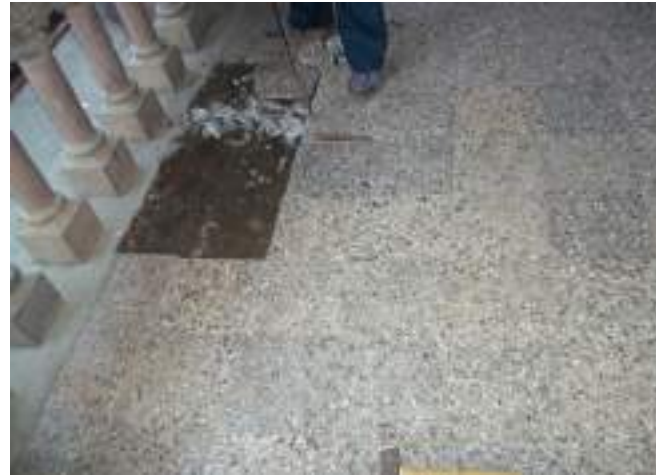
The building is surrounded by verandahs along all four sides thus enveloping the court rooms and judges' chambers in the centre. Severe structural distress, sinking of the floor was observed at multiple places in these verandahs.

A judges' side corridor with mosaic cement tiles.

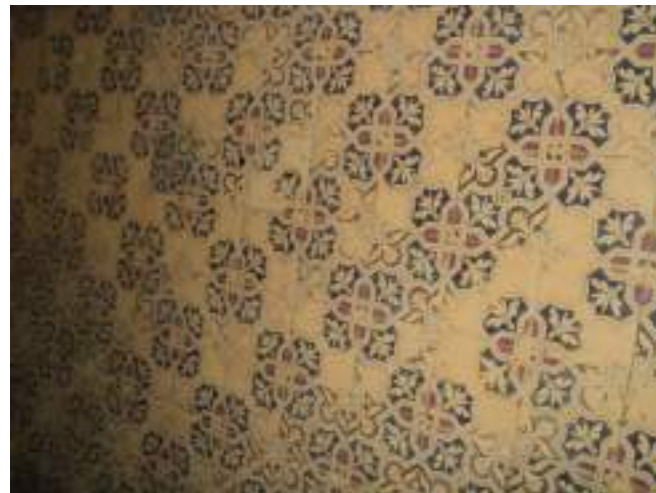
Original Minton flooring in one of the corridors.

These verandahs were covered with various types of finishes, ranging from vitrified tiles, ceramic tiles, terrazzo tiles along with original encaustic tile (popularly known as Minton flooring) flooring in some areas. This erratic choice of material, caused a loss of the identity of the building.

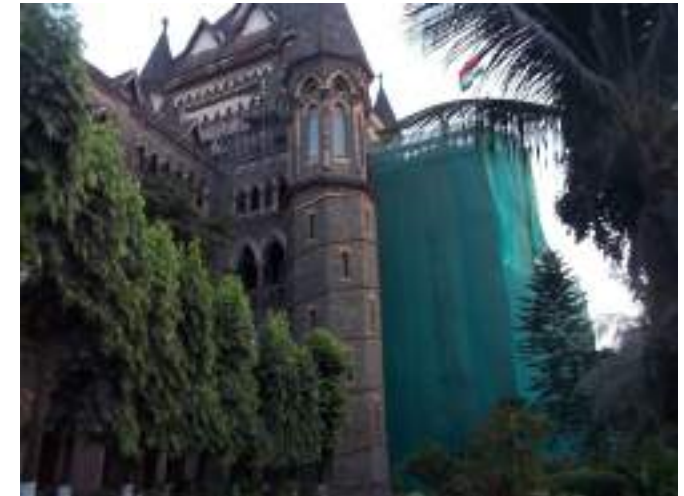
The magnificence of the dark basalt of the Bombay High Court was lost behind years of dust, paint, erosion, chipped courses, missing stone courses, poorly done pointing, exposed services, water leakage and vegetation growth. The decorative limestone details were severely affected due to weathering and dust accumulation.

The soiled facade of the building in process of cleaning.

The continuous basalt façade surfaces were cleaned with water and surfactants without damaging the stone surface. In areas with very strong facade damages and layers of dust specialised techniques like sand and copper blasting were used. After cleaning the façade, the joints in the stone masonry were carefully re-pointed using lime mortar.

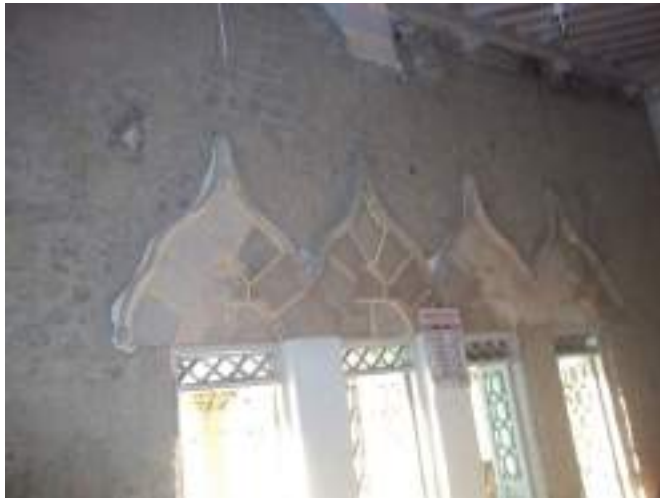
A damaged portion of interior wall.

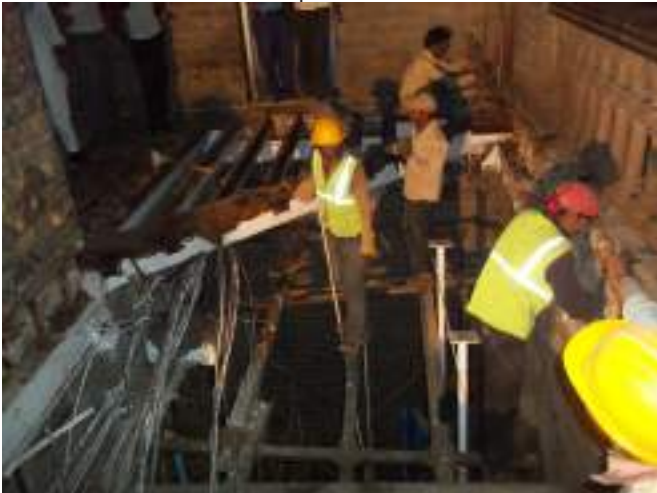
A group of workers dismantling a corridor slab.

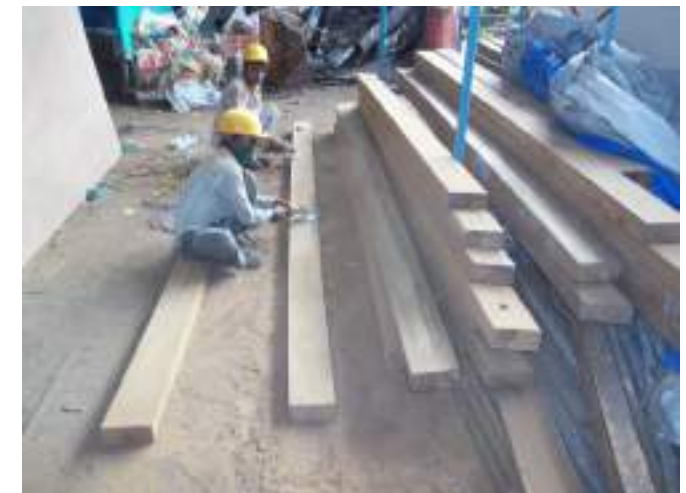
Finishing the timber rafters and stacking.

Best efforts were made by our team to ensure that maximum amount of the original wood is salvaged and re-used on site. Any small sections of wood which were cut-out from large deteriorated members but in good condition would be re-used for non-structural works like doors and window sections, furniture etc. with the sole effort to maximise wood salvage on site.

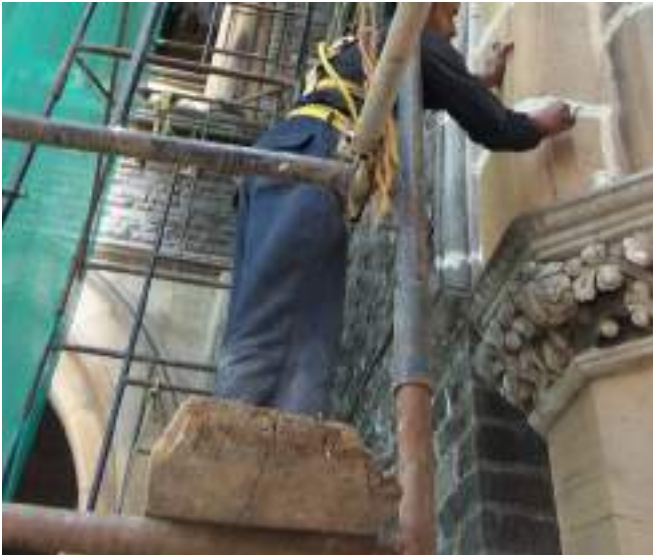
External facade restoration and pointing.

The stone work primarily included restoring certain sections of the façade and its elements, railing members of arched openings in verandahs etc. For this purpose, sections of stone were carefully procured from across the country to ensure that the new stone members are of the same type and colour as the original. These were then worked upon by skilled craftsmen to replicate the exact design and size as that of the original members found on site.

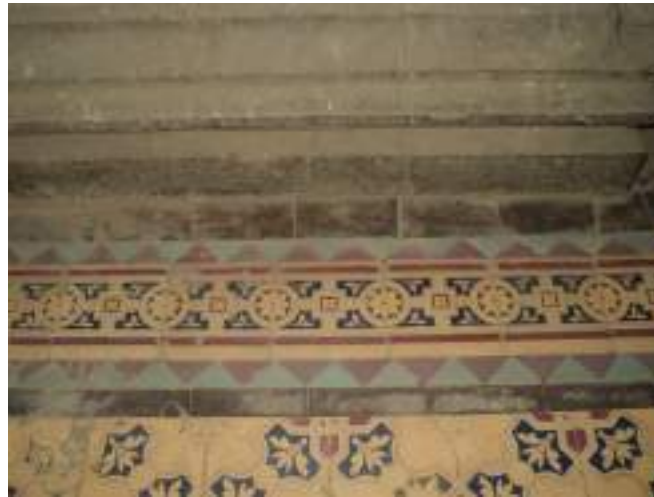
The original Minton flooring found in some areas.

Original Minton flooring was discovered in a few places within the building. The company that manufactured these tiles is now non-existent and thus sourcing similar floor tiles was impossible. To match the design of the flooring the consultants recommended cement

With inputs from consultants and cement tile manufacturers, cement tiles were customised for this project. Multiple samplings were done to ensure that the tiles matched the colour, design and size of the original. These too, were sent for testing to government authorised testing labs before installing the same on

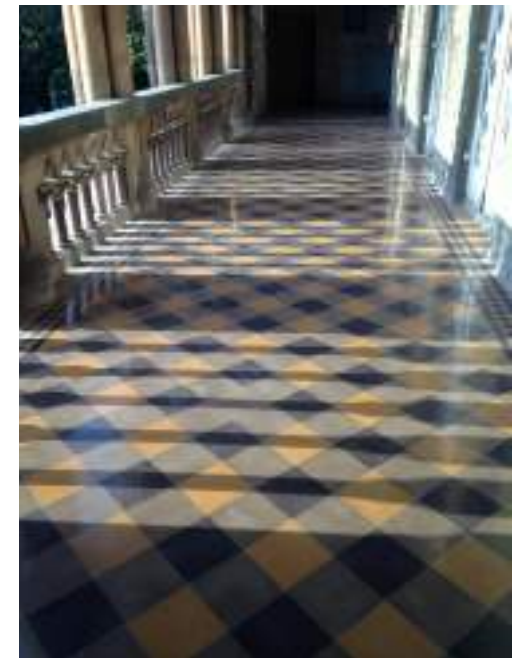
A sparkling verandah floor post restoration.

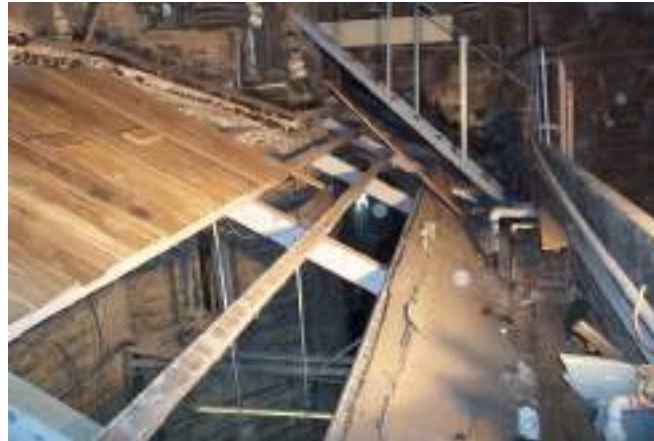
Dismantling and fixing new members for the roof.

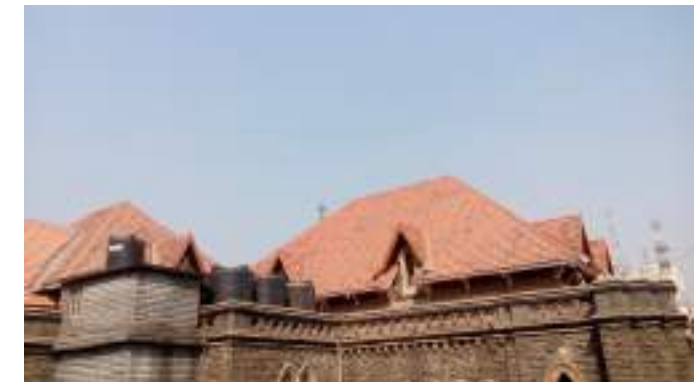
The restored roof.

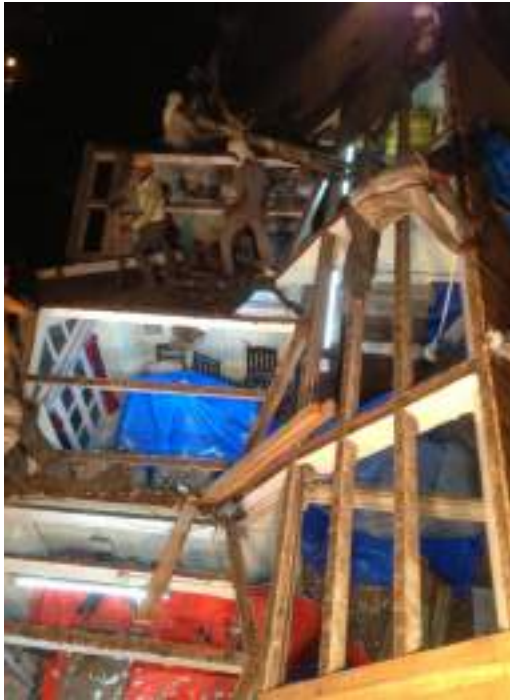
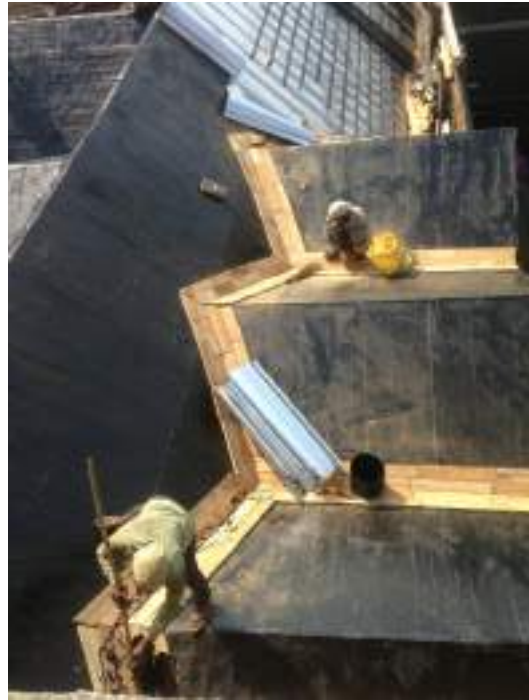
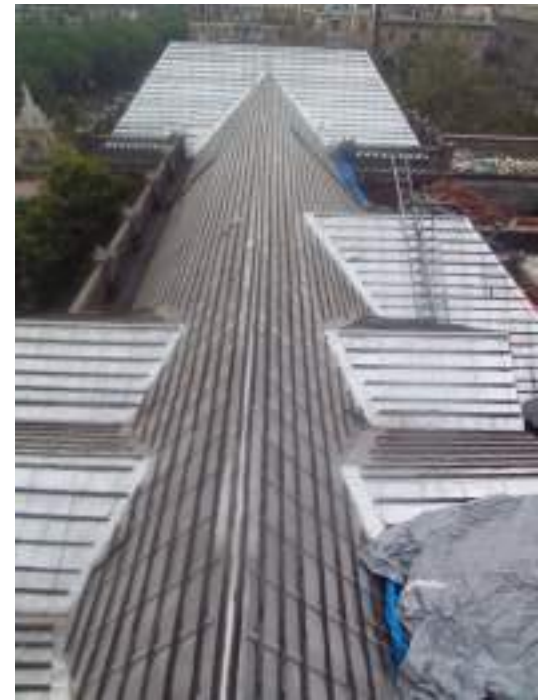
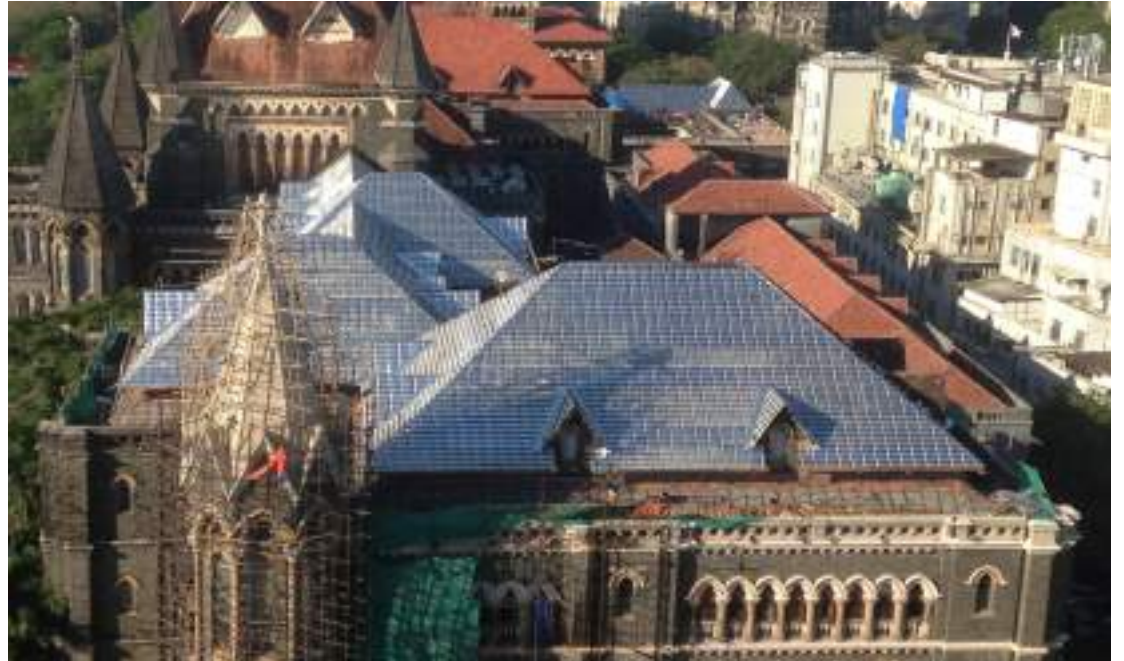
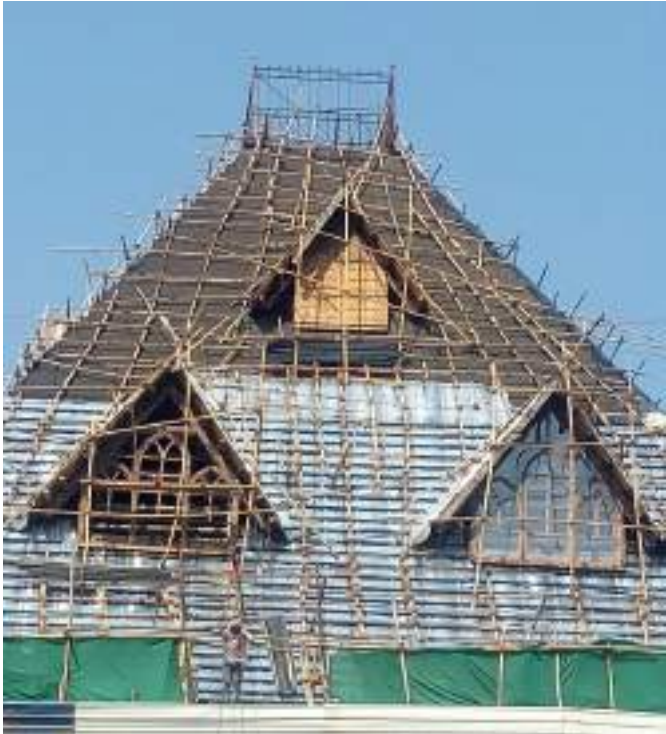
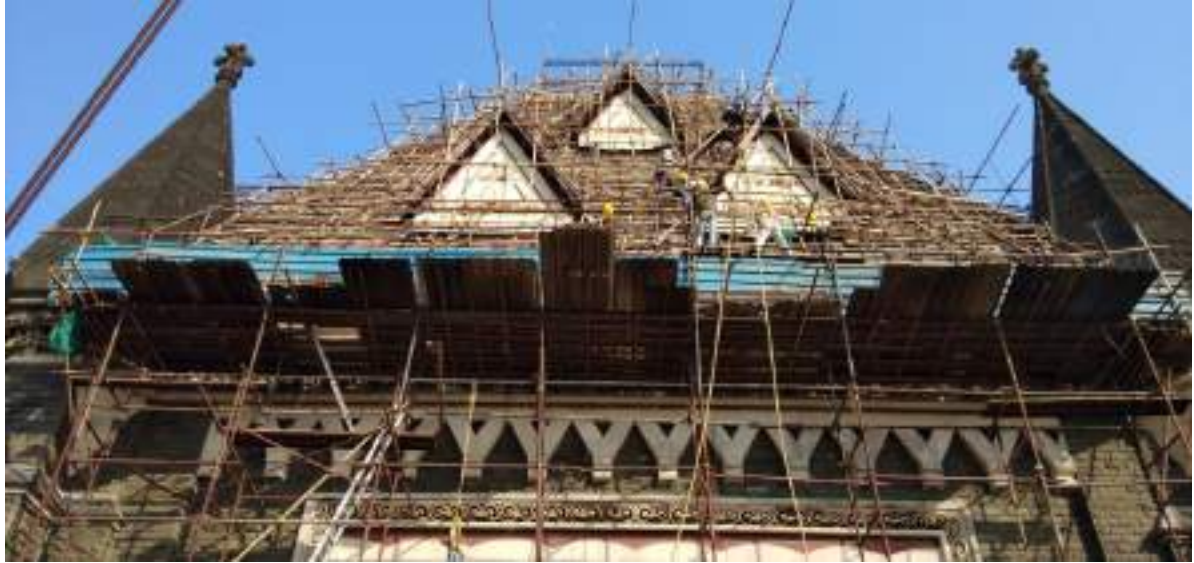
Images showing the restoration work of the central tower roof.

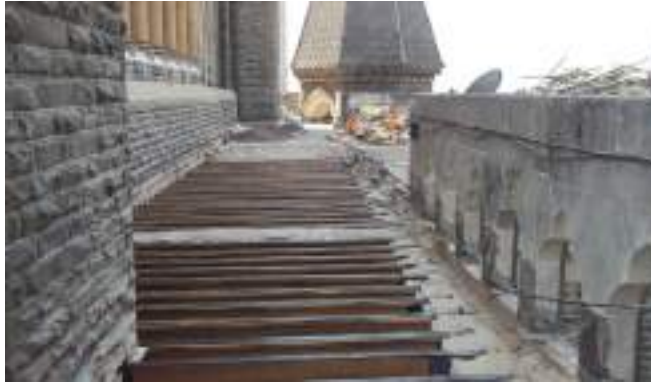
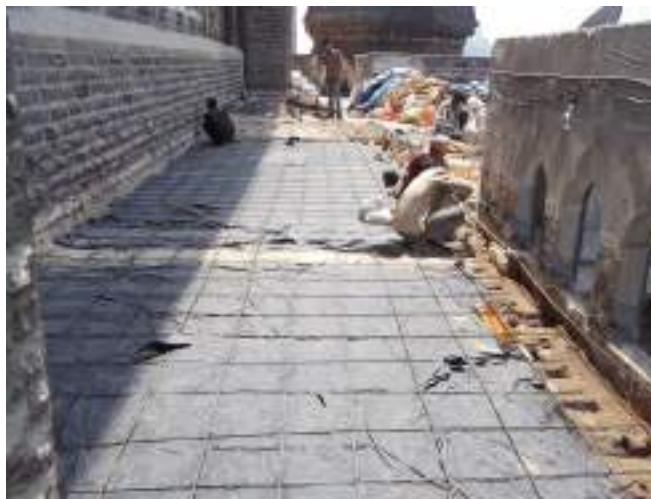
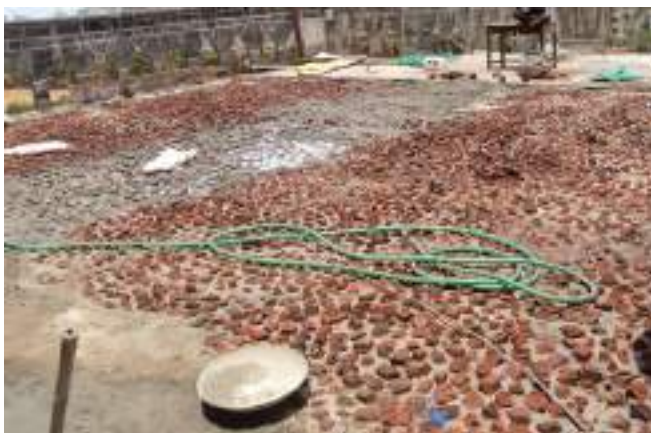
Images showing the stages of structural consolidation and terrace water proofing of the flat roof facing the Oval Maidaan.

In order to repair the flat terraces, multiple layers of waterproofing had to be dismantled, the damaged rafters replaced, fixed boarding over it. This was followed by a layer of brick bat coba and reinforced bitumen tar felt. After providing for necessary slopes, it was finished with a cement mortar layer mixed with waterproofing agents.

The flat terrace adjacent to the Central Tower, facing the Oval Maidaan was different from the remaining terraces. While dismantling the lime coba we discovered 6" thick limestone slabs placed over the teak wood boardings of the slab below as an additional build-up layer. These slabs were in excellent condition and dismantling was not recommended by the consultants. It was hence decided to directly lay the waterproofing over the existing slabs and lime coba which was also in good condition thus retained. Specialized treatment was carried out to seal the joints of the original lime coba and the new brick bat coba layers to avoid any water seepage.

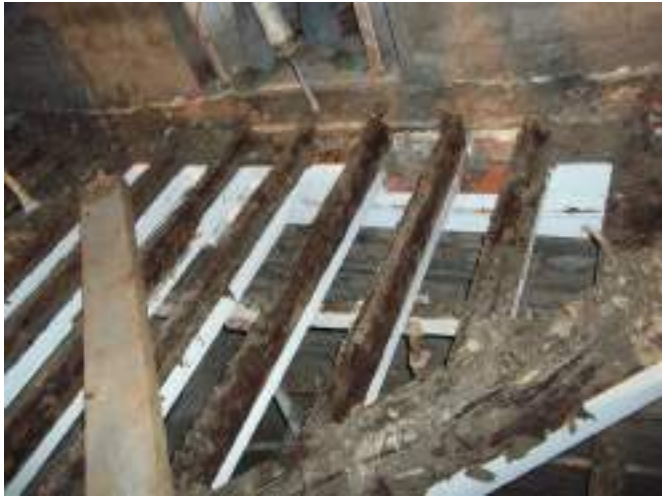
While dismantling the floor tiles, boardings and rafters, it was noticed the entire length of the rafter, was embedded in lime coba slab above it. Both ends of the rafters was embedded in the walls, one interior wall and the other was the exterior baluster wall. This detail caused all the possible deterioration as the length of the rafter was constantly exposed to moisture from the lime slab, while the ends were also exposed to moisture from the walls.

The dismantling of the slab.

After multiple investigations, the consultants proposed a different detail of construction. The load bearing capacity of the rafters was increased by fixing additional 8mm thick M.S plates, over each rafter. The teak wood boarding was placed over the rafters and R.C.C. slabs were to be cast over it. While restoring the rafters, the ends were coated with a layer of Black Japan and polythene sheets and then embedded in the walls. The boarding too were coated with bitumen to reduce the impact of moisture exposure on the wooden sections and thus increasing the life of the all the members.

These steps were undertaken while retaining the original aesthetics of the slabs. All damaged timber members were removed and maximum possible salvaged material reused wherever possible. The salvaged material too had an organised way to be stacked, stored and used.

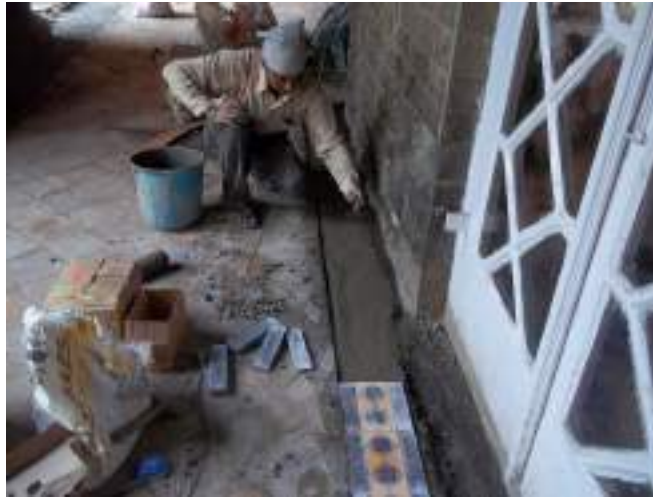
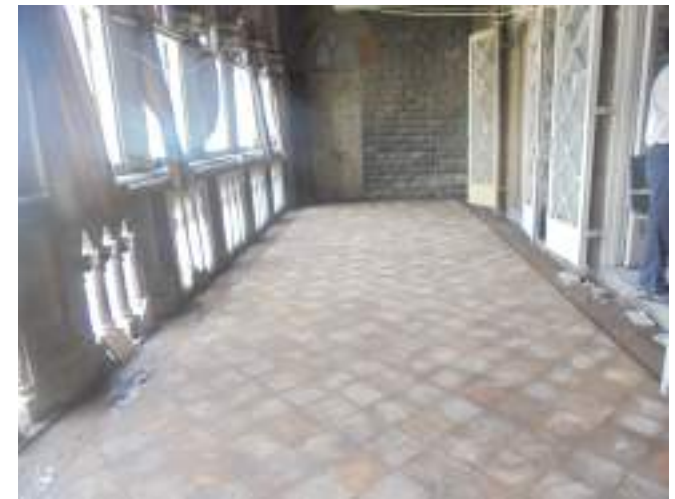
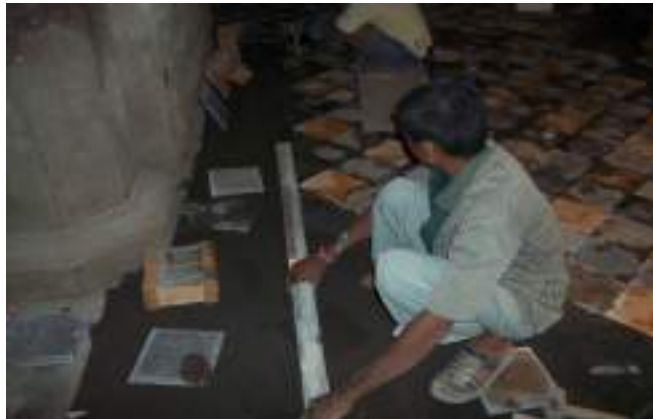
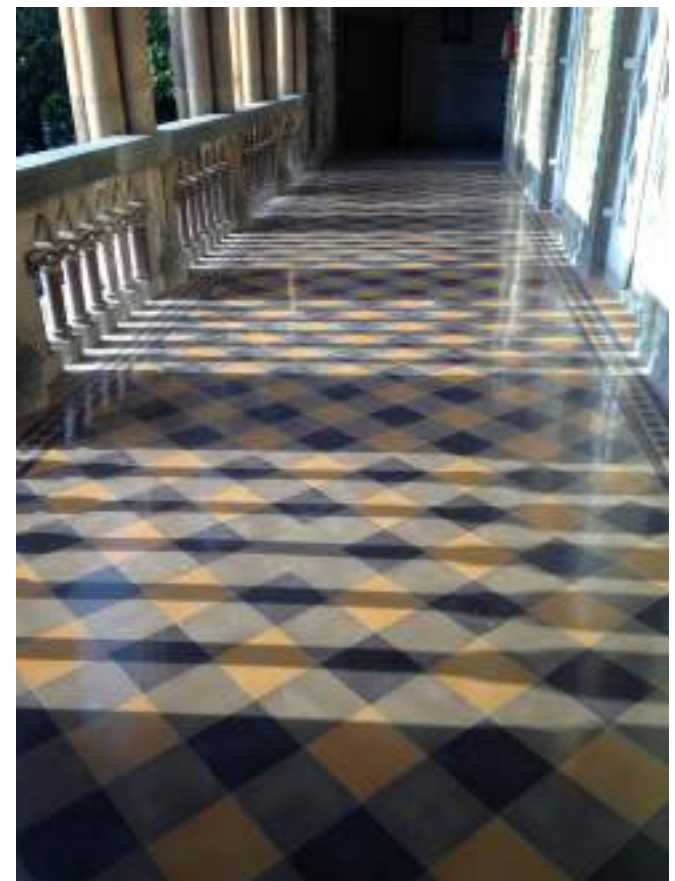
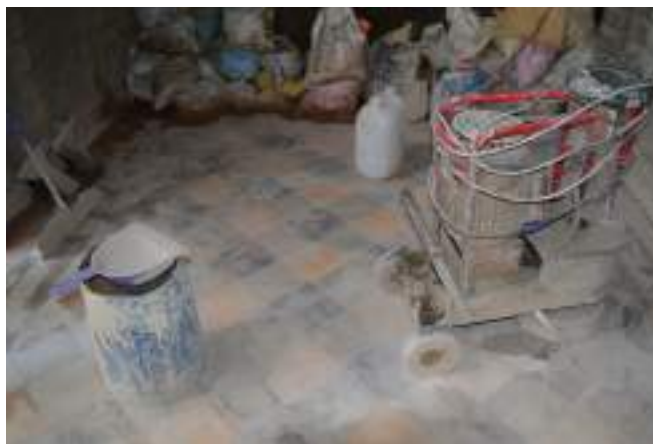
Images showing the process of finishing the verandah floors. Laying, levelling and polishing 7 times to gain a marble like finish.

Once the slabs were cast and structurally secured, these were to be finished with tiles. A heritage pattern found within the building was replicated in cement tiles. Every night our team worked on fixing the tiles and in the morning the same were covered with tarpaulin sheets and plywood so that public can continue to walk over it. Once the tiles were fixed, these were to be polished 7 times with varying grades of polishing stones and the final buffing layer was to be done using special chemicals. The original encaustic or Minton flooring found in the judges' verandahs, were only cleaned and not polished, as polishing would have damaged it further.

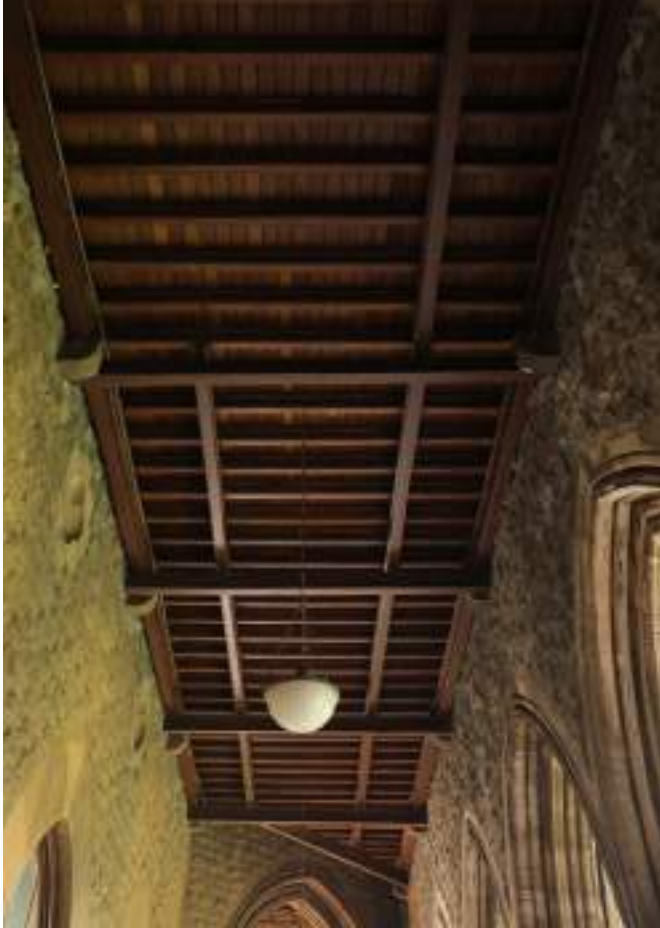
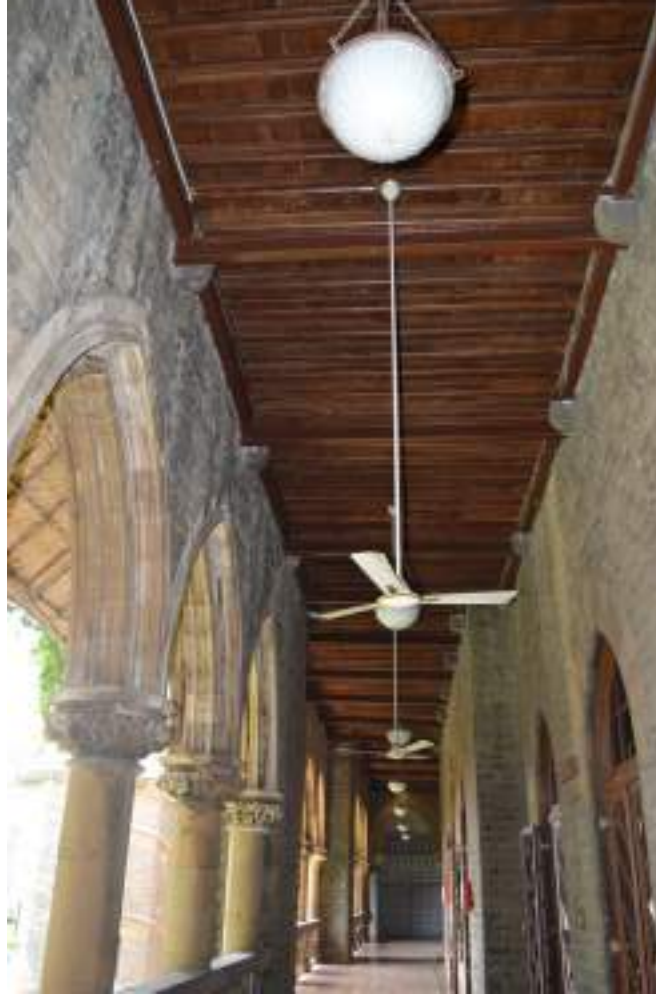
Image above and right showing finished and complete ceilings with new fans and light fittings.

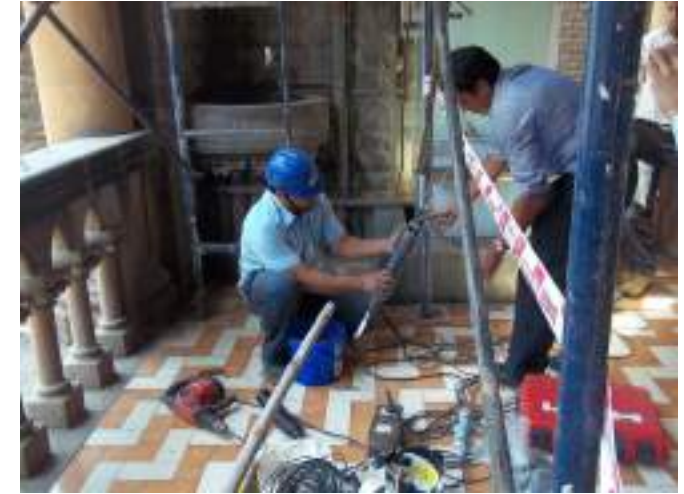
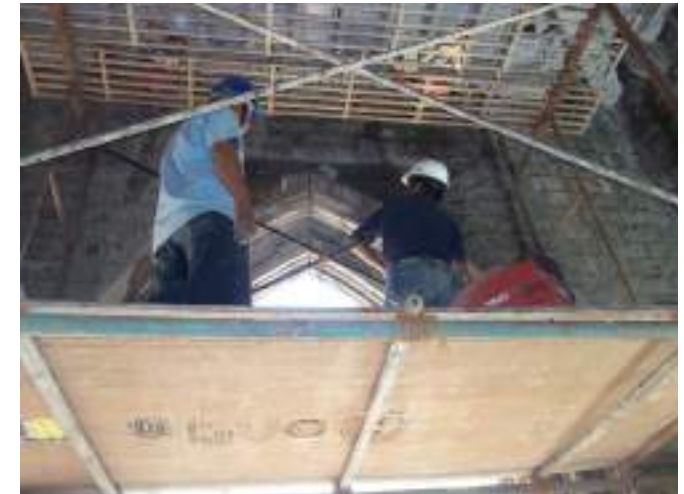
Images showing restoring the stone facade with Helifix.

Apart from a few cracks there were no major structural issues in the walls. For restoring these, Helifix- a special stitching technique was used in which long helical bars were inserted in grooves created across the cracks at regular distances. A specialized team was deployed for this.

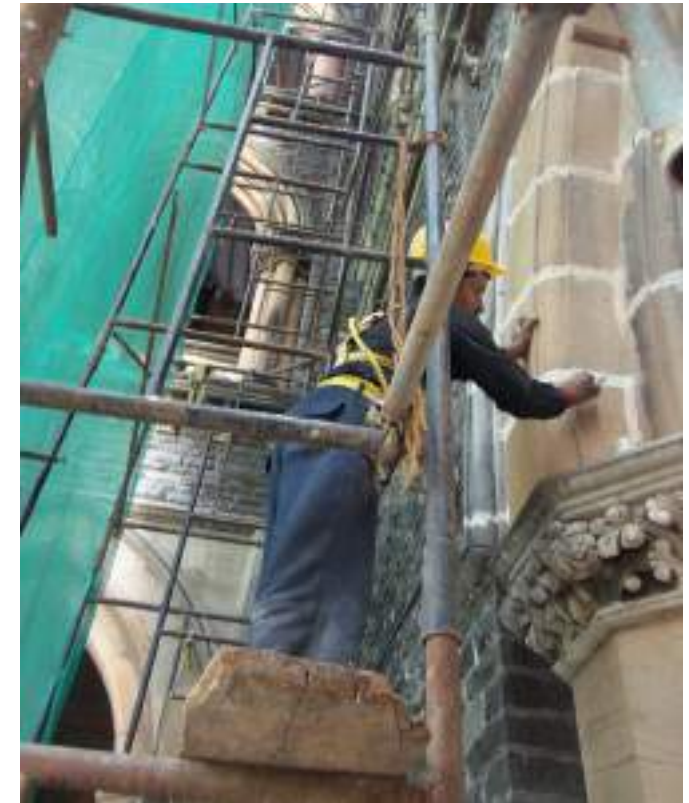
A skilled personnel doing pointing of the stone courses.

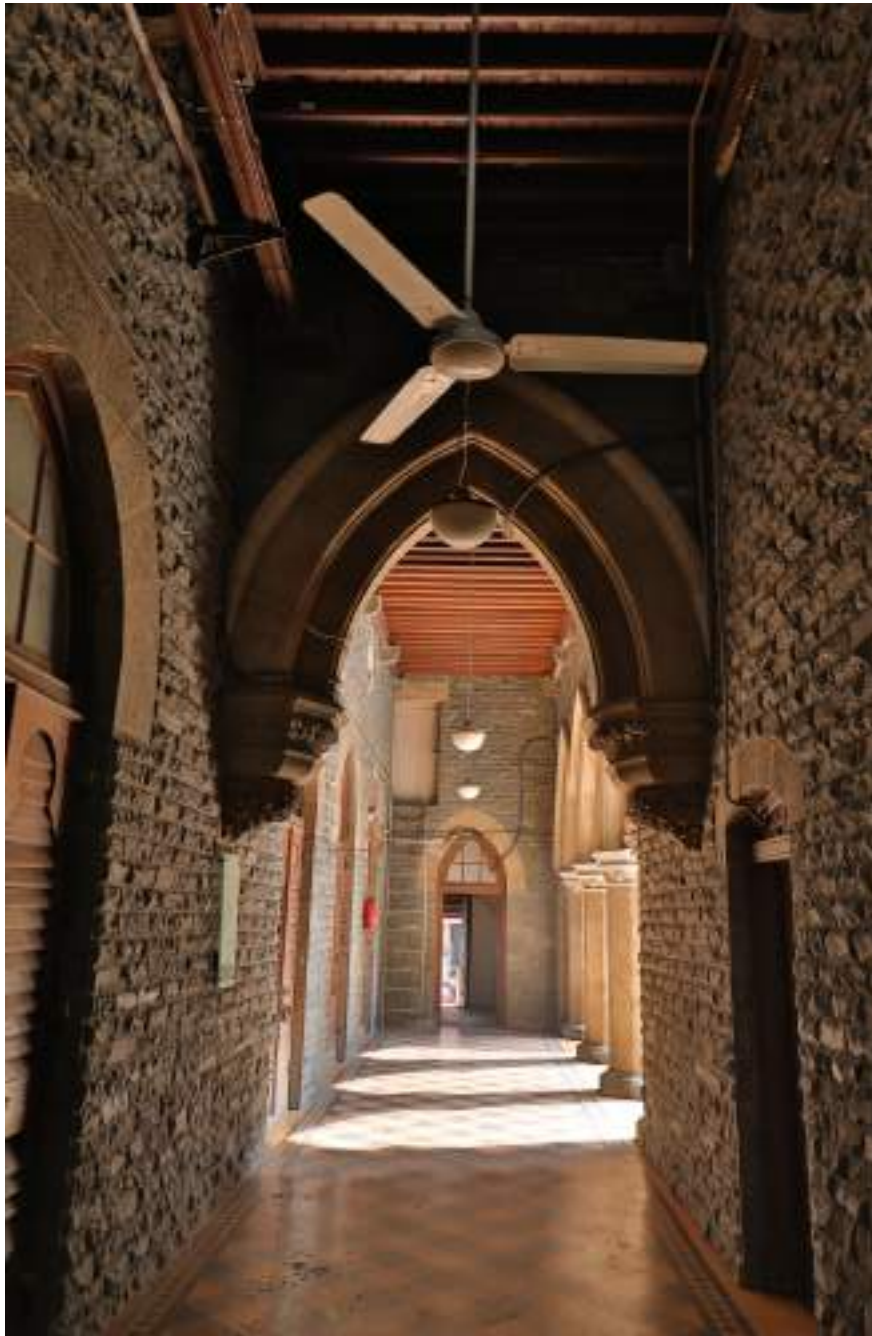
A restored corridor.

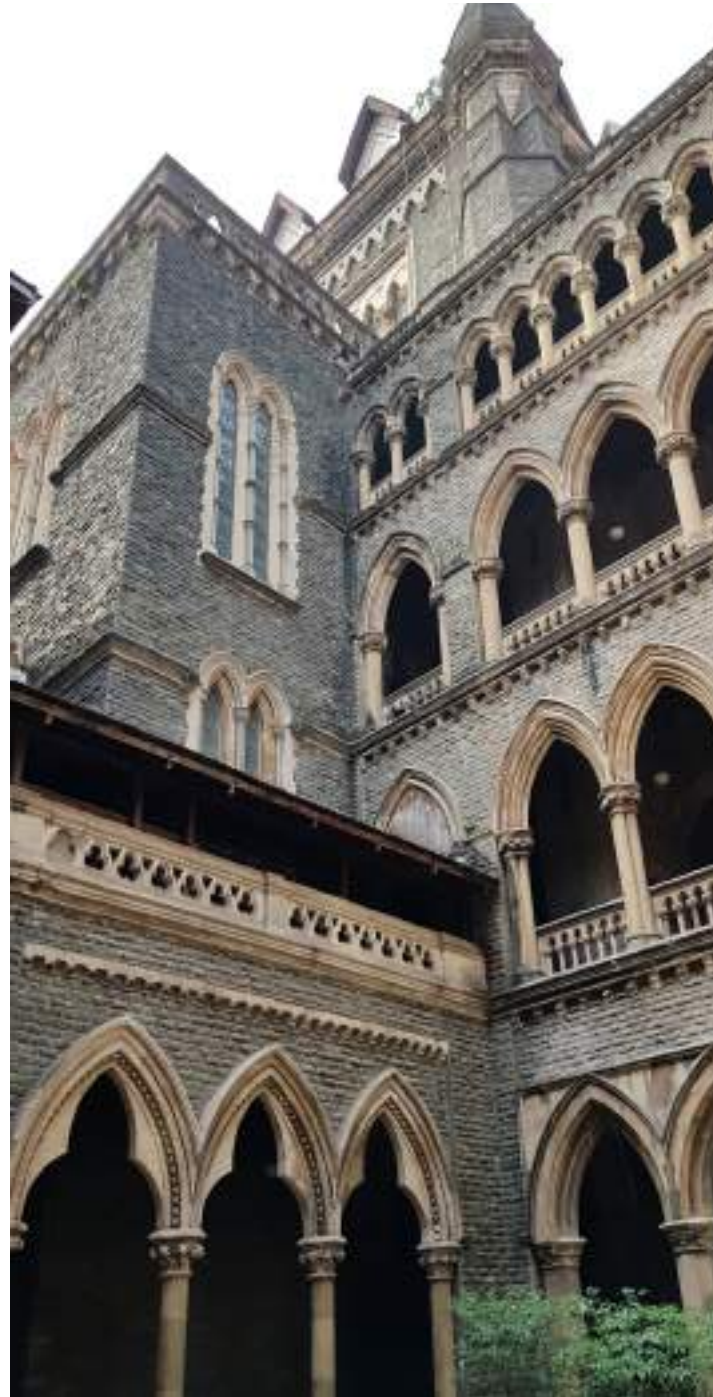
Before stone cleaning.

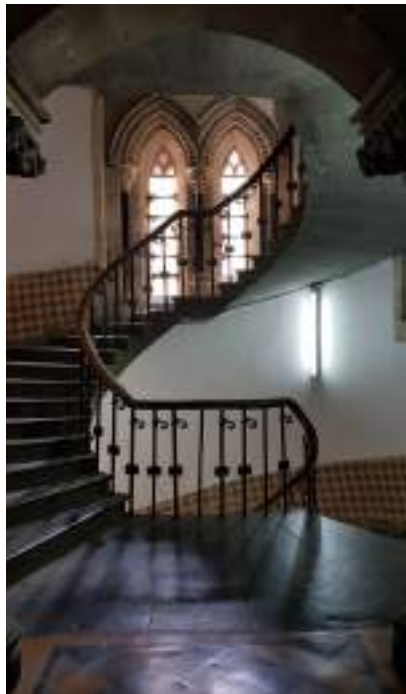
The spiral staircase blocks had peeling lime plaster along its curved walls. Some portions of the original timber handrail too were missing.

Extreme left is an image that shows a complete restored curved staircase with walls re-plastered, missing handrails fixed, along with new cement tile dado.

All the loose plaster was dismantled and the walls were re-plastered with lime mortar. The missing or damaged wooden handrails were replaced with new ones of the same type and carving pattern.

Small tiles, of a pattern similar to the floor tiles, were to be fixed along the curved walls. The curved walls were a challenge and fixing demanded highly skilled labour. The top of the tiles was finished with plaster of paris moulding and were polished to match the finish of the verandah floor tiles.

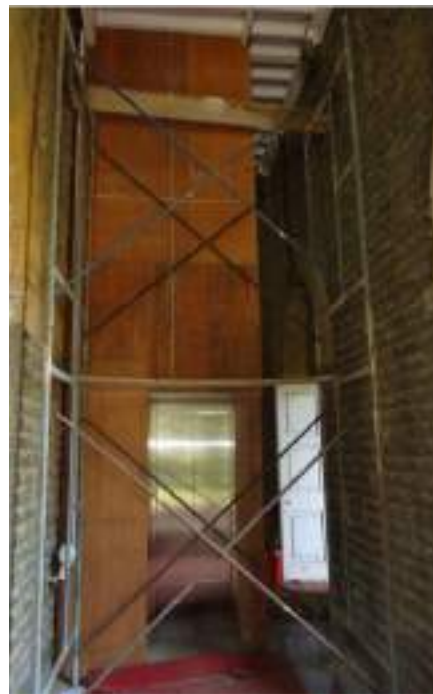
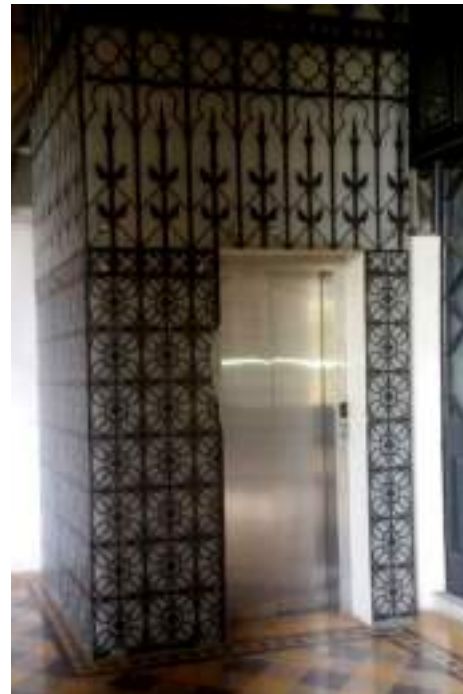
To the left are images of the lift along the judges' corridor, before and after restoration.

The lift shafts in the judges' corridor were visually chaotic and thus the consultant designed a cladding detail for it. The lift shafts were cladded with white painted plywood followed by fixing of 12mm thick toughened using stainless steel studs. This assembly of plywood and glass was further finished with vinyl stickers bearing the print of the pattern of the original cast iron grill gates present in the judges' entrance porch.

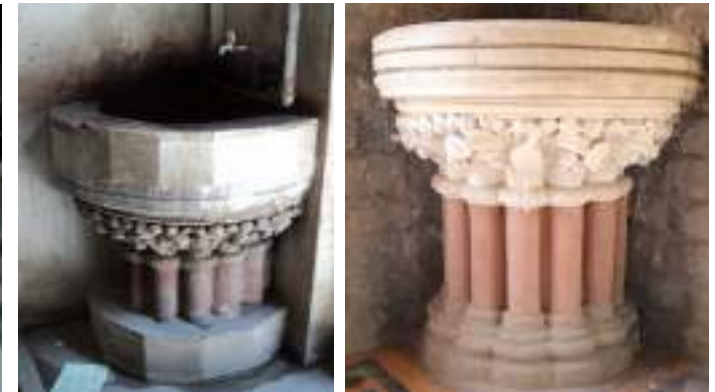
The images above shows the water fountain before and after restoration.

The High Court building has original decorative drinking water fountains in stone in the public corridors (2 on each floor). These were defunct and new water coolers were placed next to them. The consultants proposed re-charging the drinking water fountains through a central drinking water system. We were to restore the damaged stone water fountains. The fountains were carefully cleaned, missing sections of stone details replaced or replicated with new members of the same type, size, or mixed with stone dust to match the colours. The inner surface of the sink was finished with new layer of rich lime mortar to achieve a smooth surface. New brass taps of heritage design were specially customised and installed for these water fountains.

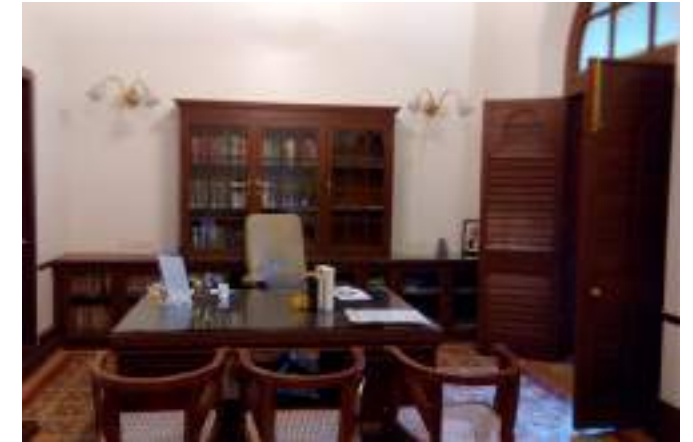
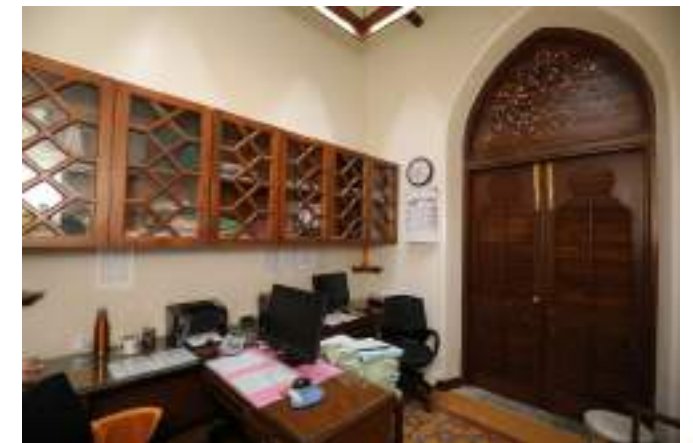
Pictures of restored interiors of the judges' chambers.

The Interior refurbishment works of the Judges' Chambers was a major component of the phase II. It required coordination with multiple people like the honourable judges, their staff, the court office, the P.W.D engineers and the consultants. Also, we had to coordinate with different working agencies like the HVAC, electrical and data works. We along with the consultants tried our best to customise the space design as per the user requirement.

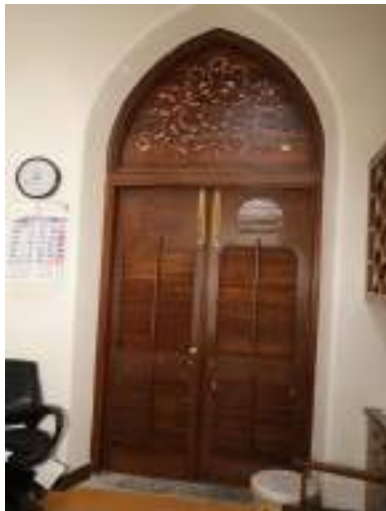
A restored door.

The original details were largely compromised upon. Packing up the fan lights, replacing the shutters with plywood and laminated doors, missing fixtures, broken glass infill layers of paint, were a common site. The damaged door parts were carefully dismantled and replaced with new members. Salvage material from roof boardings were used at places. Further, a specialized team carefully scraped off all layers of paint and finished with new thin layers of polish with natural finish. All the missing fixtures were replaced like the original.

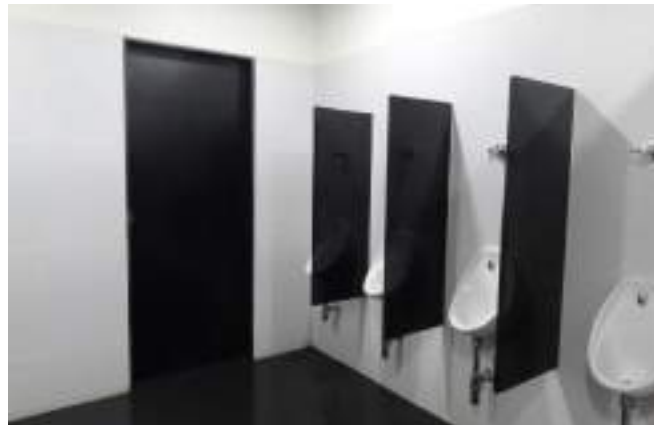
Restored public toilet.

The public toilets in the building are located in the extreme north and south corners of the public corridors on each floor. Heavy seepage has caused major structural concern. Like all other areas the slabs of the toilet slabs were taken up for structural consolidation/re-construction after which the interior works of the toilets were done. The interiors of the public toilets were kept similar in design with river washed kadappa flooring and green marble dado.

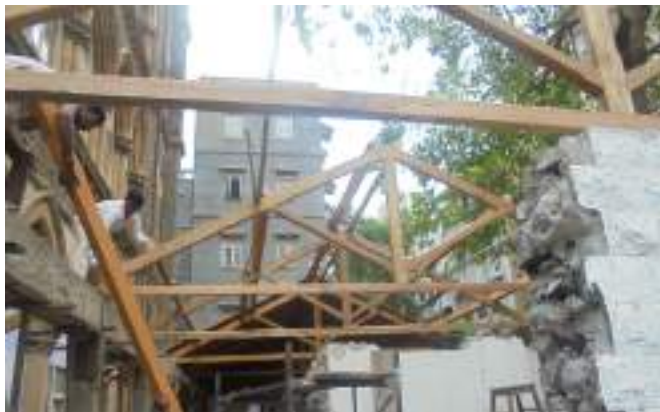
Timber roof over the new canteen building block.

A new ground storey canteen block with pitched mangalore tiled roof and stone walls was constructed instead of the existing R.C.C block. The roof was fabricated using well-seasoned Burma teak wood members with mangalore tiled finish. The walls were made in large stone slabs specially procured and hand dressed individually by skilled workers. The canteen furniture was replaced with newly designed wooden benches and tables.
