ST. PHILOMENA'S CHURCH

MYSURU

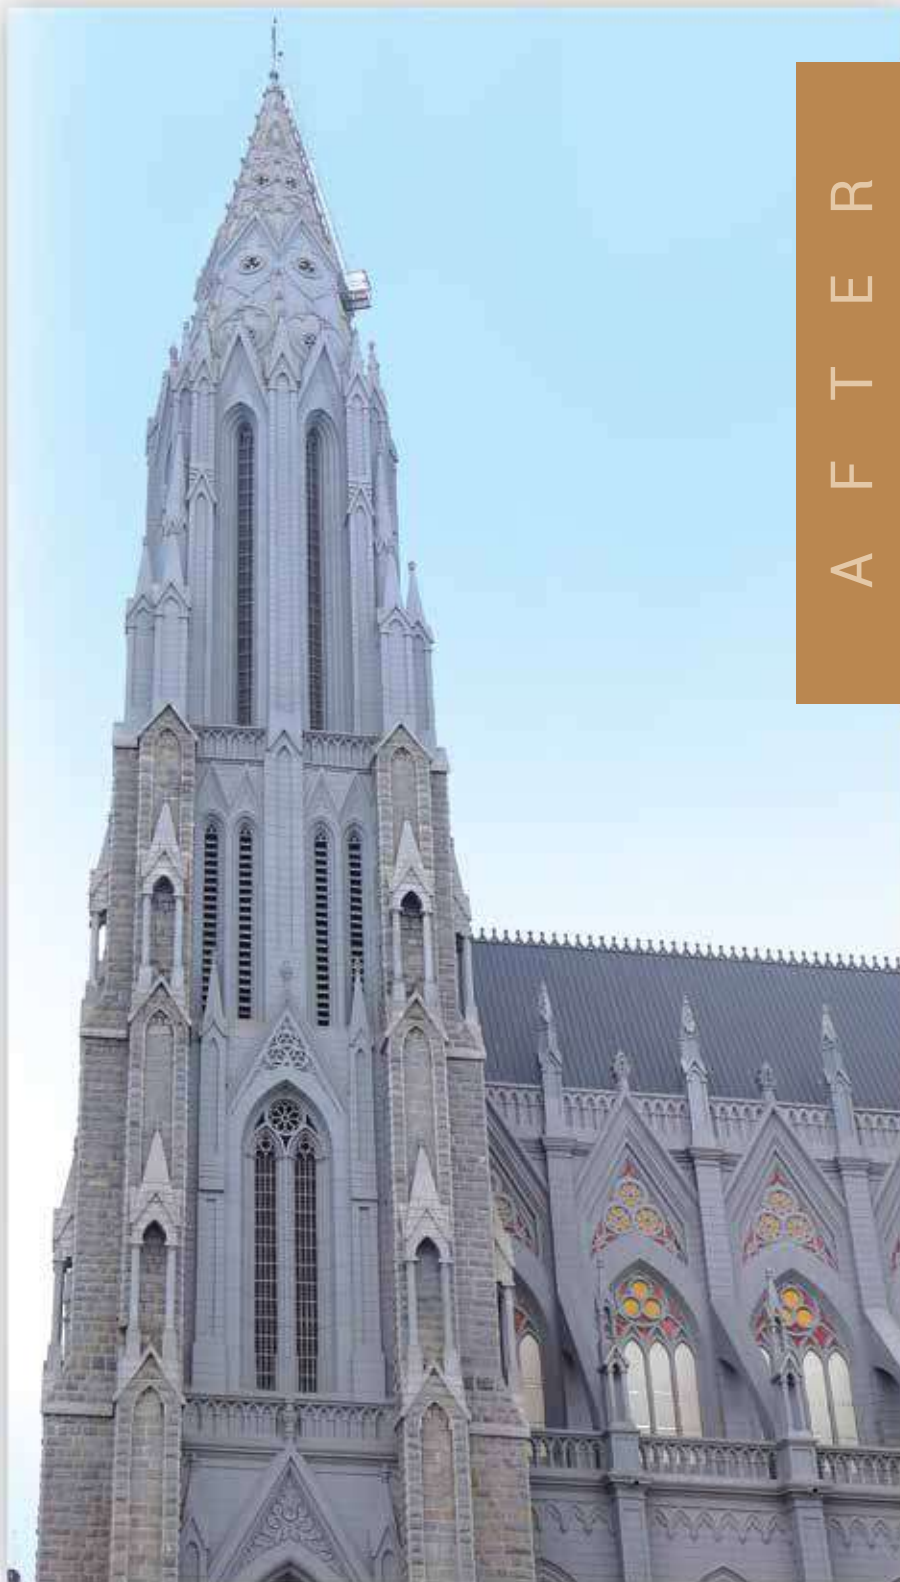
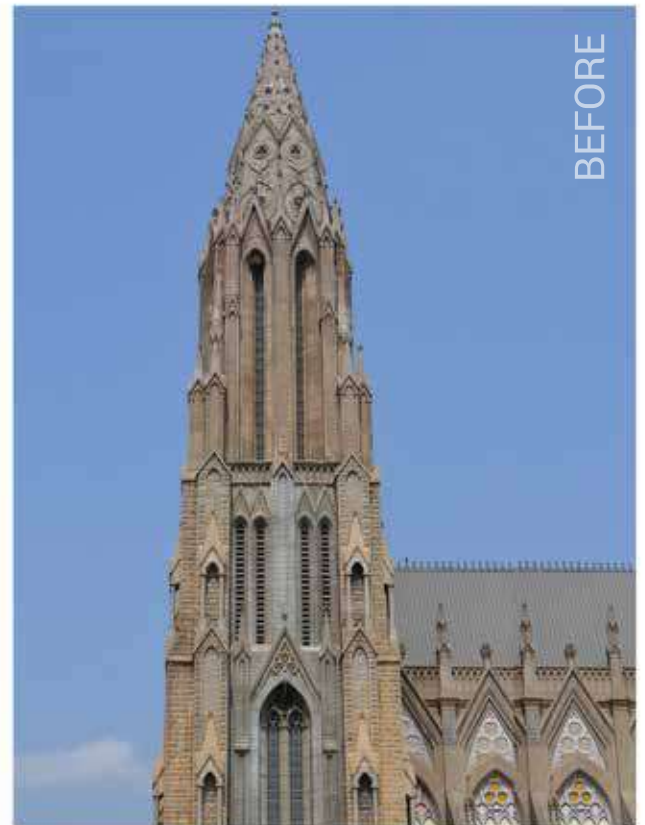
AFTER

The restoration work of the ancient St. Philomena's church was initiated. The chevet encloses within apse and an ambulatory. The chevet is the identity of the church and acts as a focal point of the church from a distance.

It is adorned with different styles of windows at various levels and hence breaks the monotony of horizontal structure. The chevet is typical of church's design irrespective of the style of architecture it belongs to.

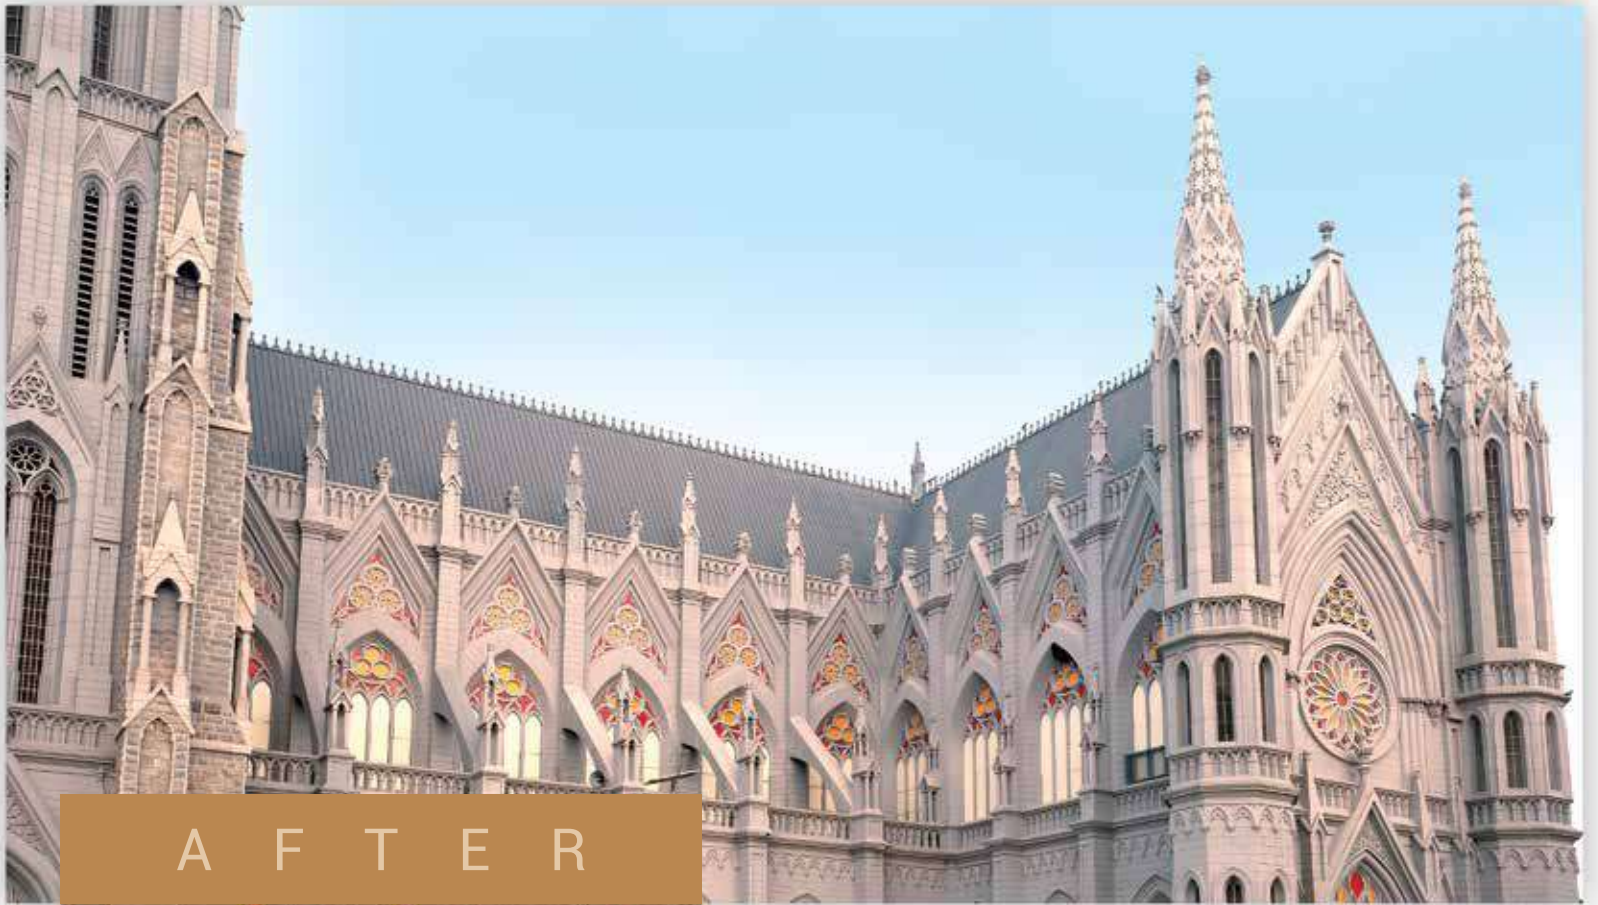
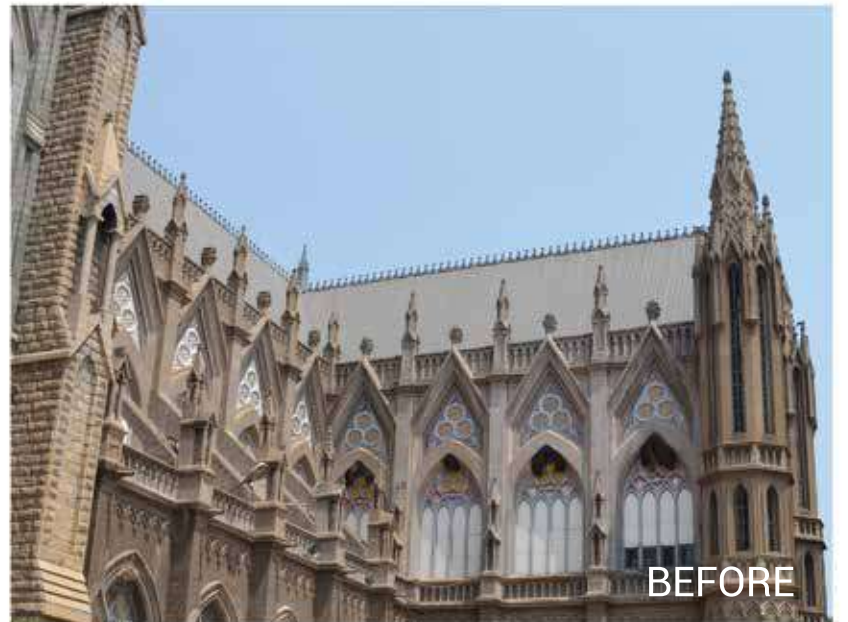
AFTER

Structurally the building is sound supported by flying buttresses on the exterior which strongly grasps the church building. The buttresses appear to be holding the structure together and blend with other architectural elements making the buttresses look like a part of the structure yet standing free.

One of the transept can be seen which forms the part of the cruciform plan. This transept has an entrance door adorned with a rose window above it.

A church has two transepts and both have entrances from either side. These entrance doors are enclosed well into the frame and extended by facade which is typically gothic oriented. Hence, the doors along with other architectural decorative were restored and the door was replaced with a new one.

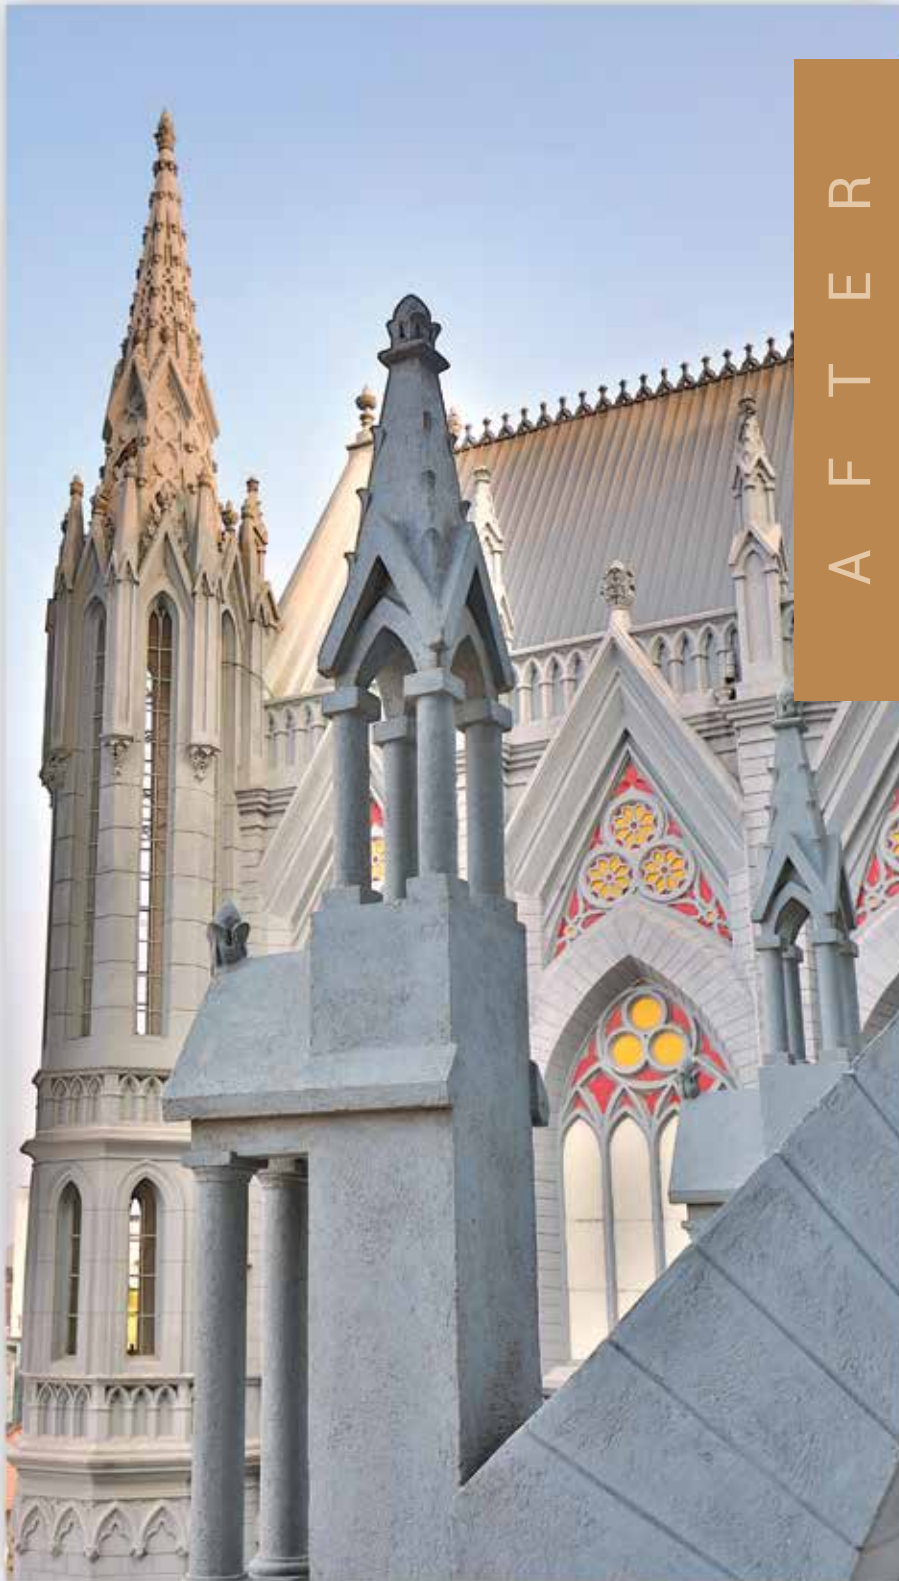
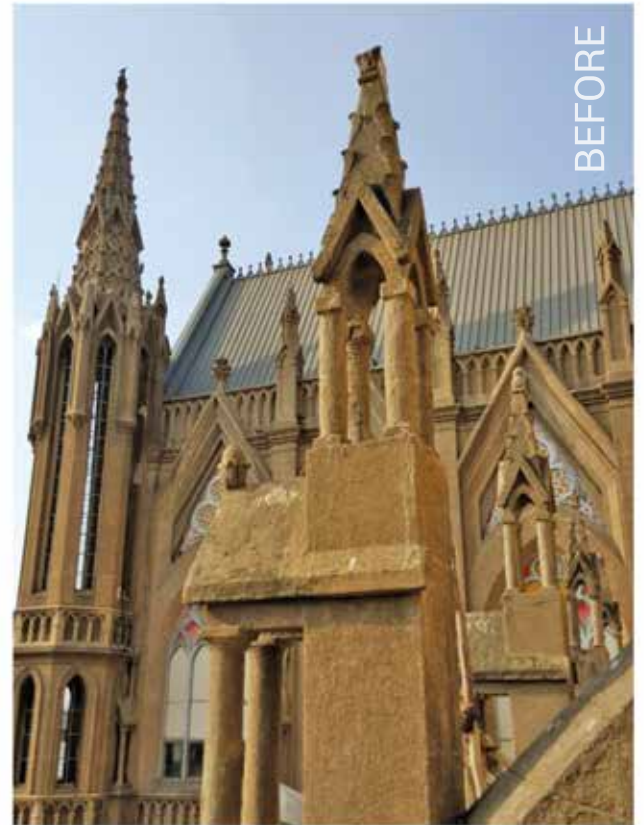
AFTER

The minaret and adjoining spires which are typical of the gothic architectural style adorns the mysore church by giving an appearance of extended height to the structure. These spires are present over the flying buttress and the corner steeples in the form of spires and minarets.

The presence of decorative over the spire is visually appealing and lends unique characteristic identity to the church's structure.

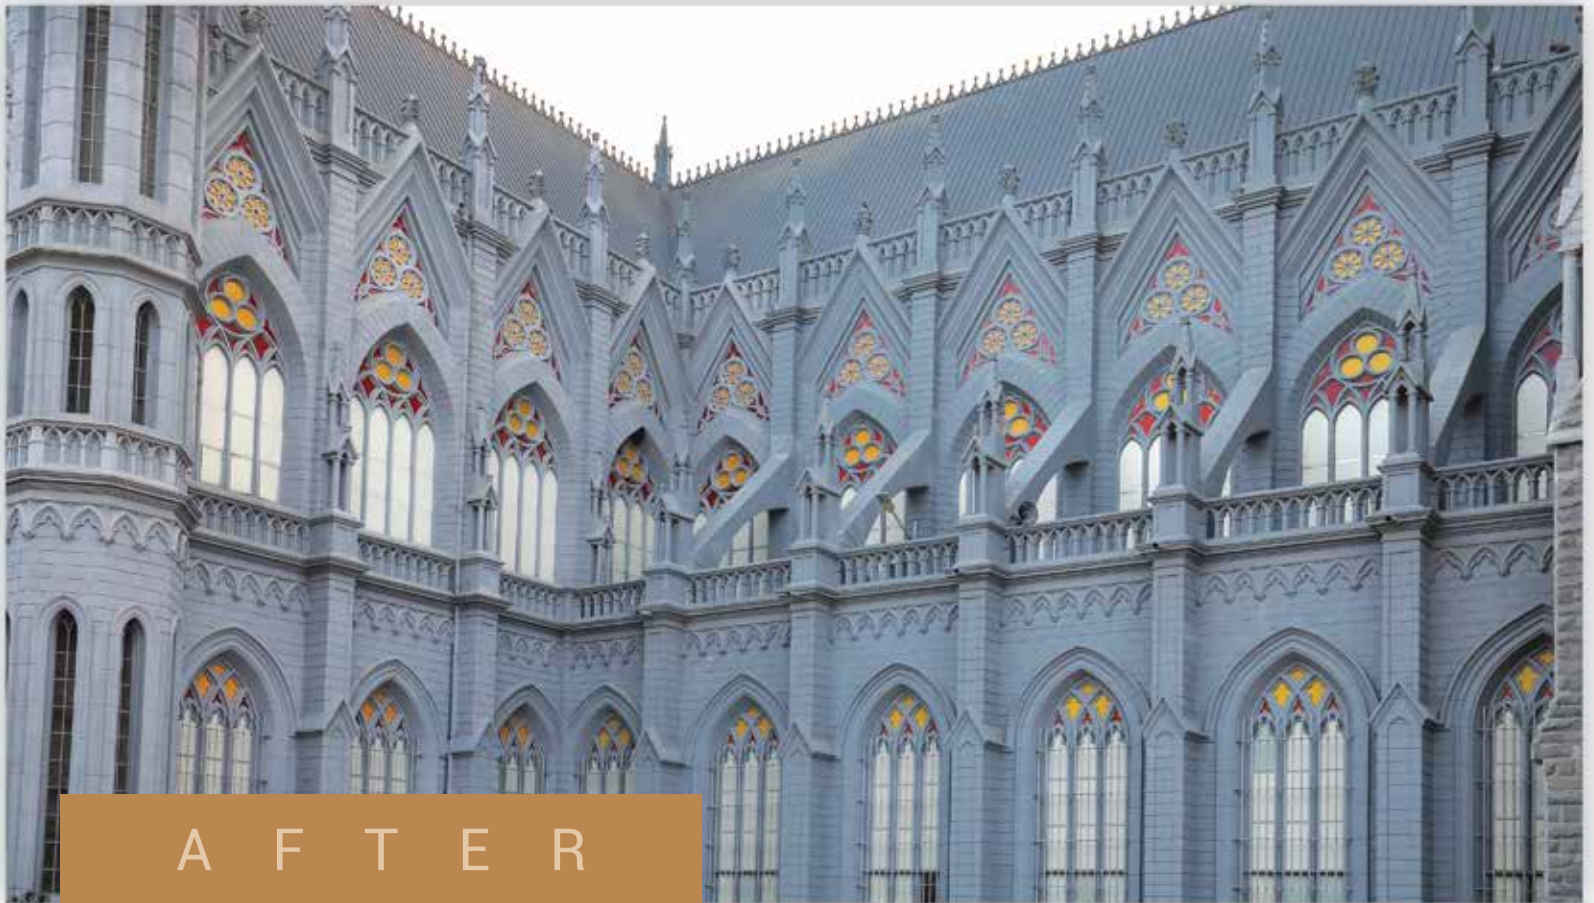
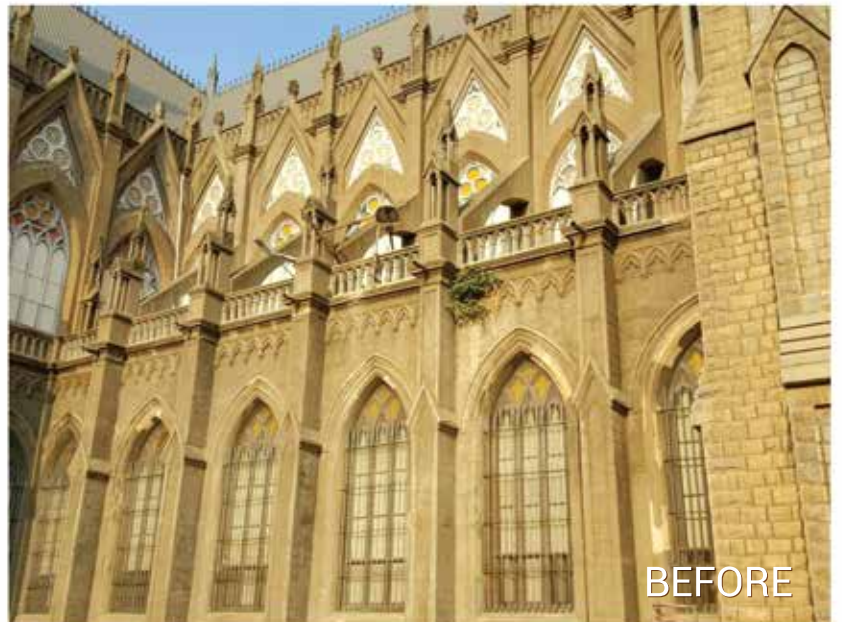
AFTER

The dominating character of the windows and arches at two different levels can be clearly seen.

The facade and the windows were restored and interventions executed were necessary.

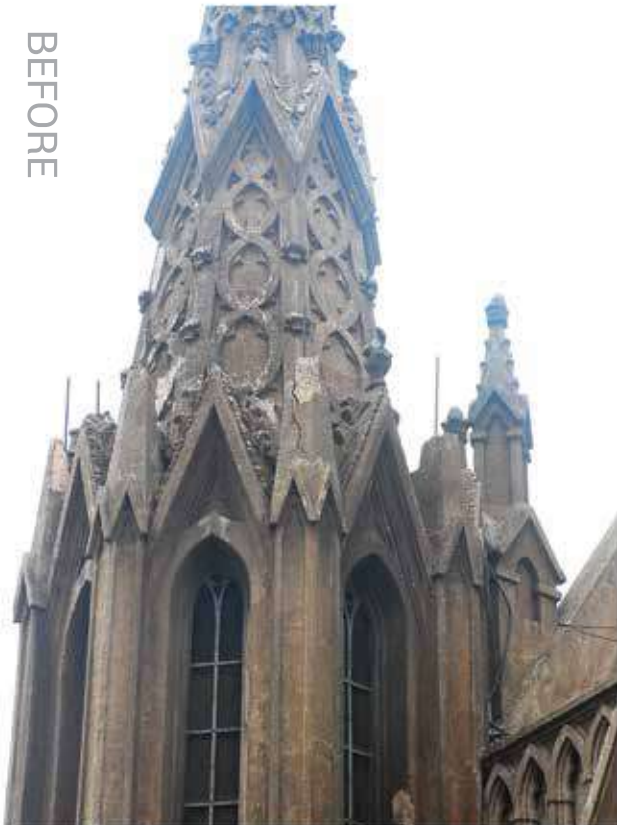
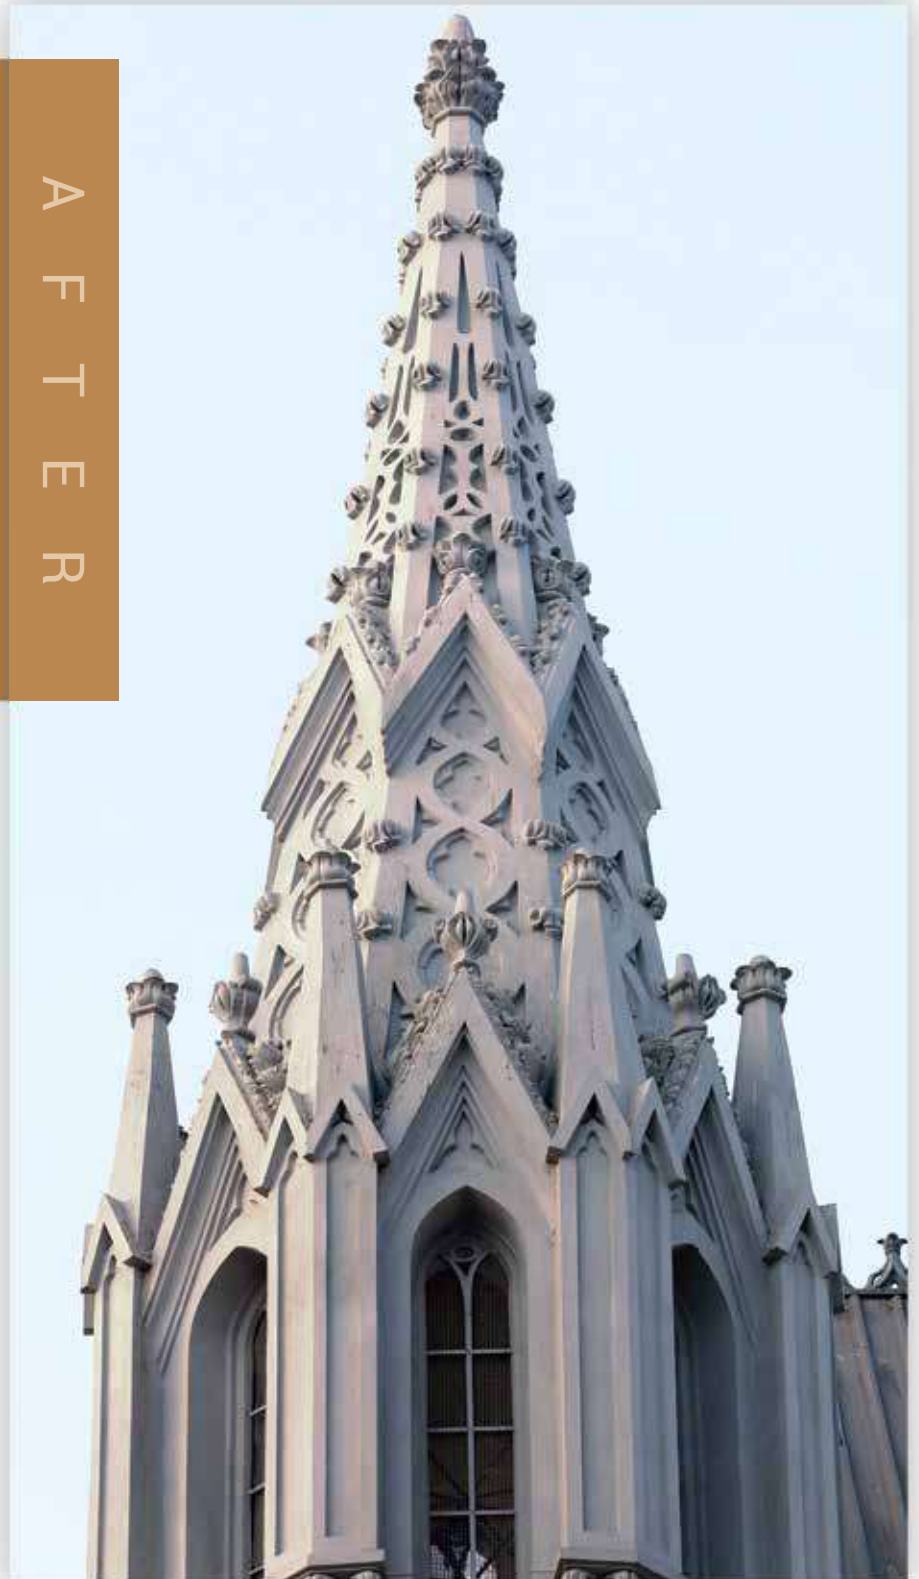
A
F
T
E
R

The spire being the top most part of the tower is acutely tapering pyramidal structure. The spire exhibits its gothic character due to the presence of trefoils and various forms of foliage patterns. The top of the spire is adorned with a finial, a small foliated ornament terminating at the peak of spire.

Being the top most point of perspective, the restoration of its adjoining members was one of the preliminary concerns of church restoration.

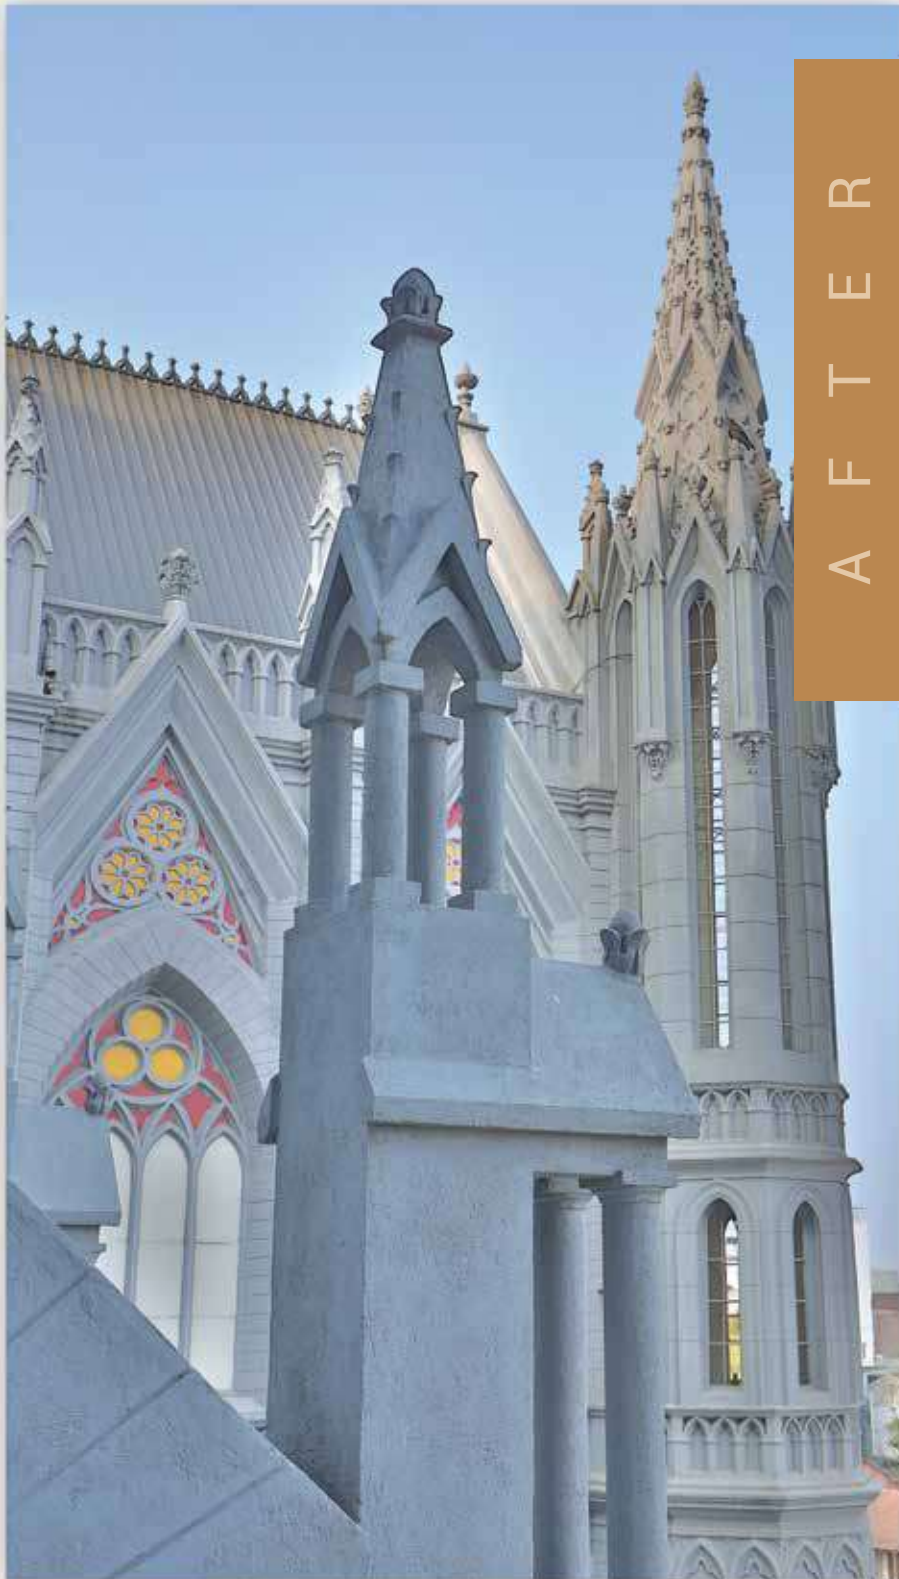
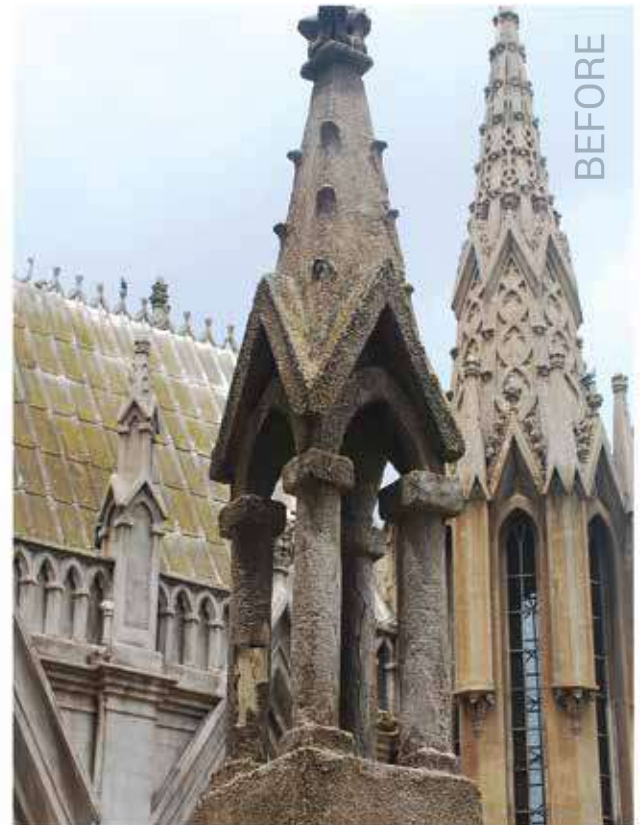
AFTER

The spire of the church is a member which is tall, acutely tapering pyramidal which surmounts the tower. The tower has long slender windows just beneath the spire and smaller windows at middle level. Hence the spire and the turrets were Restored with traditional Lime mortar.

These foliated ornaments terminate at the peak and add distinctive character of the church at the roof level.
