St. Thomas Cathedral, Fort, Mumbai

With standing the test of time and climatic changes, church building began to show the signs of wear and tear which was spotted by the trust caretakers. 'Savani Heritage Conservation Private Limited' a prestigious name in heritage site restoration was given the task to resurrect the building whilst preserving its architectural and textural features. A dedicated team of experts from Savani Heritage Conservation Private Limited engaged in the task by employing skilled masons and labourers under the supervision of Engineers to execute the task. In the year 2003, the Phase-I of the restoration began under the leadership of the Principal Ar. Brinda Somaya of Somaya and Kalappa Consultants which focused on the Altar and the Ancillary structure. While, the Phase-II restoration and repairs were carried out as required under the Consultation of Conservation Architect, Ar. Sheetal Gandhi, who focused on the tower and the internal repairs. Generous donations were made from Philanthropist Mr. T. Thomas and Mrs. Meera Issacs that made the big task of restoration of Cathedral possible.

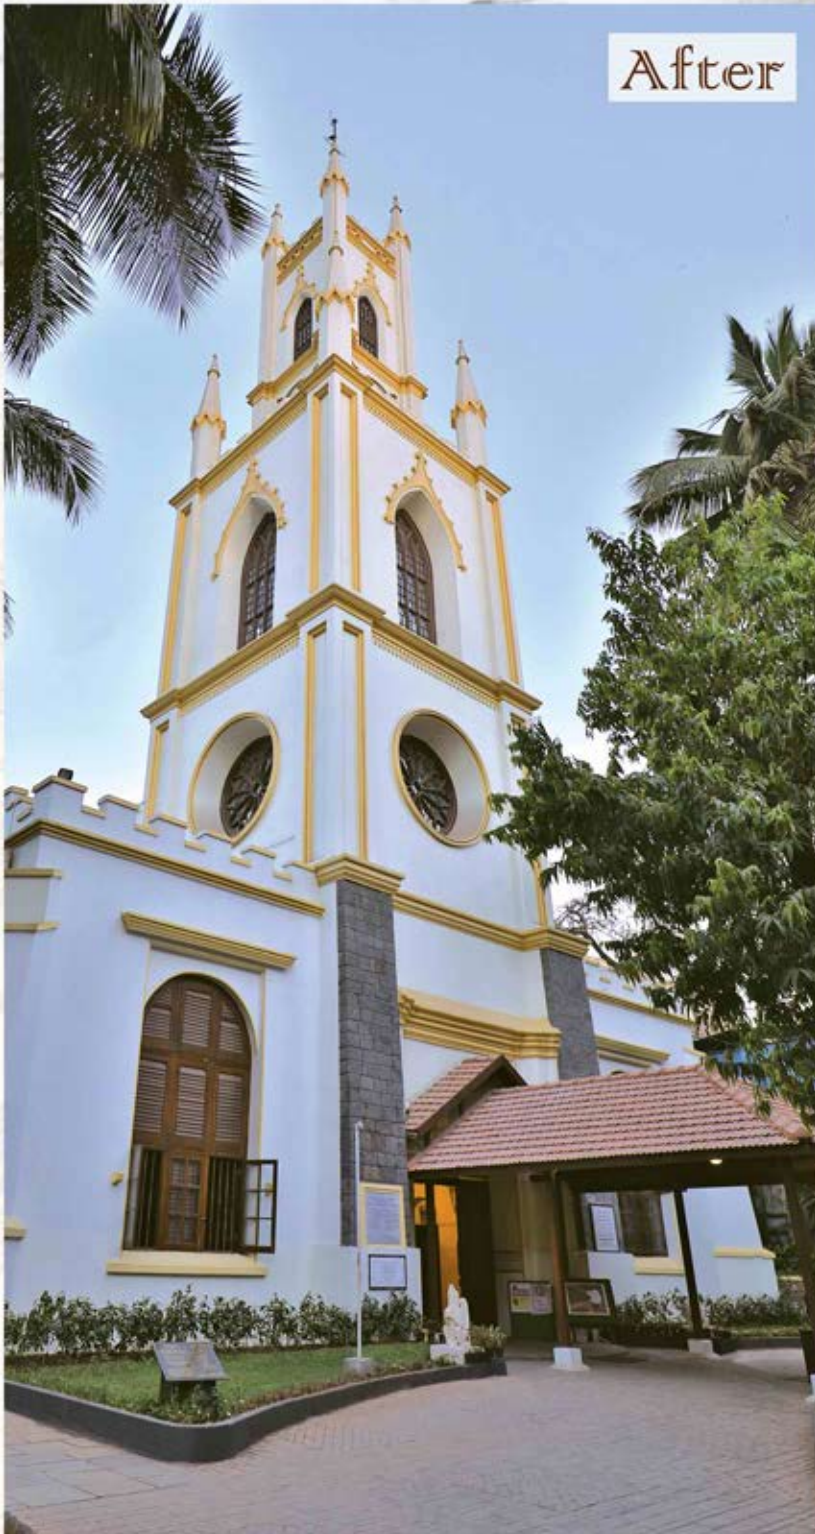
With the passage of time, the entire structure of tower (its total length) got contaminated by biodeteriogens which resulted in algal growth and the plaster appeared flaked or faded giving a dull appearance. The dampness was the chief reason of deterioration as the damp patchesshowed prominently on surface of the tower and on its windows. After taking cognizance of the cause and effect, thoughtful measures were taken for conservation, restoration and repair work. All the flaws were eliminated from the structure of the tower which has been duly justified by the pre and post photograph of the site.

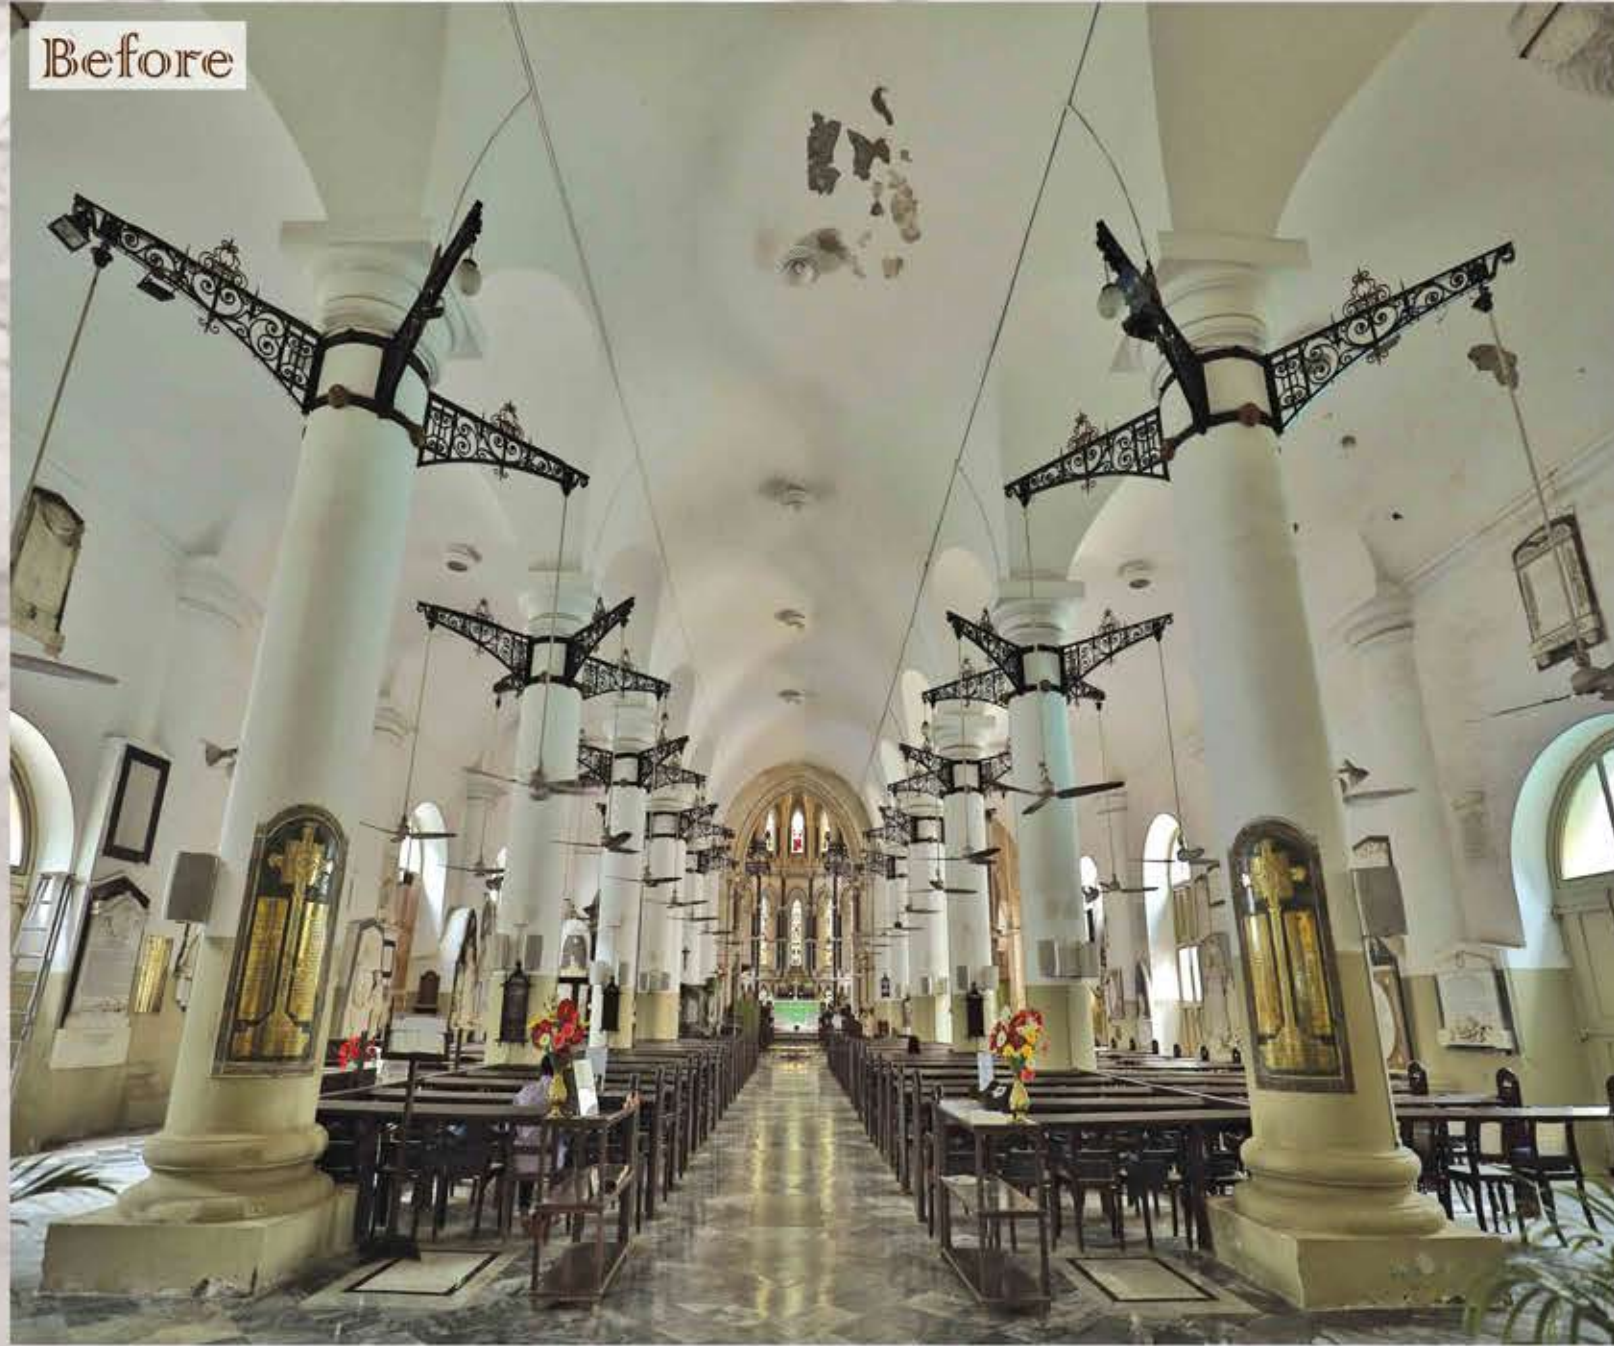
Before

The vault arrangement forms an air-chamber to serve the purpose of air ventilation. This had developed intensive dampness due to flaked plaster. A considerable interior restoration and repair works of different kinds were executed to restore the structure. Moreover, the structure was applied with warm shades of illumination, which brought back the grandeur of the cathedral.

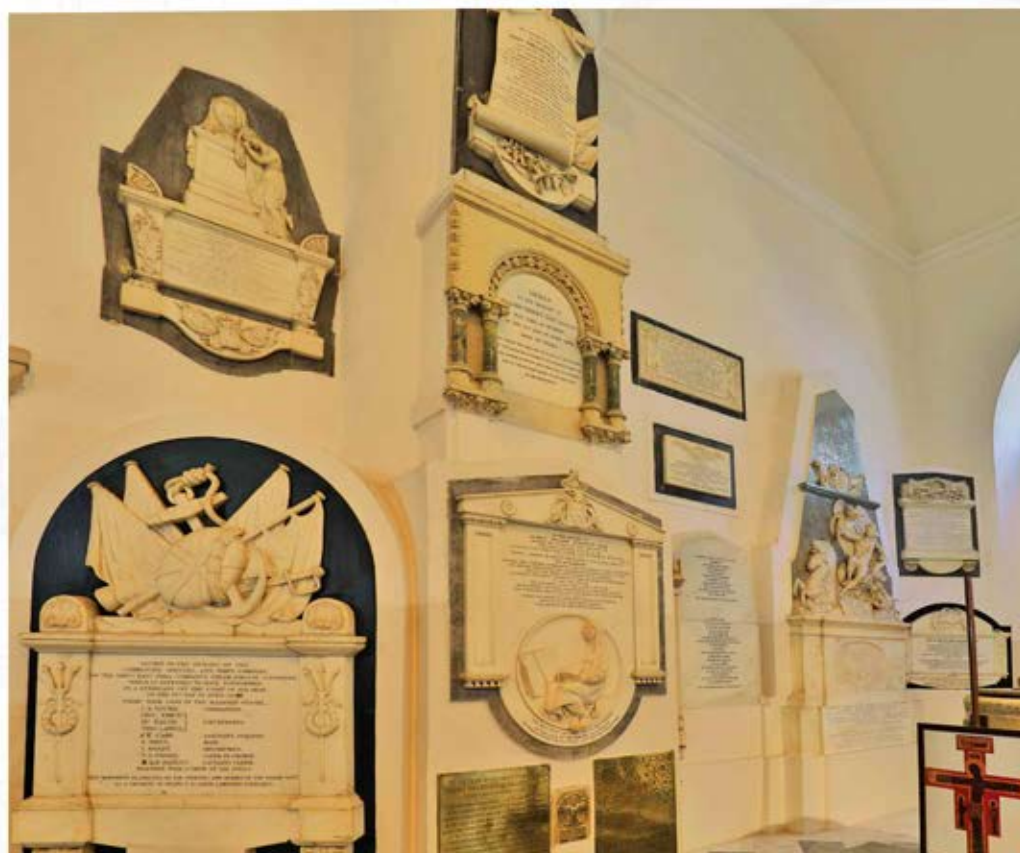
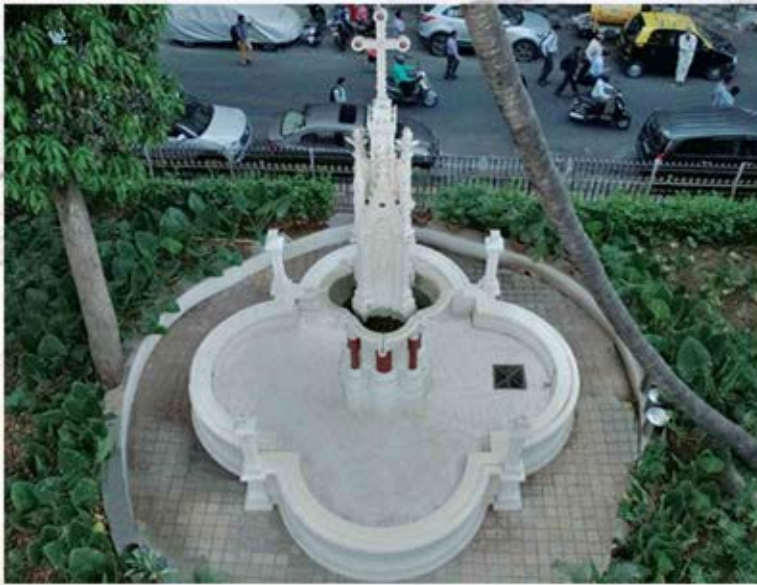
The elegant fountain was designed and executed by Ar. Gilbert Scott where the pipes are well concealed. But with passage of time, the fountain developed severe damages and leakages and wore a stained look due to algal growth.

The fountain was cleaned, plastered and brought back into working condition.
