TOWN HALL
&
OLD MUNICIPAL OFFICE
VISA KHAPATNAM

About Us

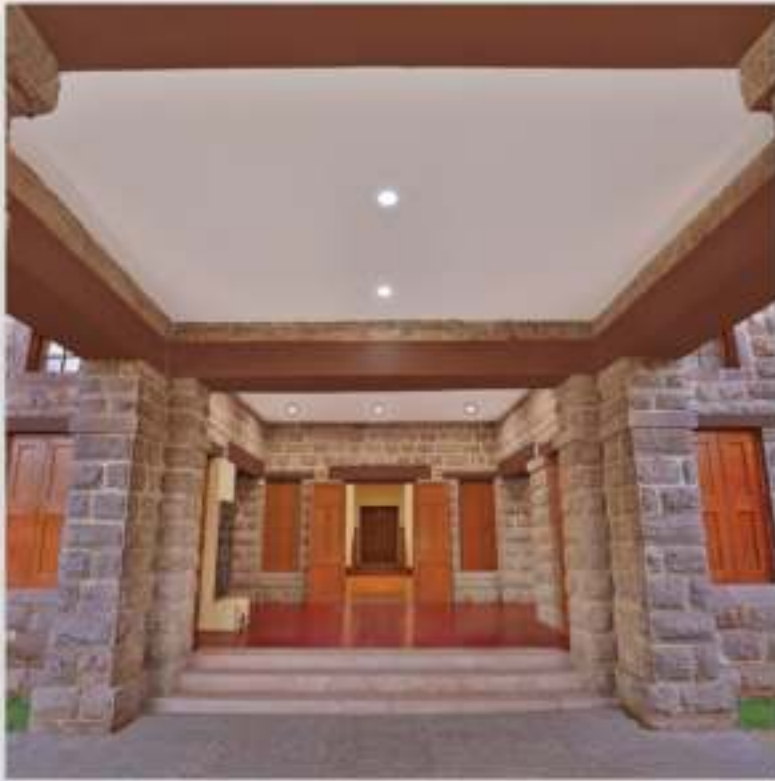
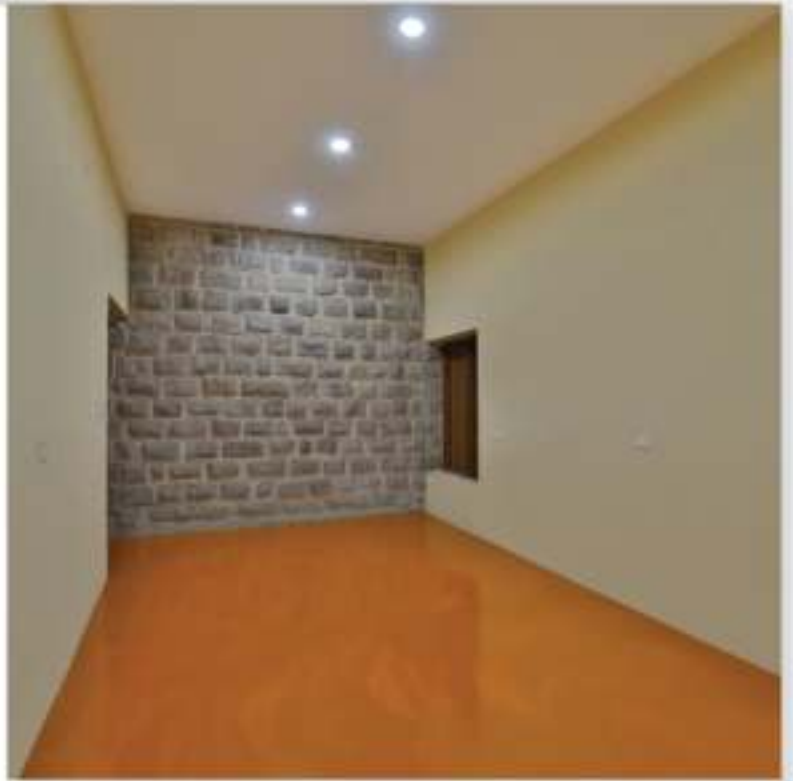
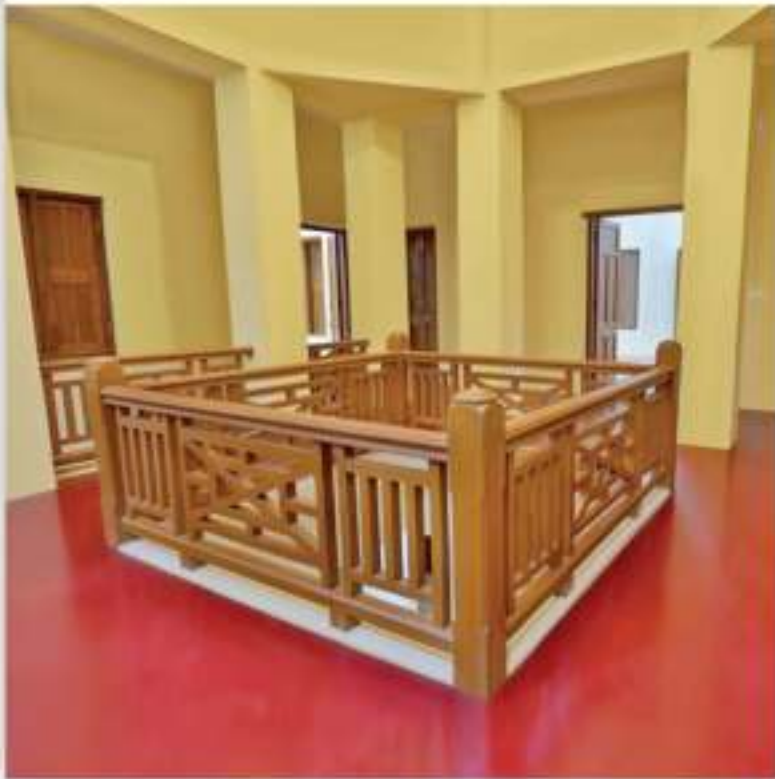
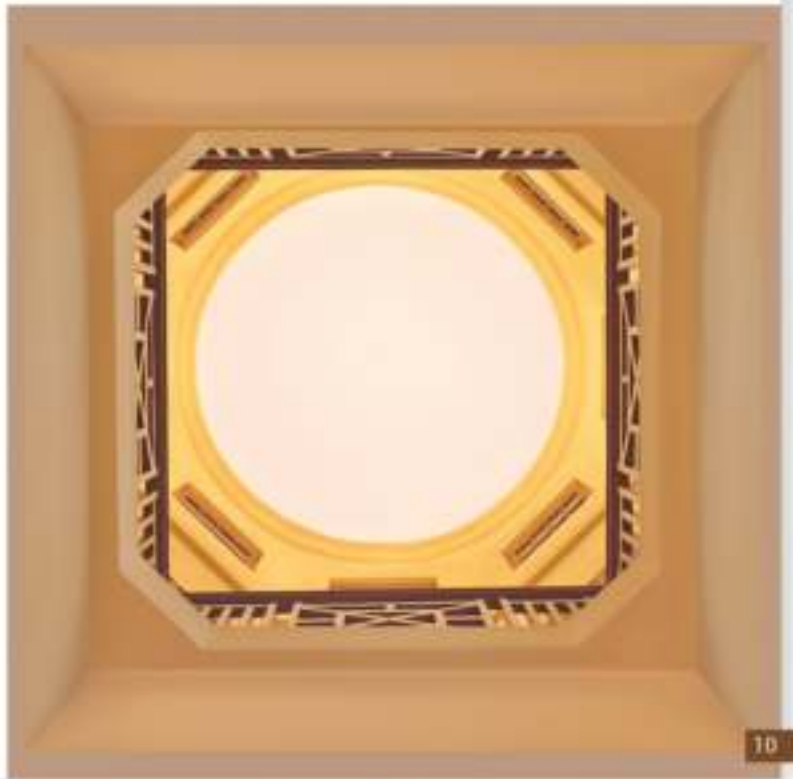
The two entrances to the Town Hall display their own styles. The area in the foreground of the amphitheatre will serve as a place for performances of various shows. The amphitheatre will act as a leisure place from where one can adorn the structure.

The introduction of Landscape elements such as an amphitheatre, lampposts, paved pathways and green patches has pleasingly enhanced the surroundings.
